1-15 Fontenoy Road

Macquarie Park, NSW 2113

Condition Report

July 2012

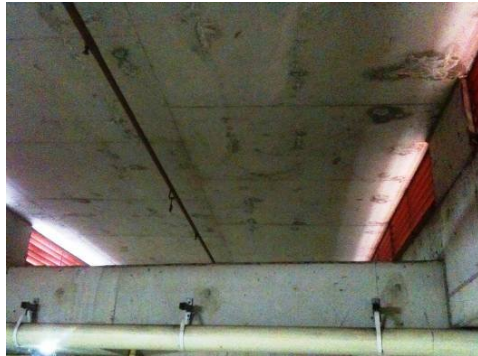
We noted an isolated area of minor water penetration through the concrete soffit of the basement car park adjacent to the raised roof light area between Block A and the tennis courts. This is likely due to the planted areas above which, in heavy rain, will seep water through the planter boxes to the car park below. This will not affect ongoing operations however routine monitoring of the soffit and perimeter walls for any major water seepage is recommended.

Minor water penetration through soffit

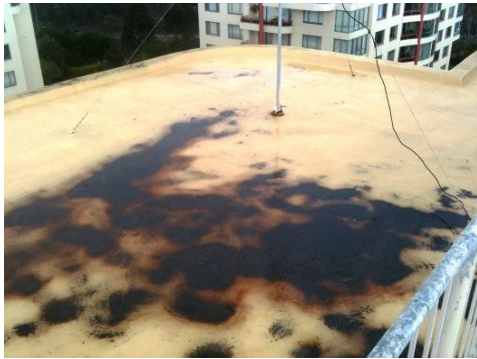
The flat concrete deck roof areas to Blocks A, B, C and D contain large areas of standing water. A number of previous patch repairs have been carried out. The surfaces require preparing and recovering with a liquid applied waterproof membrane within the short to medium term (1-5

years). Block C was observed to be in good overall condition with Block D suffering the most standing water.

The falls to the drainage are insufficient and improving the existing falls should also be considered. The internal units were not inspected for any water penetration via the roof slab.

Standing water to flat roof deck, Block A

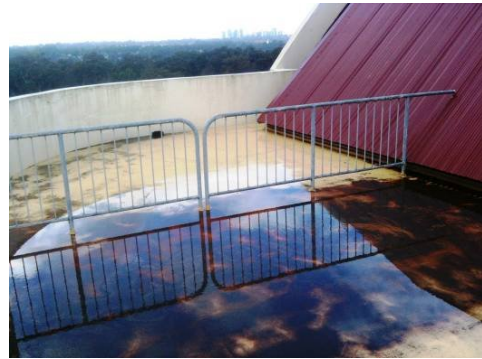
Standing water to flat roof deck, Block B

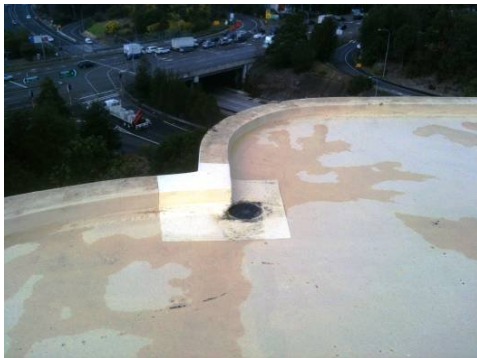
Previous patch works evident

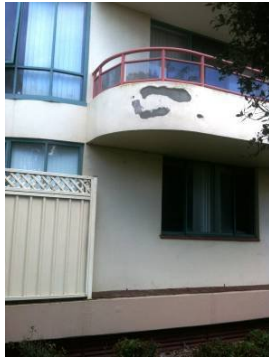
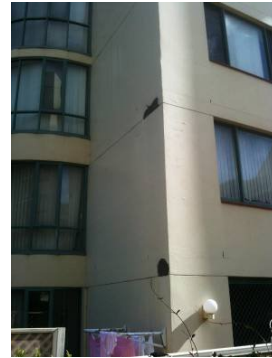
Where visible, the tower façades were generally in fair to good condition commensurate with their age and construction type. Minor patch repairs have been undertaken in the past where rendered finishes have become loose over time. Other isolated areas will require minor repairs over the medium and long term to preserve the appearance of the façades.

Isolated patch repair awaiting redecoration

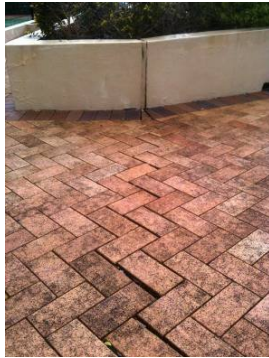
The construction joints formed within the basement car park soffits allow differential movement of the structure. This is subsequently affecting the brick paving to the common circulation areas above as well as the dwarf walls to the planter boxes causing isolated areas of cracking and minor movement. Affected areas of paving have risen in line with the construction joints below potentially causing trip hazards. Affected areas should be repaired through ongoing routine maintenance to prevent any future trip risks. The dwarf walls can be cosmetically repaired with sufficient movement jointing incorporated.

Isolated raised paving

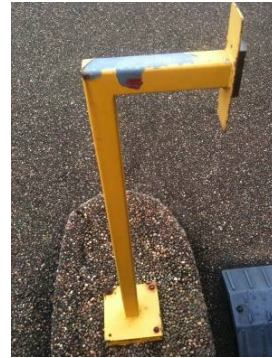
Timber and metalwork to common areas such as painted balustrades, handrails and fire exit doors are largely in good condition however decoration is deteriorating in areas. Redecoration of affected surfaces should be undertaken as per routine repairs and maintenance.

Redecoration required to metal surfaces

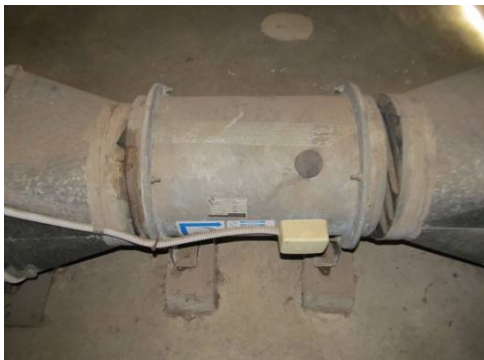
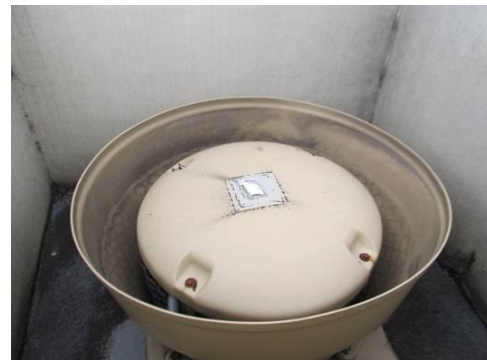
No plans or maintenance documentation was made available for review. The roof top fans were not labeled it was not possible at the time of inspection to identify the different types of ventilation systems. It is recommended that all ventilation fans be clearly labeled.

Typical unlabelled Inline axial fan located in roof top plantroom

Typical unlabelled roof mounted fan

It is recommended that the mechanical ventilation duct work be internally inspected and cleaned if required.

Regular testing and maintenance of the mechanical ventilation systems is recommended to manufactures specifications.

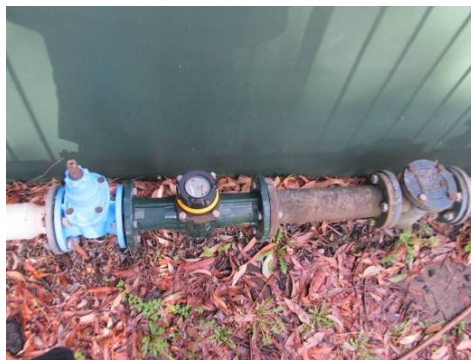
The main domestic water supply does not have a backflow prevention device installed as required by AS 3500:1 and Occupational Health and Safety Regulation 2001, Division 1 Clauses 34 & 35. It is recommended that a backflow prevention device be installed.

Authority water meter without back flow prevention device installed

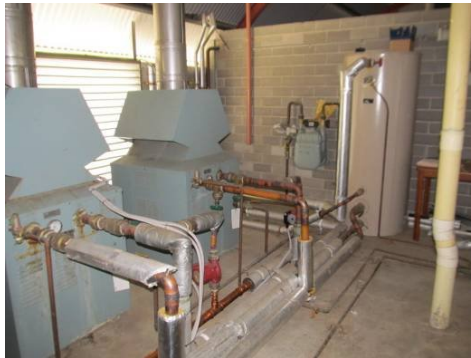
The domestic hot water system appeared to be in good condition with no reported defects. However, life cycle replacement of the hot water heaters may be required within the long term, depending on the level of repairs and maintenance.

Inspection of the tower buildings' roof top plantrooms found them to be used for storage and the redundant water storage tanks still in the plantrooms making the plantrooms unsafe for repairs and maintenance. The plantrooms need to be made safe and Occupation Health and Safety compliant.

Typical tower building domestic hot water system

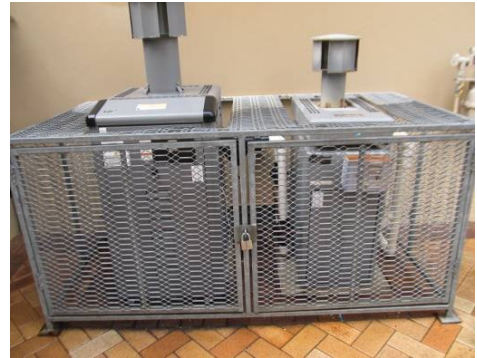
The gas fired heaters appear to be in fair current condition, however, are likely to require replacement toward the end of the long term.

Gas fired swimming pool and spa heaters

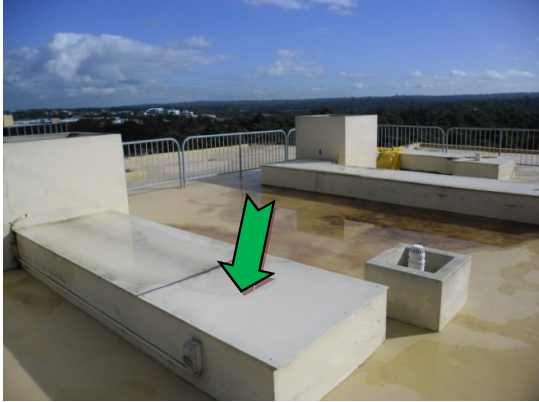
Photo 1. Block A, roof, box covers – non-asbestos containing compressed fibre cement panels

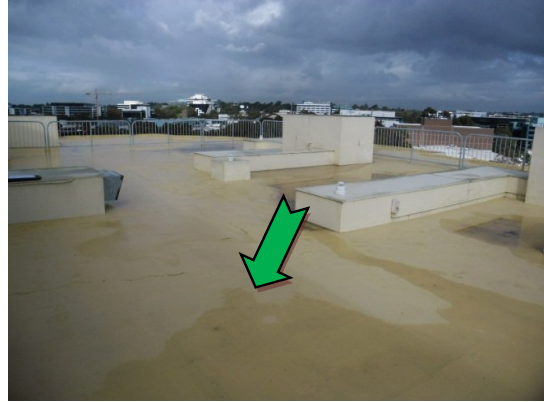
Photo 2. Block A, roof, floor – non-asbestos textured coating

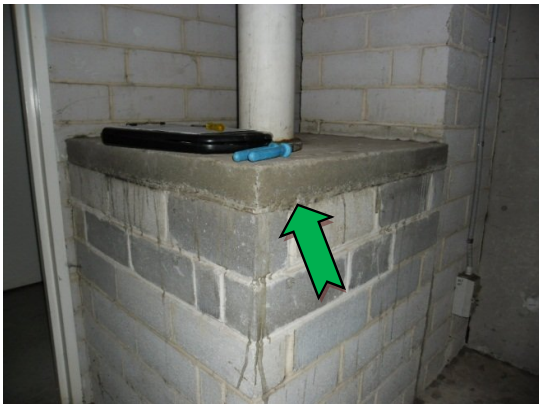
Photo 3. Block A, roof, plant room, packer – non-asbestos compressed fibre cement panel

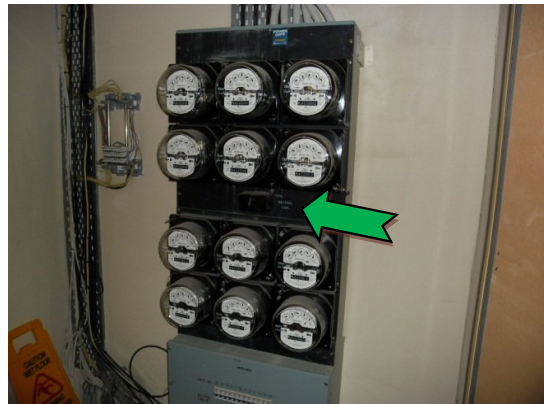
Photo 4. Electrical boards, throughout Block A, B, C & D – non-asbestos bakelite panels

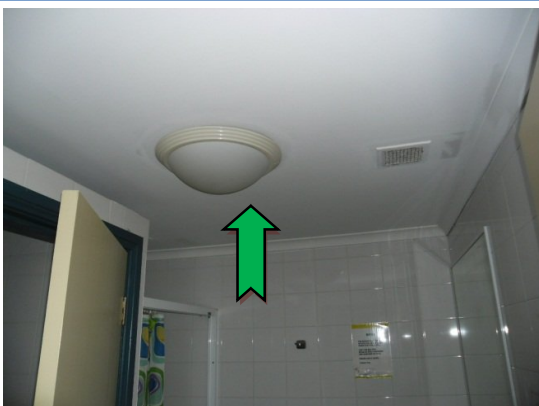
Photo 5. Spa facilities, change rooms, ceiling – non-asbestos fibre cement sheeting

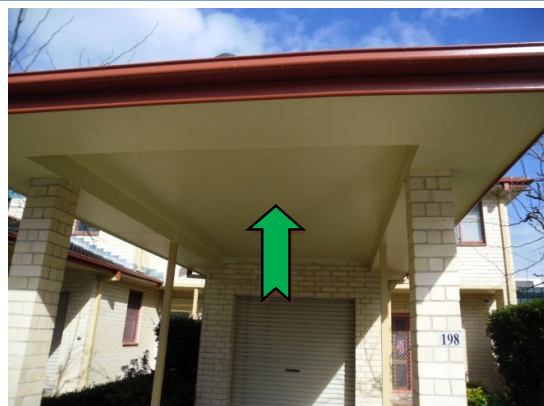
Photo 6. Terrace houses, carport awning – non-asbestos fibre cement sheeting
