SP52948 Lot 158 outstanding repairs of common property on 12th of May 2021

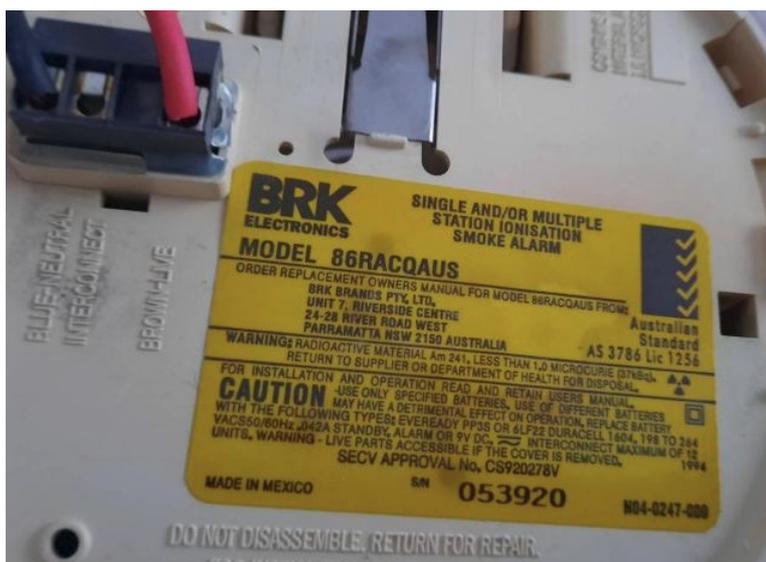
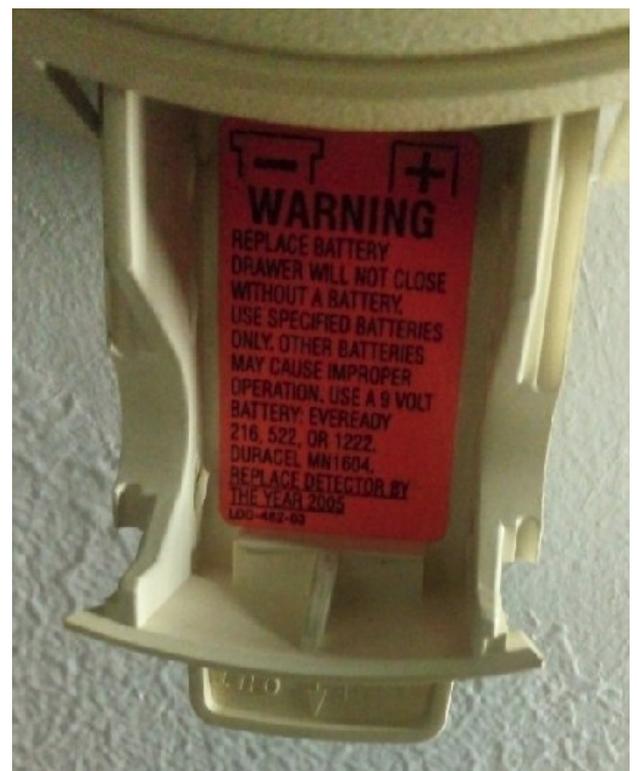
Ensuite bedroom (manufacture date 1994, expired in 2005)

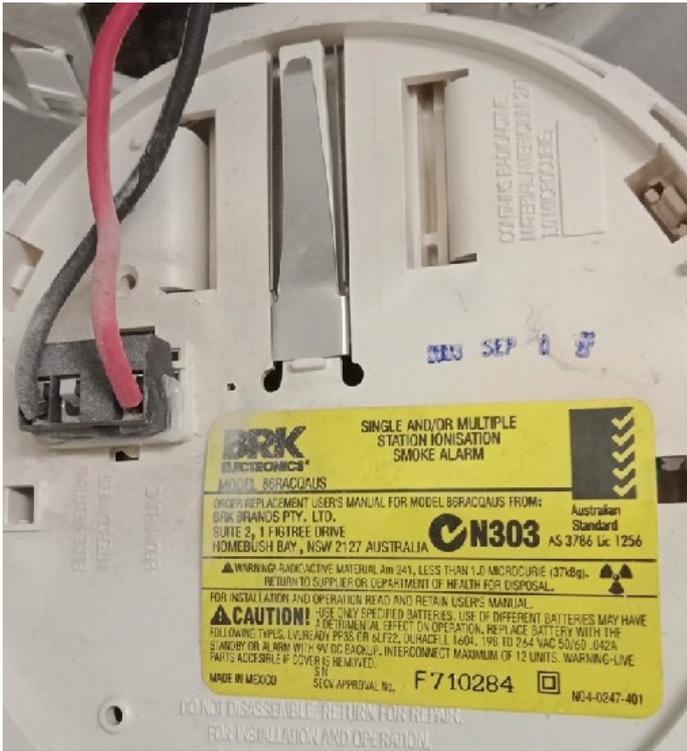
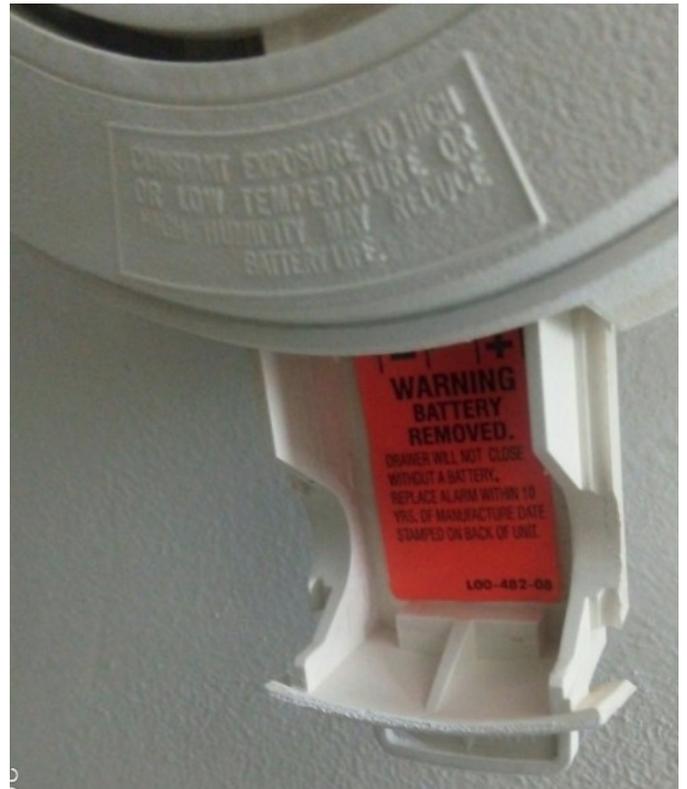
Foyer near main bathroom and kitchen (manufacture date 2008, expired in 2019)

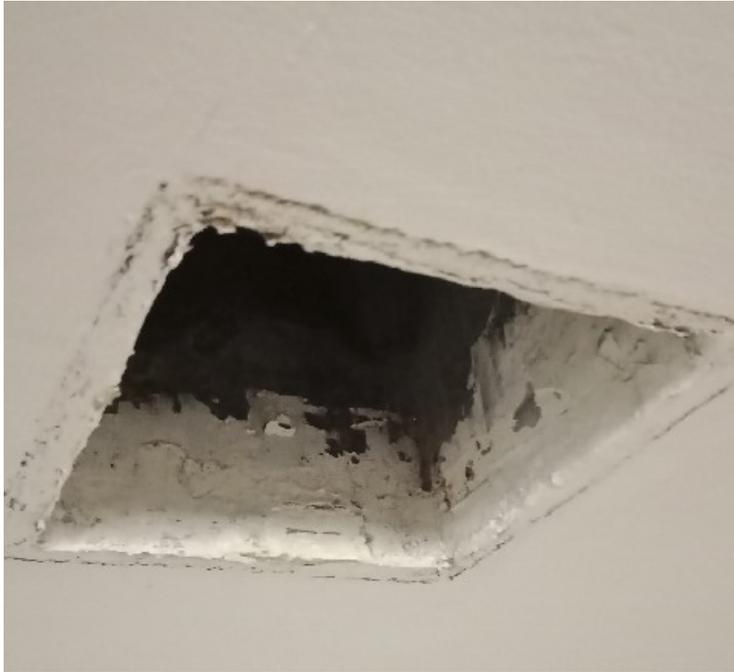
2) Broken grille in ensuite bathroom

26 September 2020 (handyman made a temporary repair that lasted till early 9 February 2021)

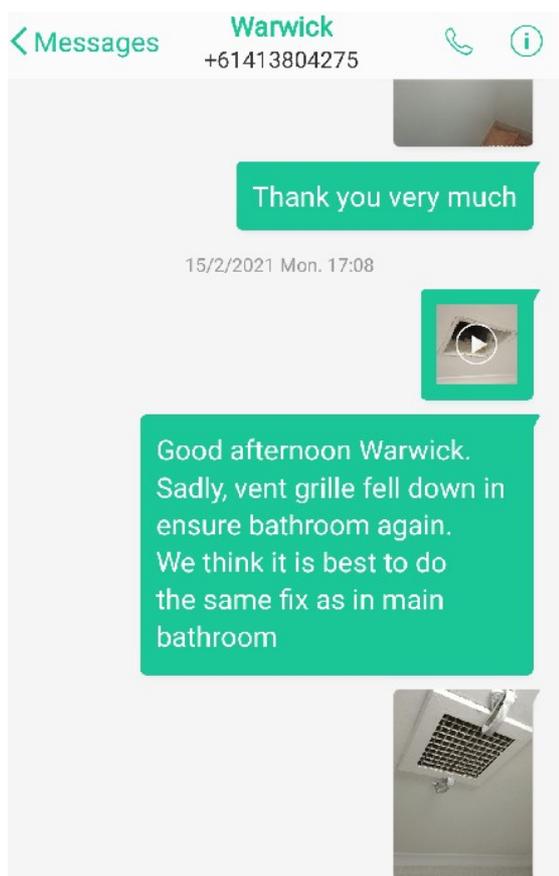
Handyman Warwick promised to come back and fix it properly on 15 February 2021, as per SMS evidence:

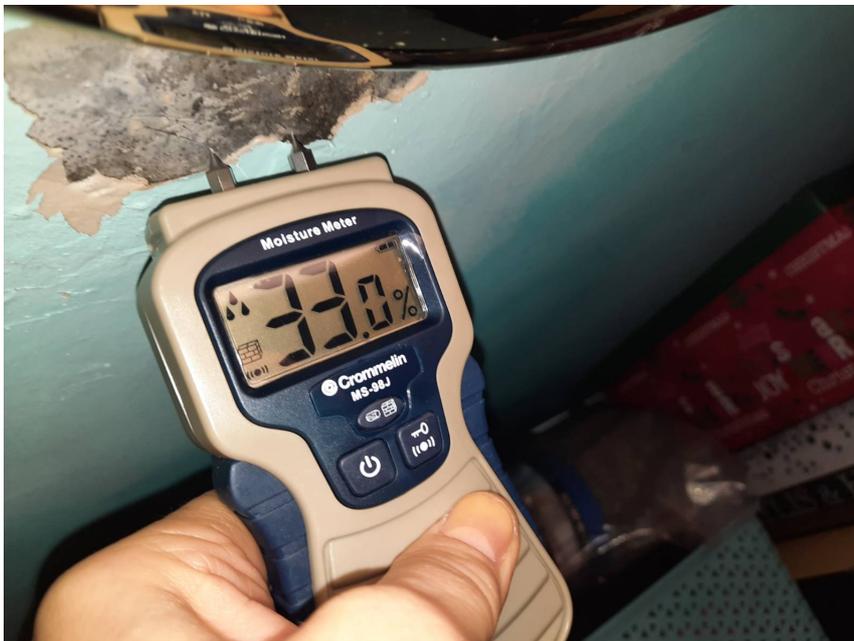
4) Water leaks near electrical lighting in sunroom

Photos and videos taken on 11 and 12 May 2021 show that the ceiling is moist and full of water residue in certain areas near electrical lighting, creating high risk of fire hazard and electrocution.

Lot 158 took moisture meter readings in various areas of the ceiling and it is obvious that water damage near electrical lighting is a major problem, with disaster just waiting to happen.
