Health hazard – Supporting smoking by providing access via fire doors

In spite of many warnings about health hazard and non-compliance with SP52948 By-Laws and SSMA 1996 and 2015, owners corporation provides direct and unrestricted access through fire door at the back of Block A.

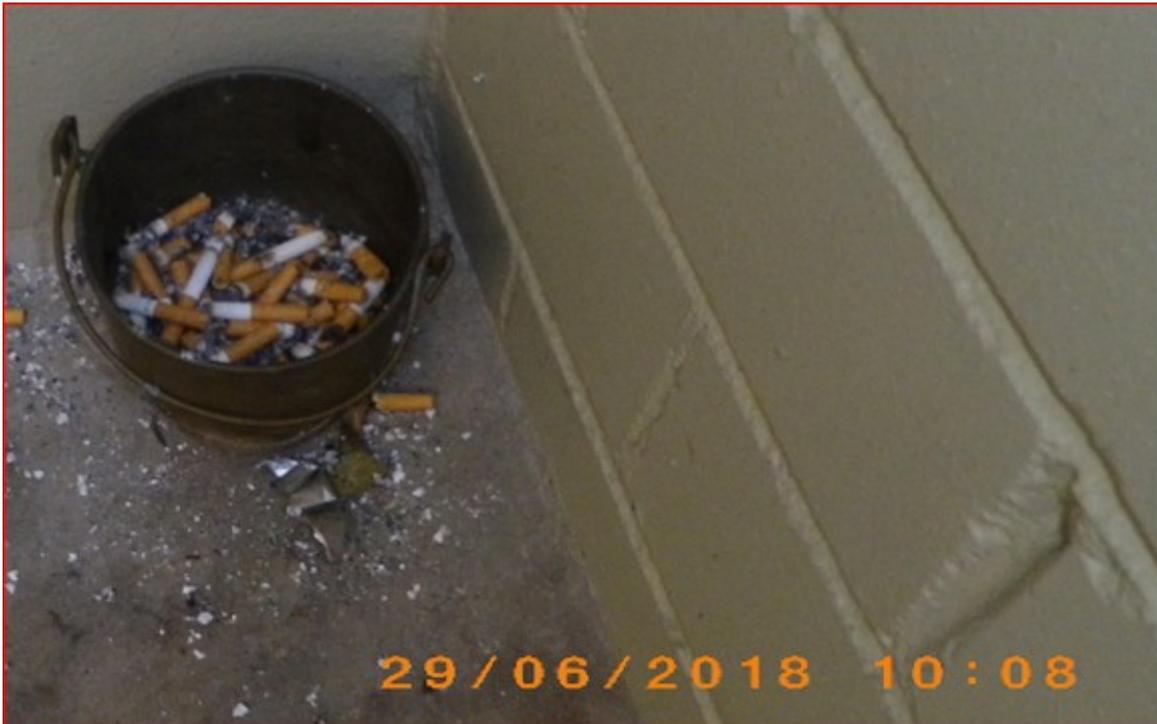
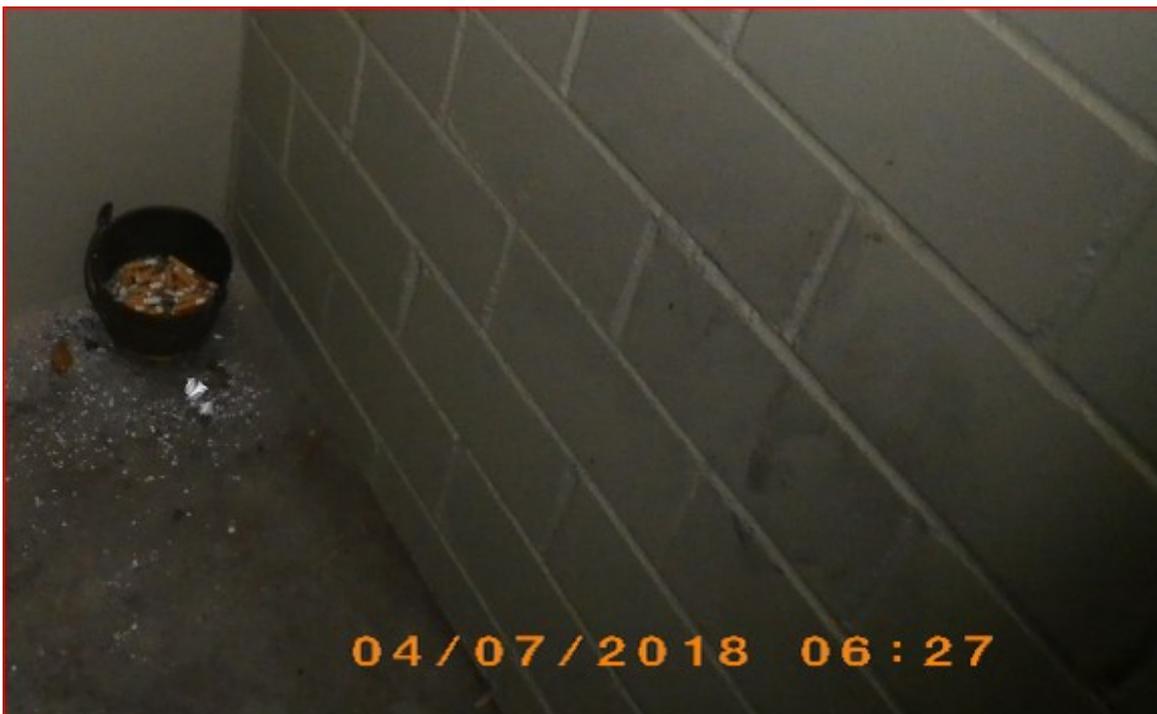
The two photos, show lack of maintenance, and poor schedule for cleaning.

In the past, cigarette lighters and dirty cloth was found to be thrown on the grass at the back of Block A for prolonged periods of time.

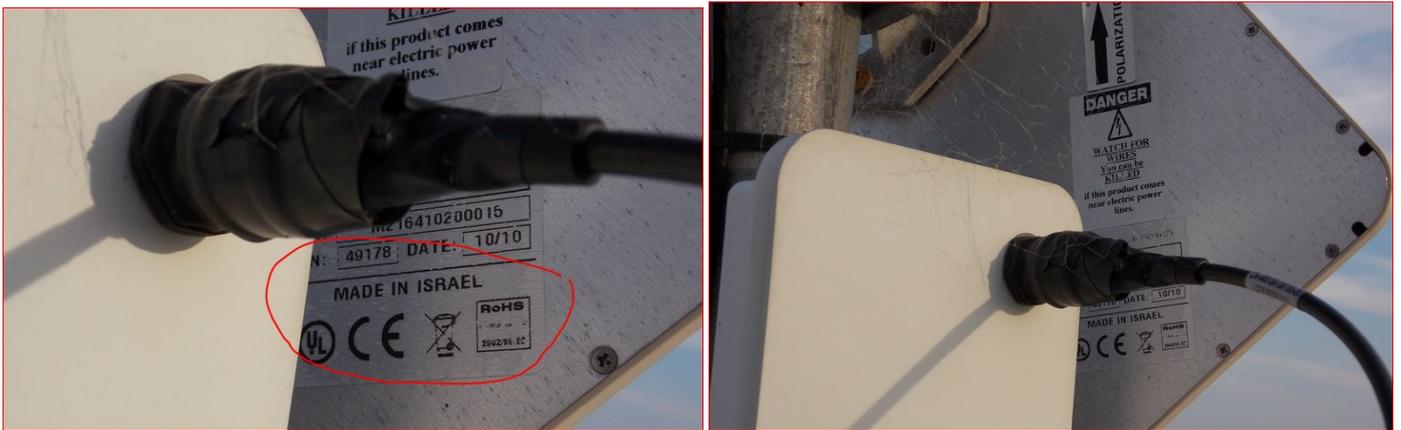
In late 2014, the following photos were taken by me on roof n Block C, during my regular checks of the management of the complex:

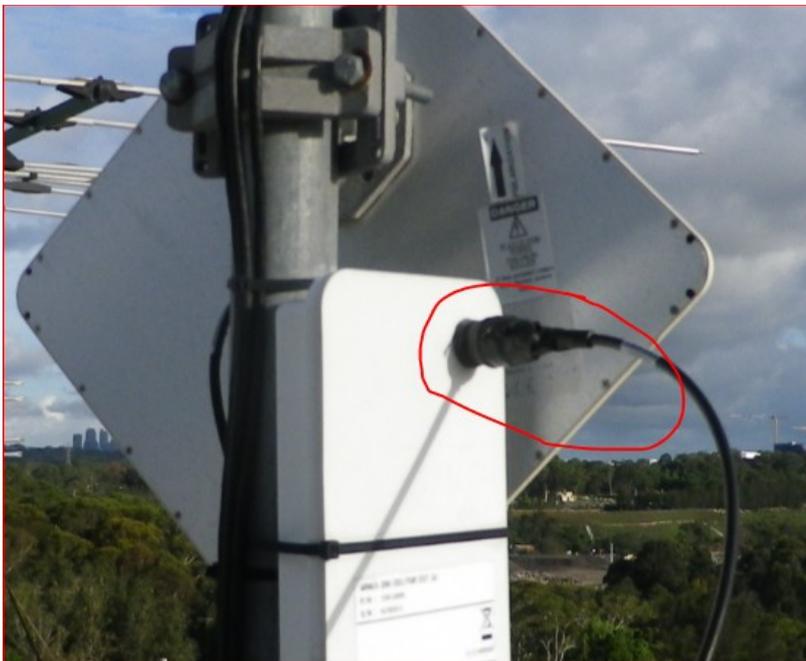
During visit to the roof area on 1st of March 2017, done jointly with owners corporation staff , it was apparent that somebody (can only happen with their direct knowledge or approval) removed the label with country of origin on one of the antennae:

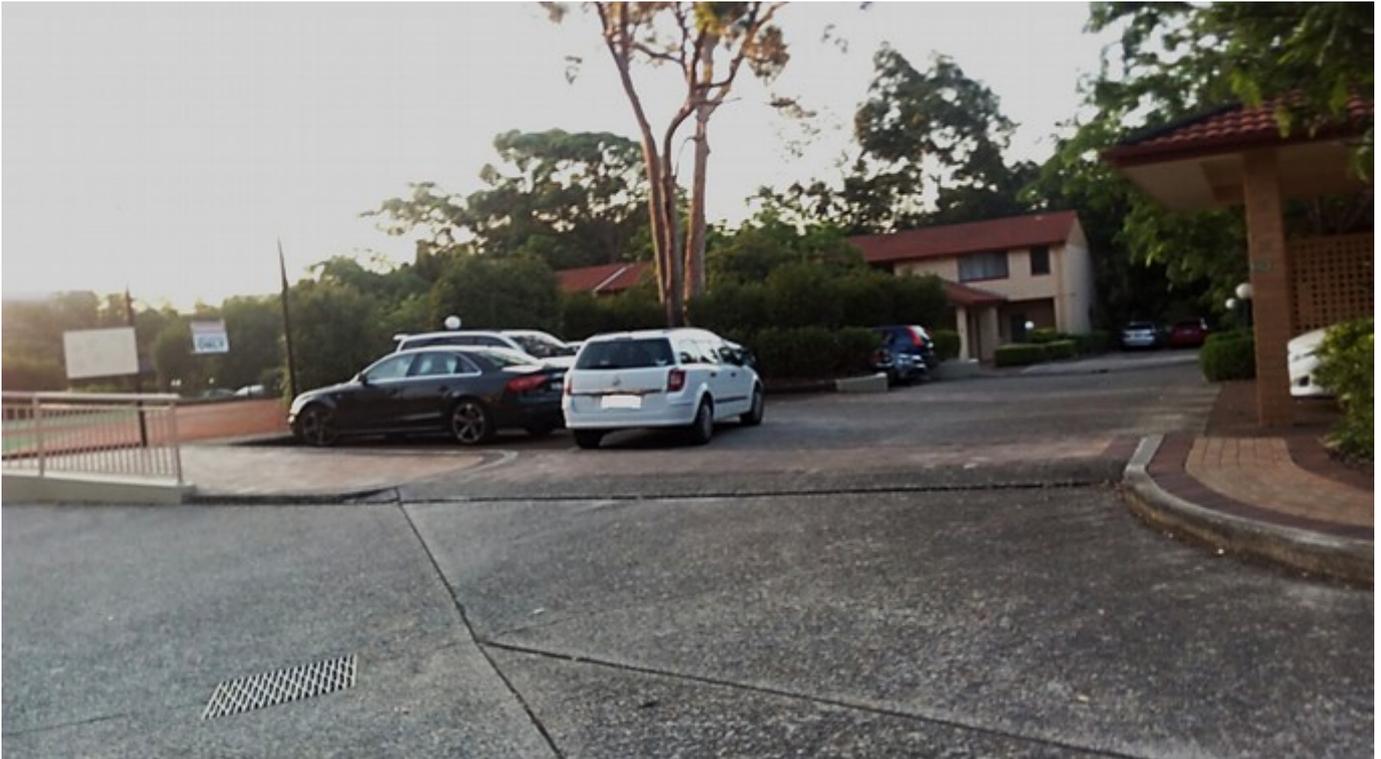
Staff member deliberately ignoring strata by-laws and parking illegally for more than four hours on 17th of December 2017:

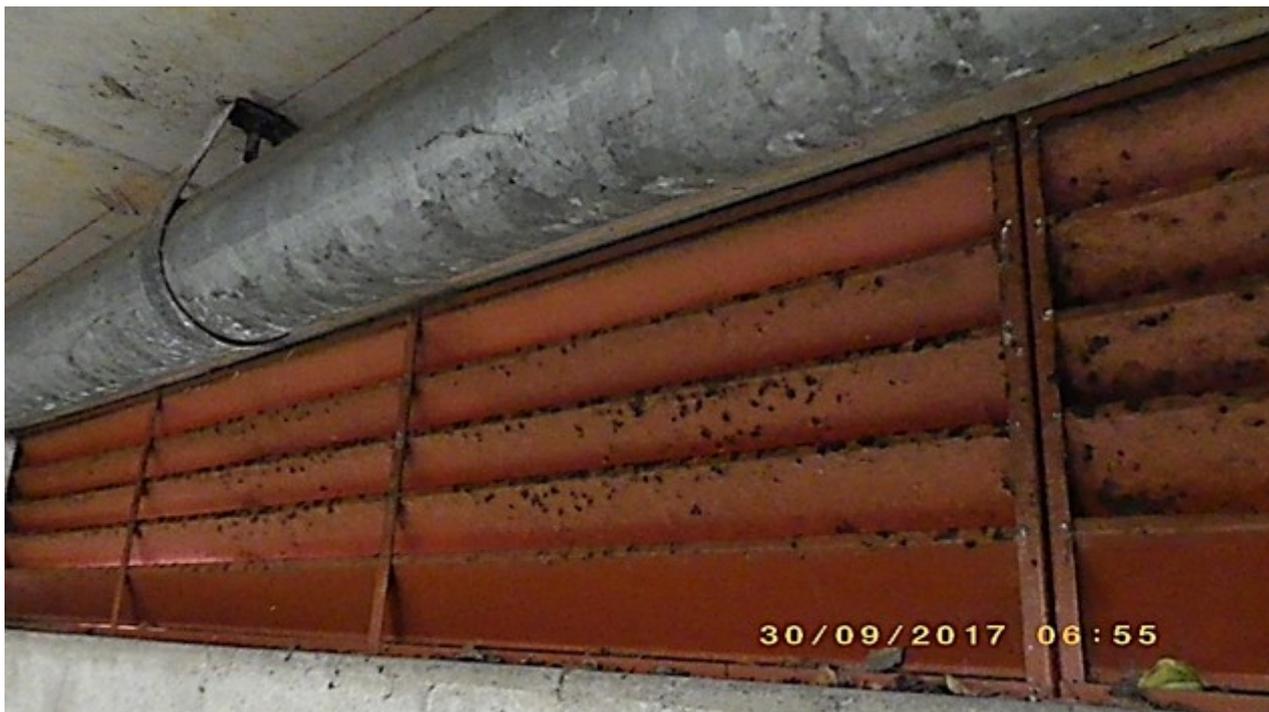
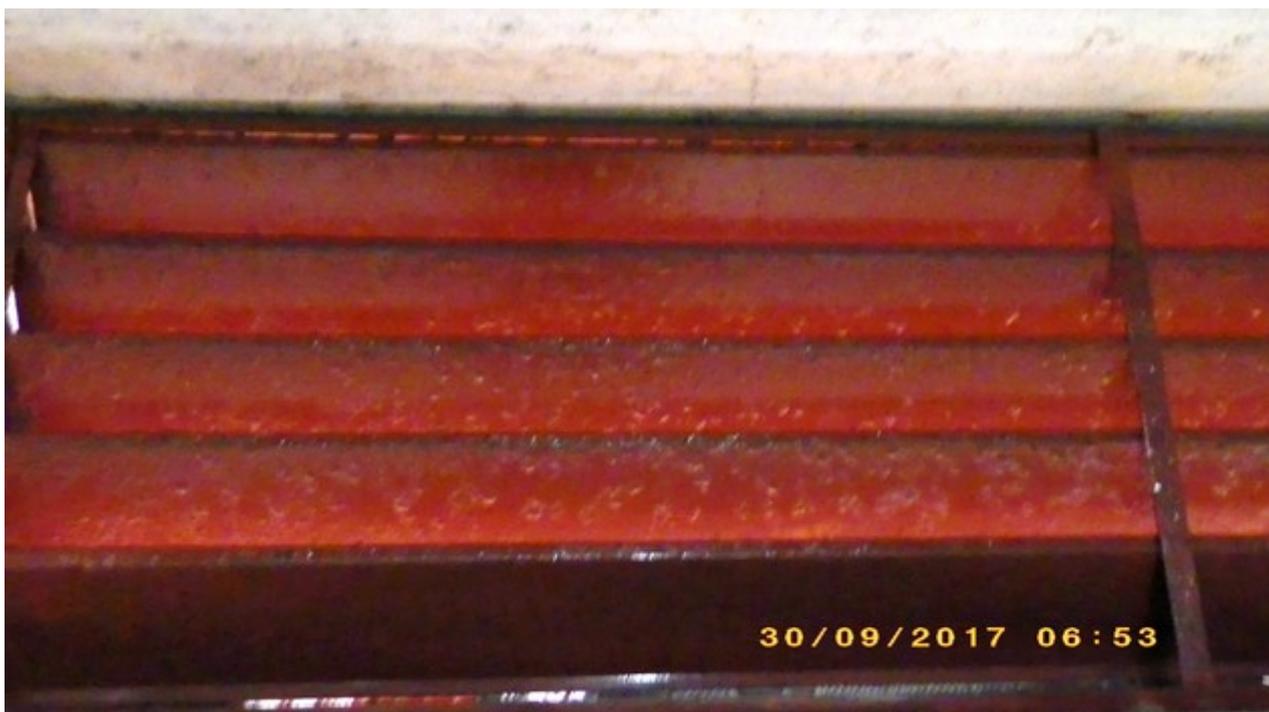
Poor repainting of louvres and keeping it secret from owners in SP52948

Number of warnings were submitted to owners corporation about the need to properly maintain louvres in the basement of the buildings.

Owners corporation was constantly reminded about poor maintenance. An example about louvres from July 2017:

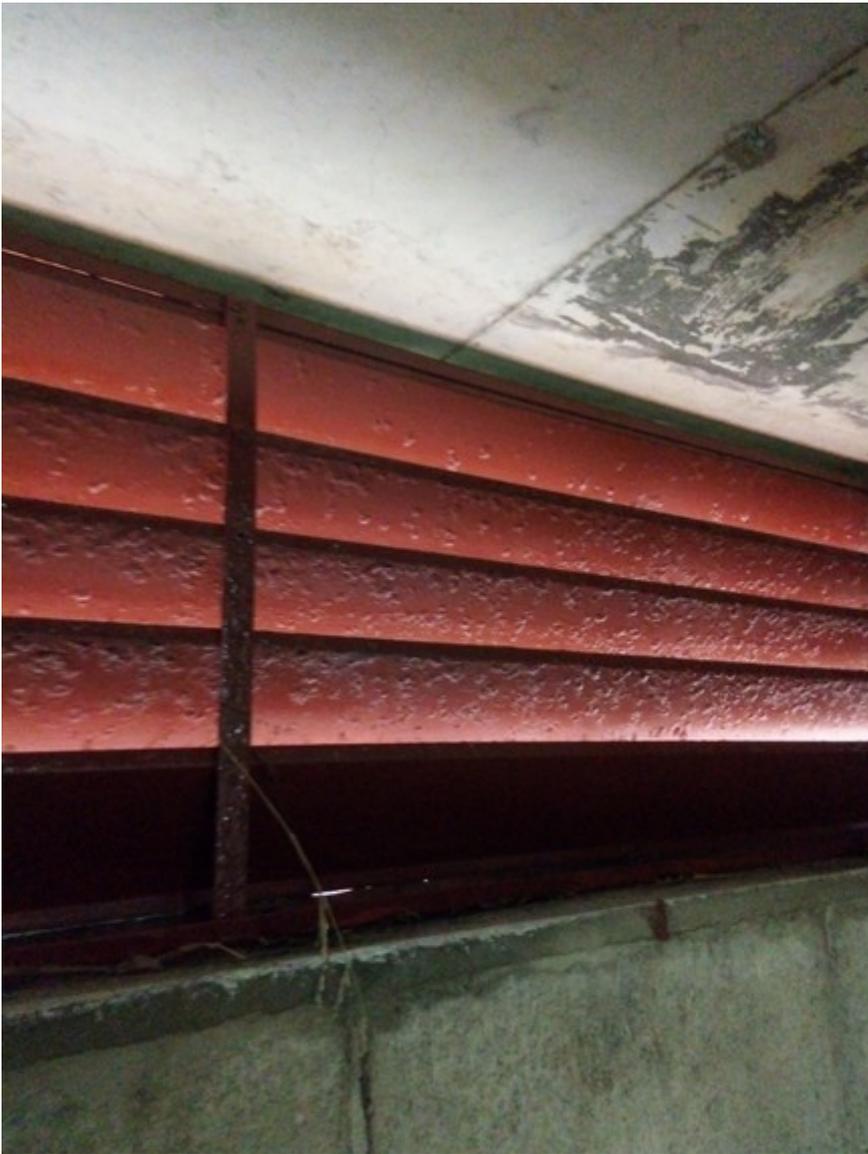
This one was taken straight in front of garage of one of the EC members on 28th of January 2018:
