Table of Contents – SP52948 discrepancies in BIV report for SP52948 10-Year Capital Works Fund in 2017 and 2021 (with strata complex status update in September 2023)

BIV assessments for SP52948 10-Year Capital Works Fund drastic changes in assessments in March 2017 and October 2021, delaying major works for 10 years without professional engineering reports

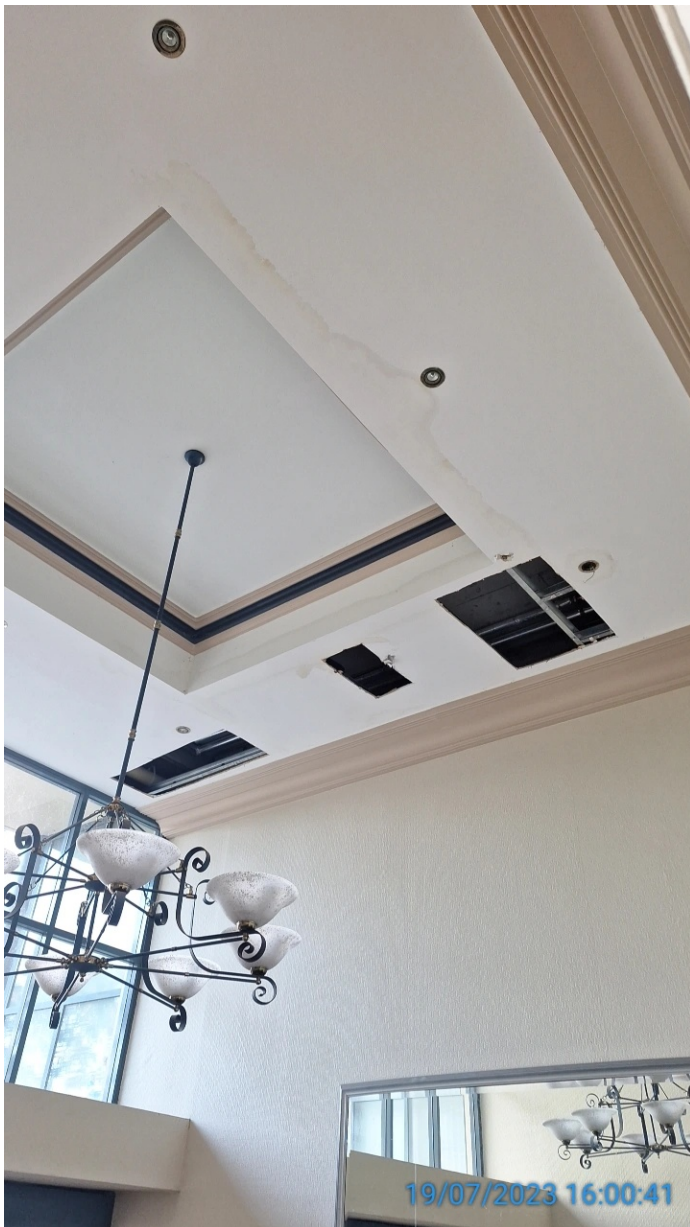
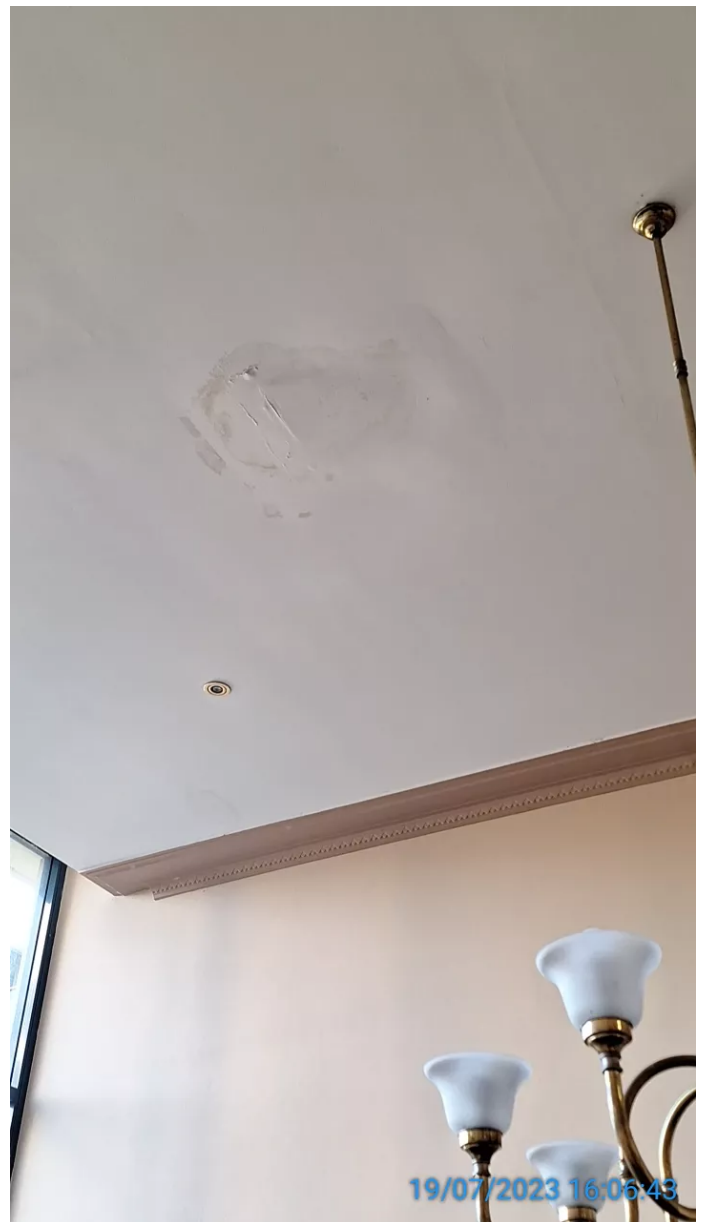
In July/August 2023, two significant water leaks happened in foyers of Block B and D, and none of them were reported at any meeting. The first incident in Block B happened in March 2020, without proper resolution:

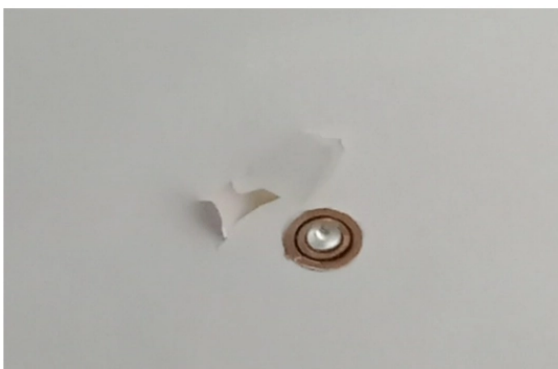
4 March 2020

Block B Foyer, example of how Waratah Strata Management and Uniqueco Property Services manage water leaks and risks

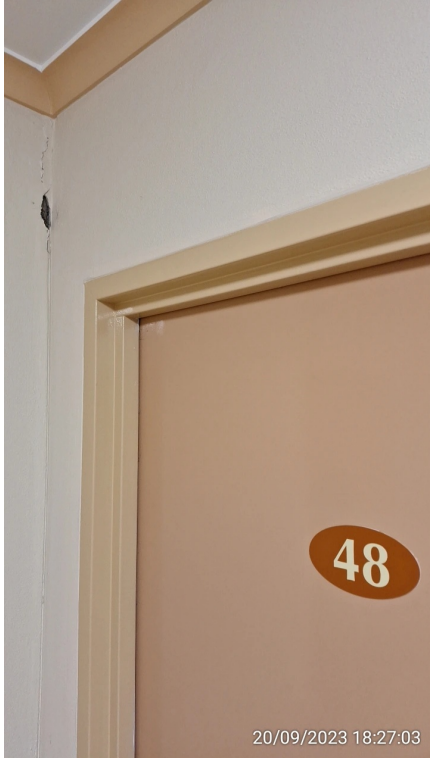
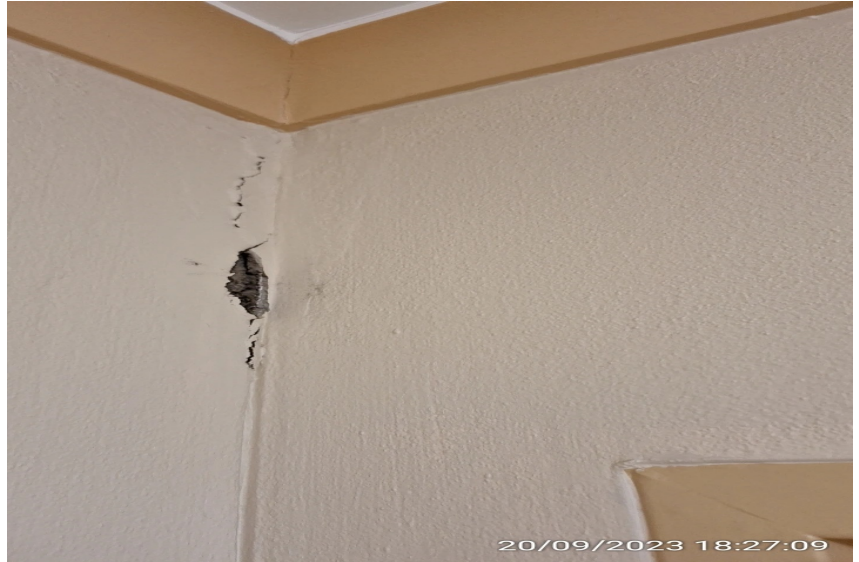
Lot 48

There are many large cracks and problems with internal walls in buildings.

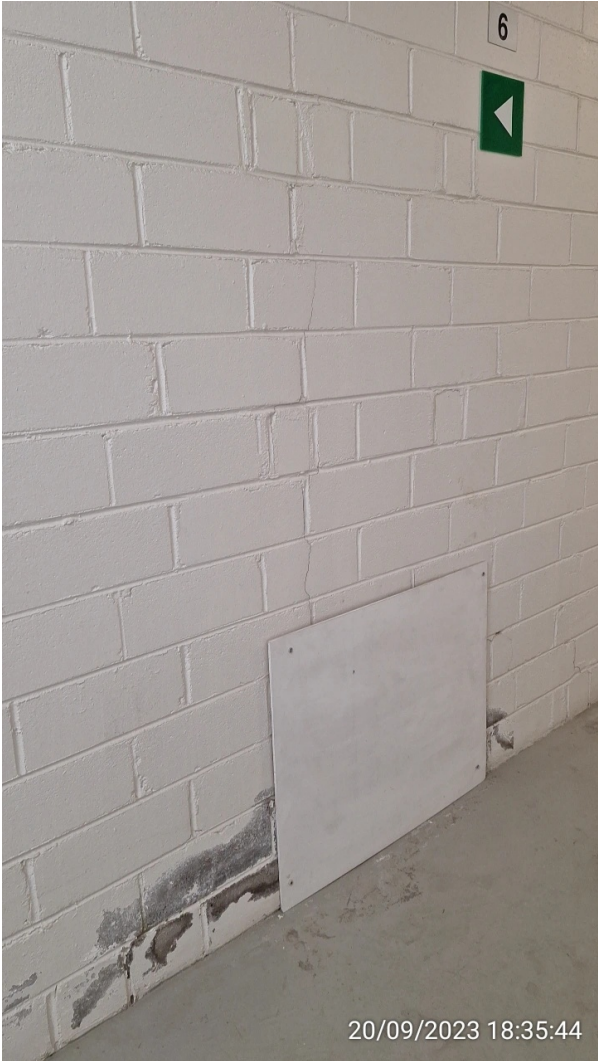
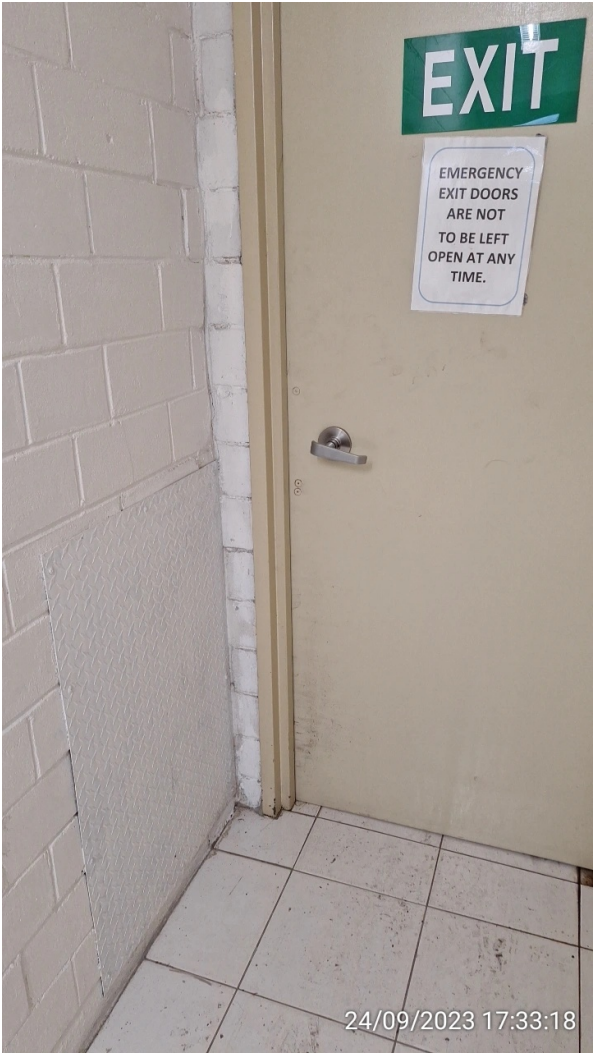
Block C level 6 fire stairs – unrepaired wall due to water leaks since February 2019, and Block C ground floor fire exit – unrepaired wall due to water leaks since June 2021

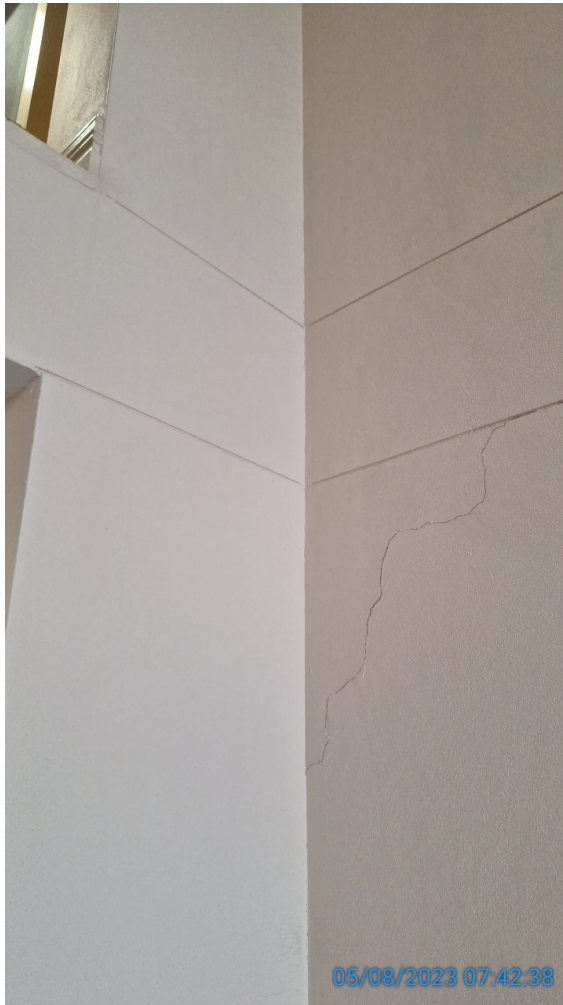
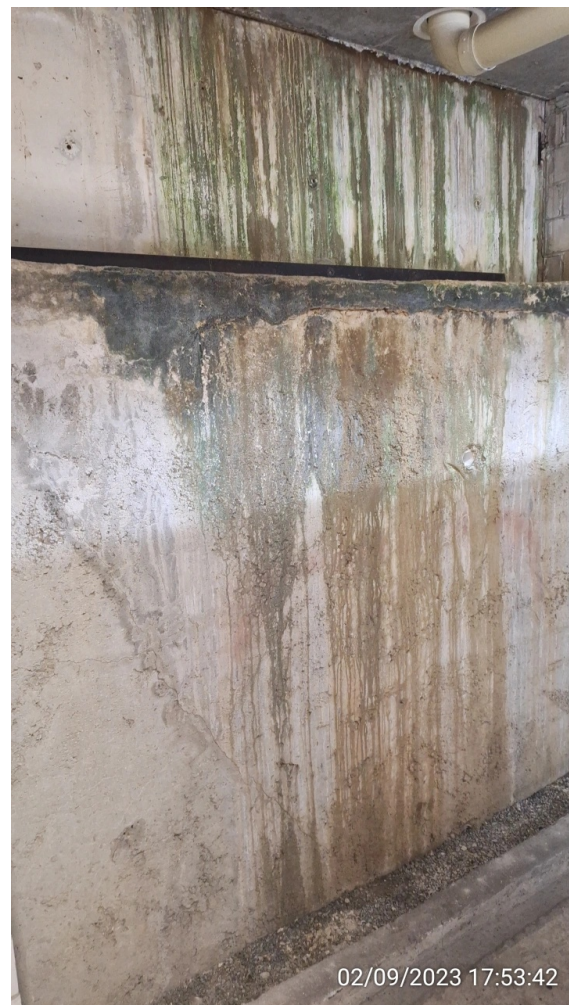
Block B lobby and Block B basement – cancer-ridden wall near fire exit, unresolved since 2013

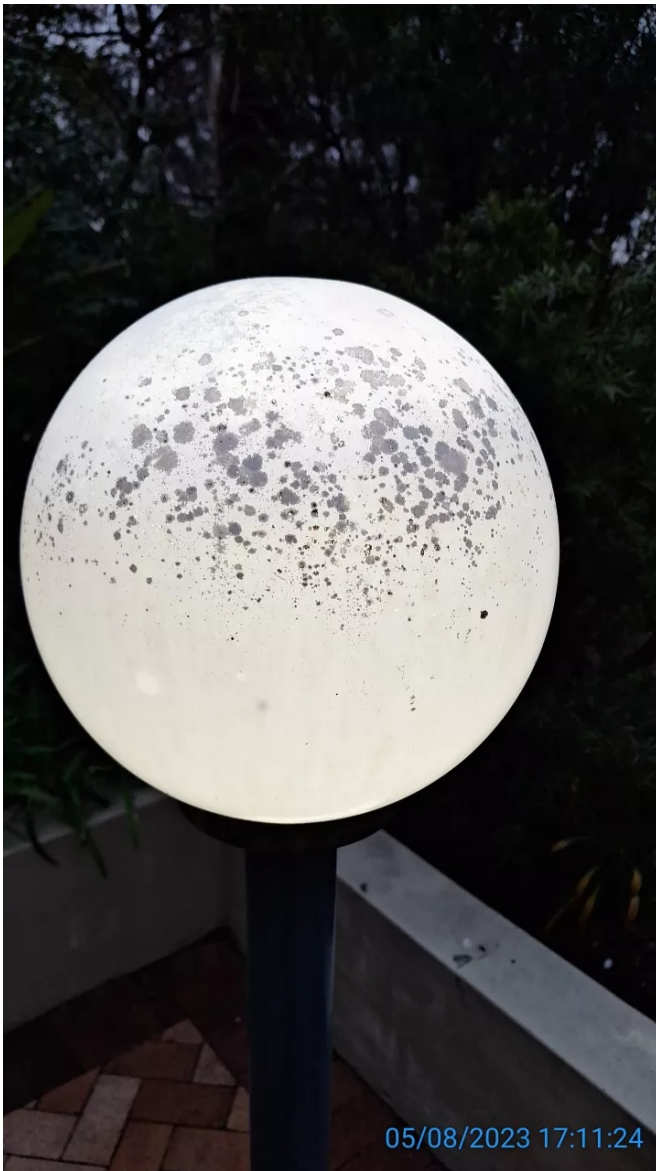
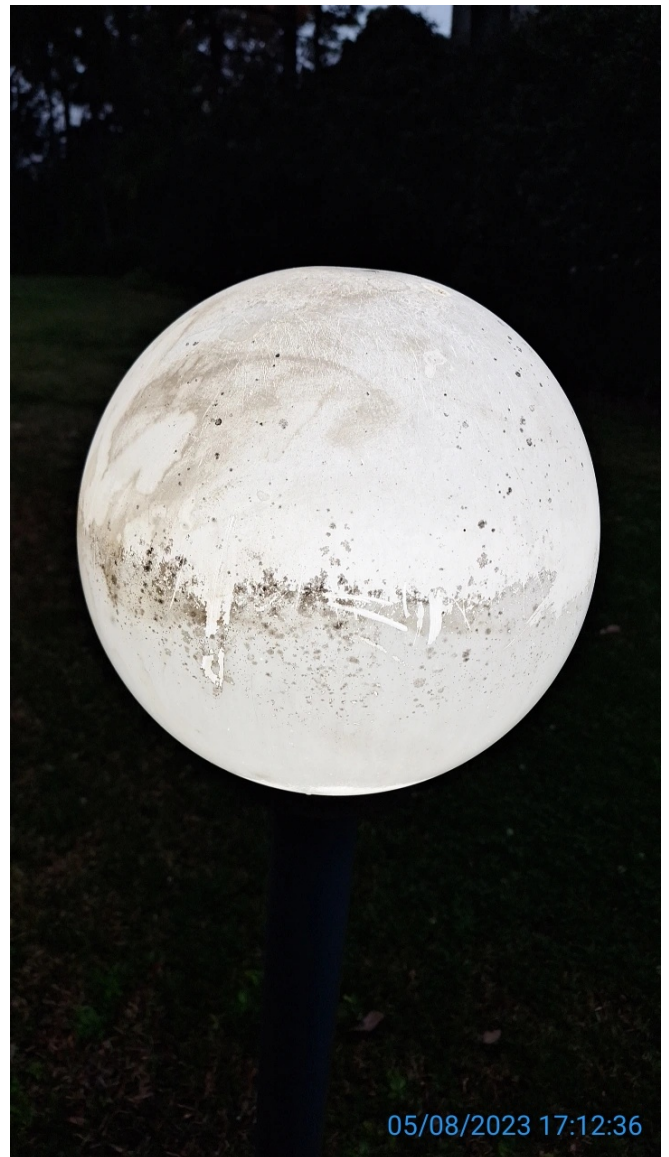
- In BIV's plan in October 2021, it scheduled the work for common property lighting to September 2023 at estimated cost of \$26,781.00. Almost no work was done on this item.

Few examples of how lights are maintained in the gardens.

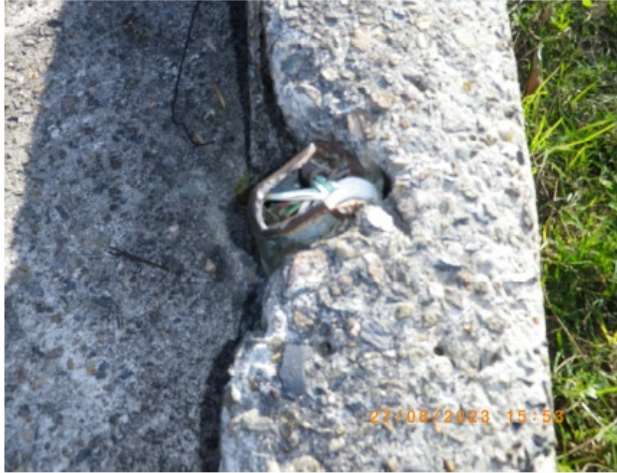
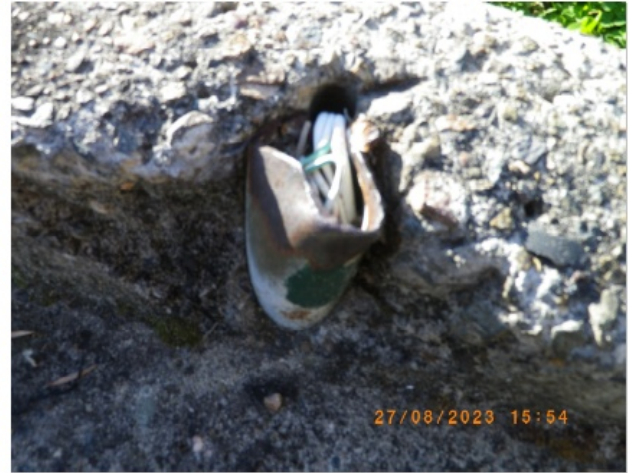
27 August 2023 - SP52948 unprotected electrical cables creating OH&S risk near townhouse 199 for many years

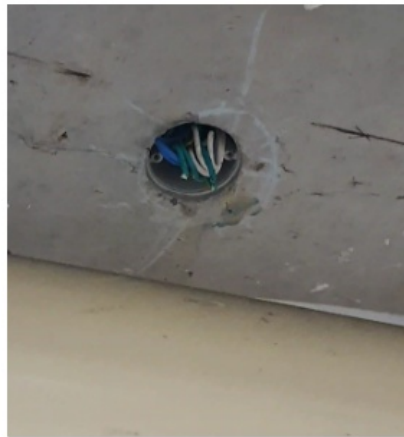
SP52948 unprotected electrical cables Block A basement creating OH&S risk for many years

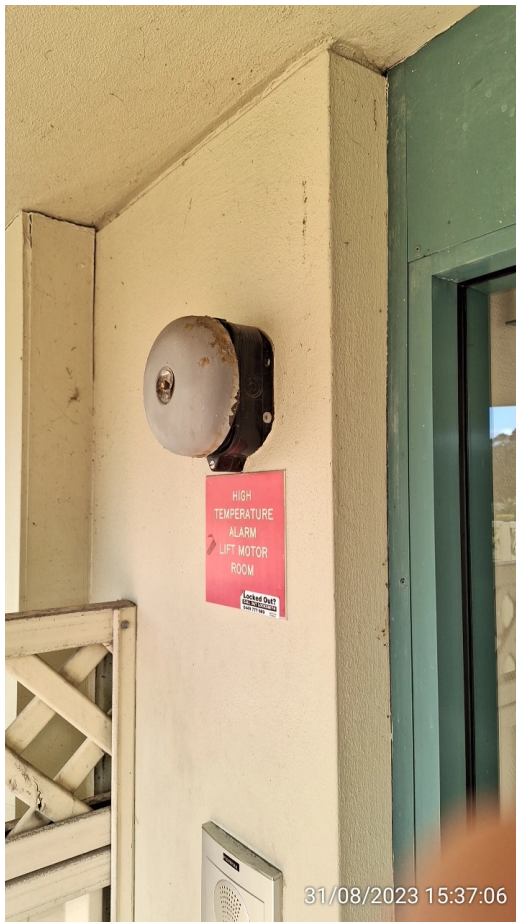
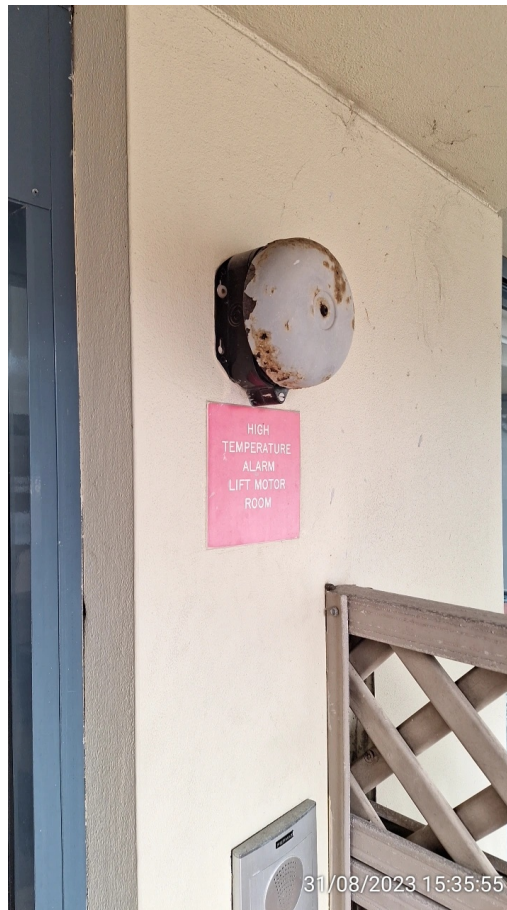
... and all four rusted high temperature alarms in four buildings

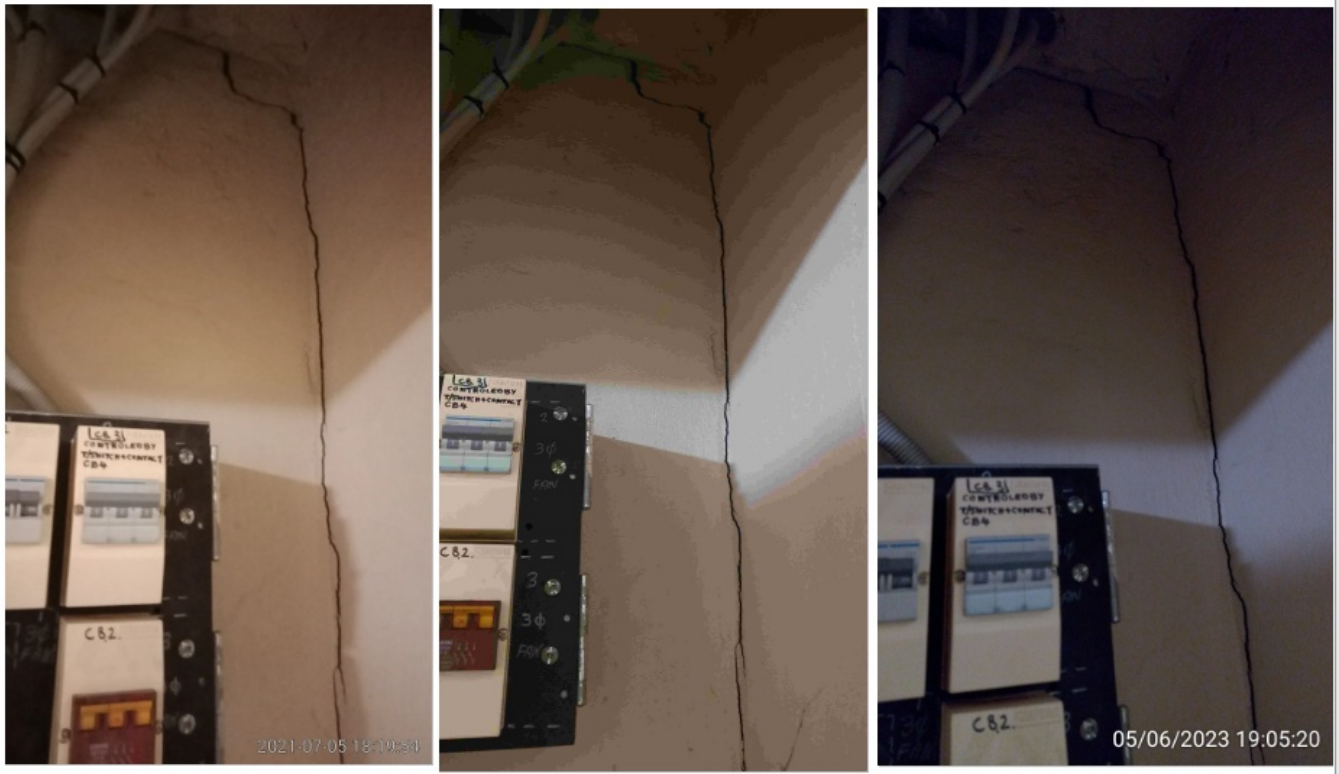
- In BIV's plan in October 2021, it scheduled the work for utility services, cabinets, and conduits to September 2023 at estimated cost of \$13,926.00. Most of work was not done, with one drastic example of cabinet in Block B level 7 photos taken in 2021, 2022, and 2023:

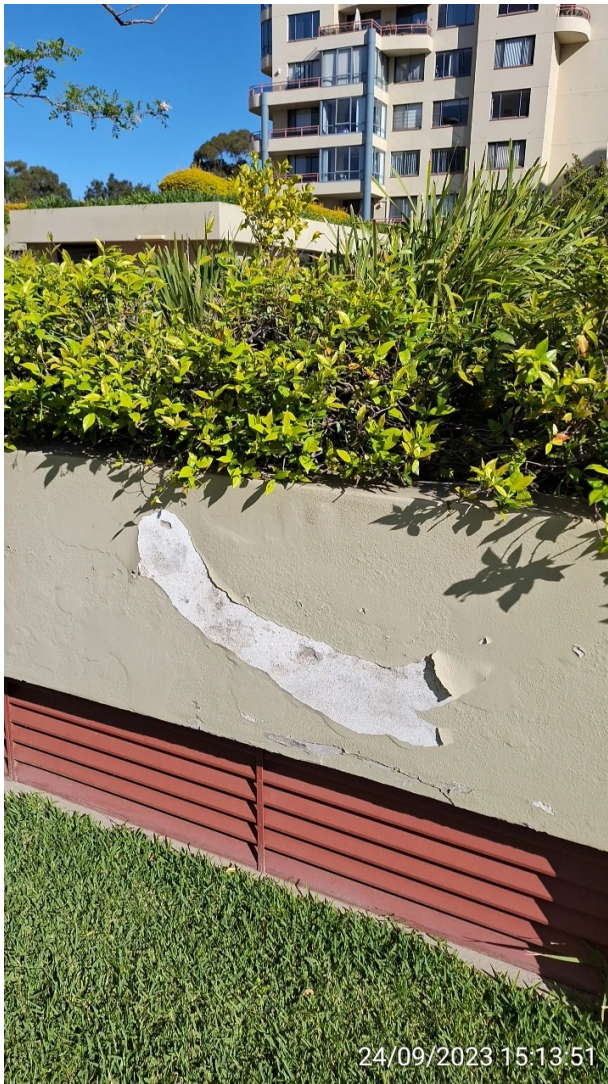
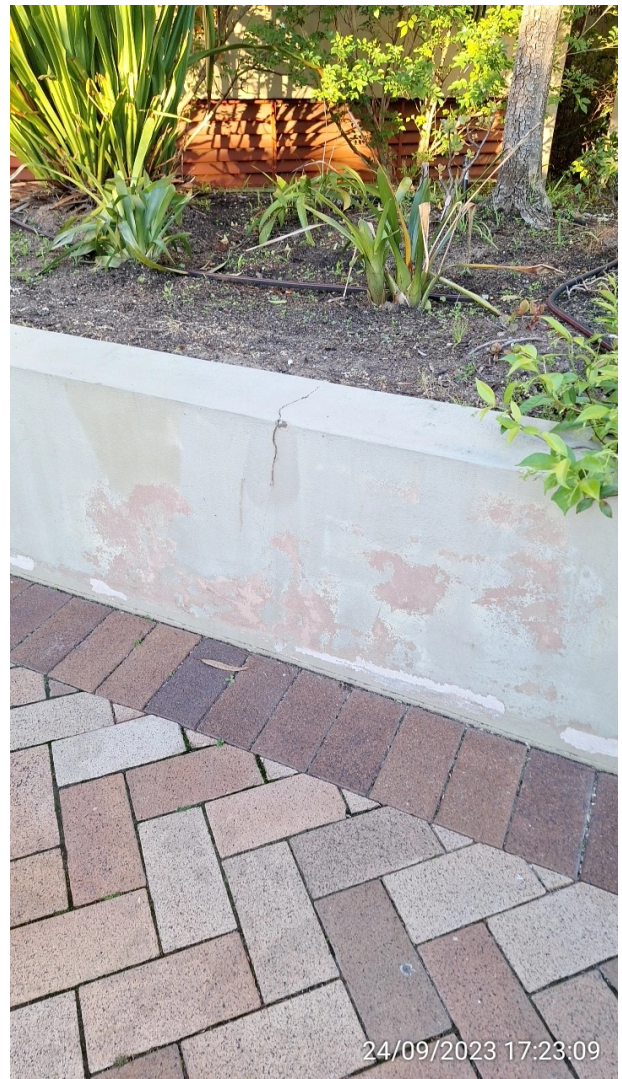
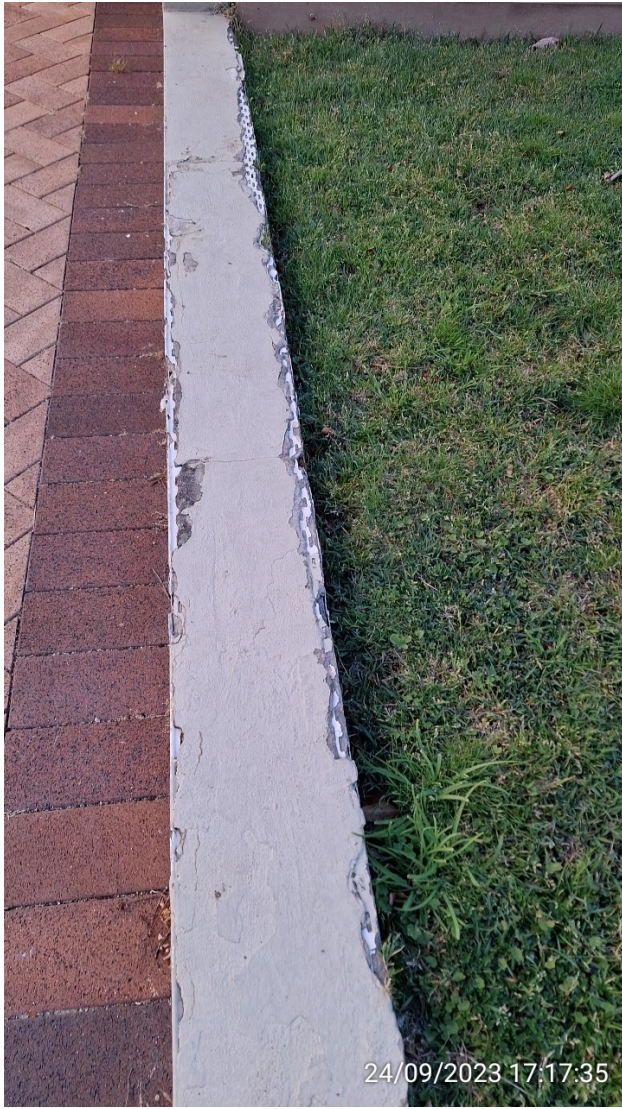
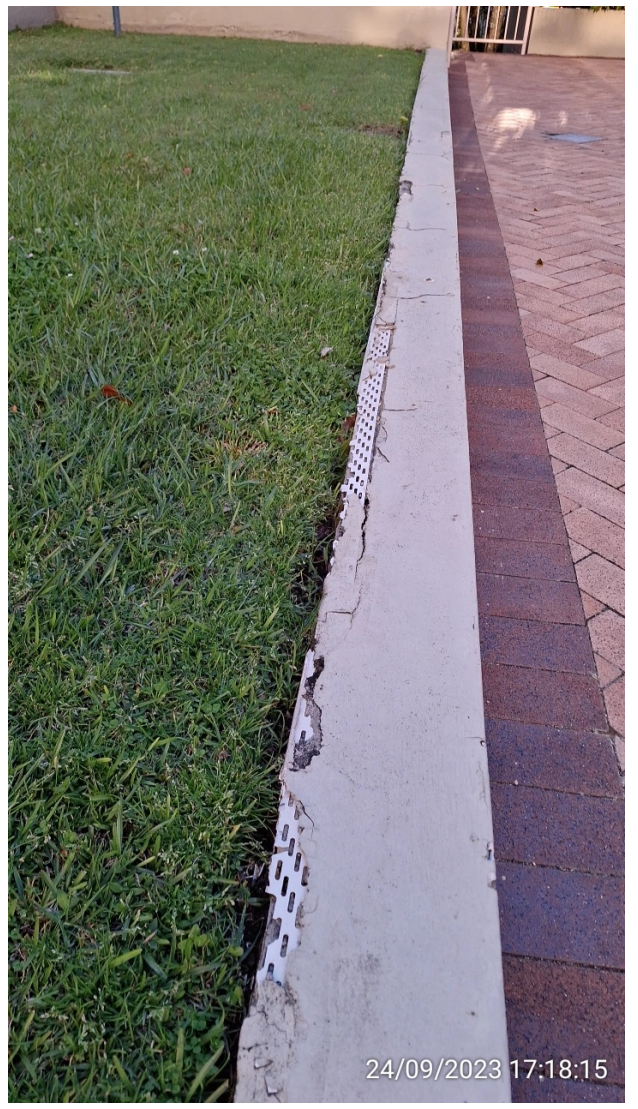
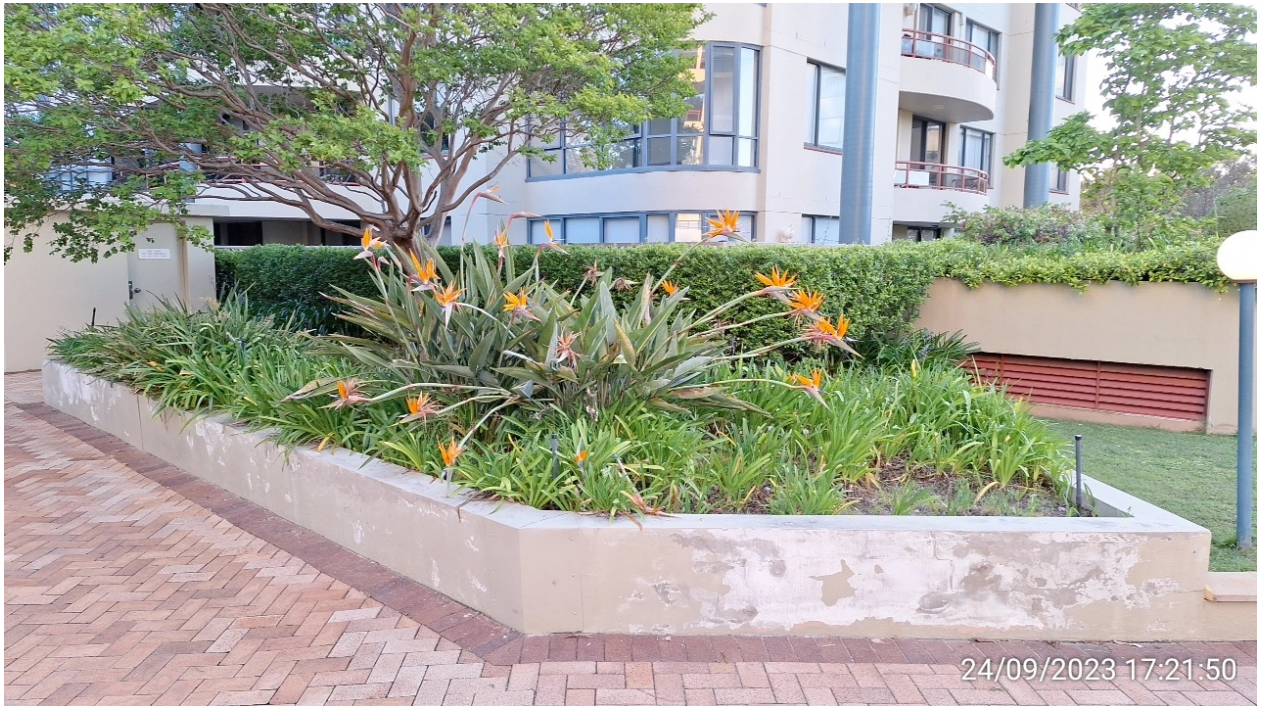
Examples of garden bed damages:

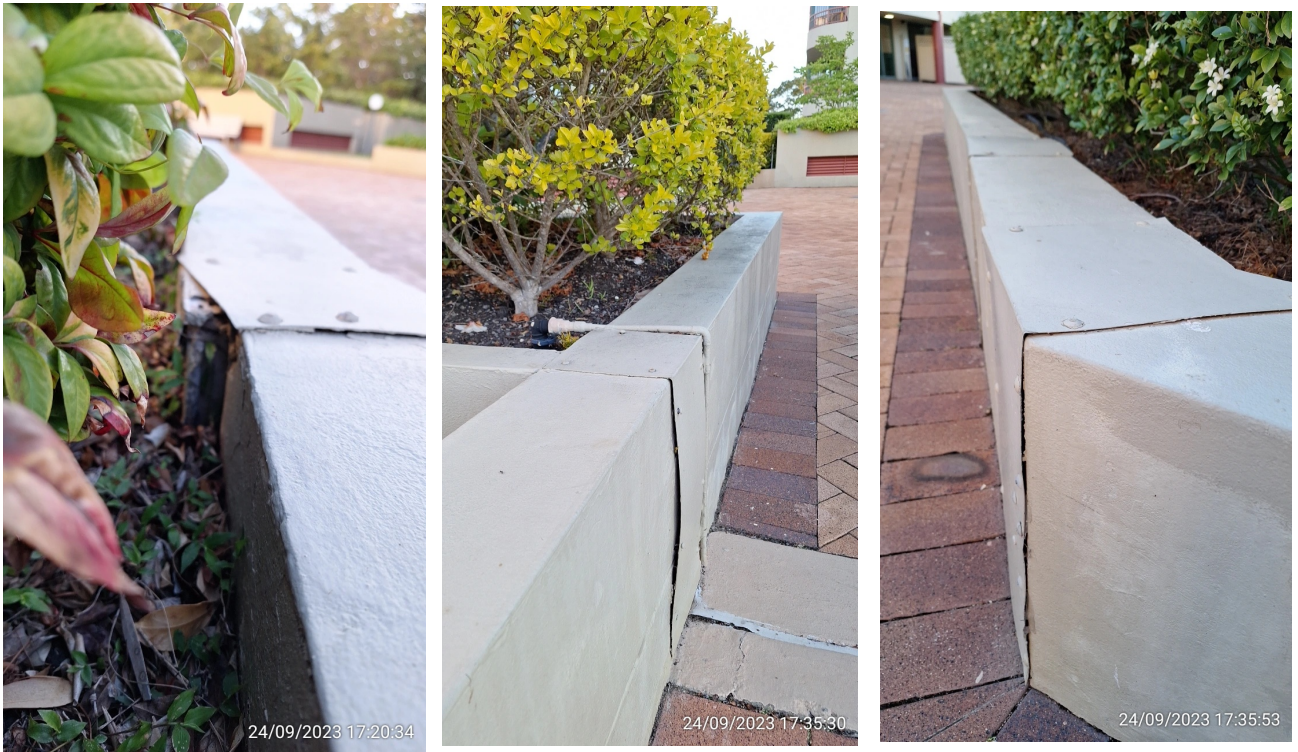
OH&S and insurance risks: metal plates hiding concrete cancers, with risks of collapsing garden bed walls and injuries to children playing nearby

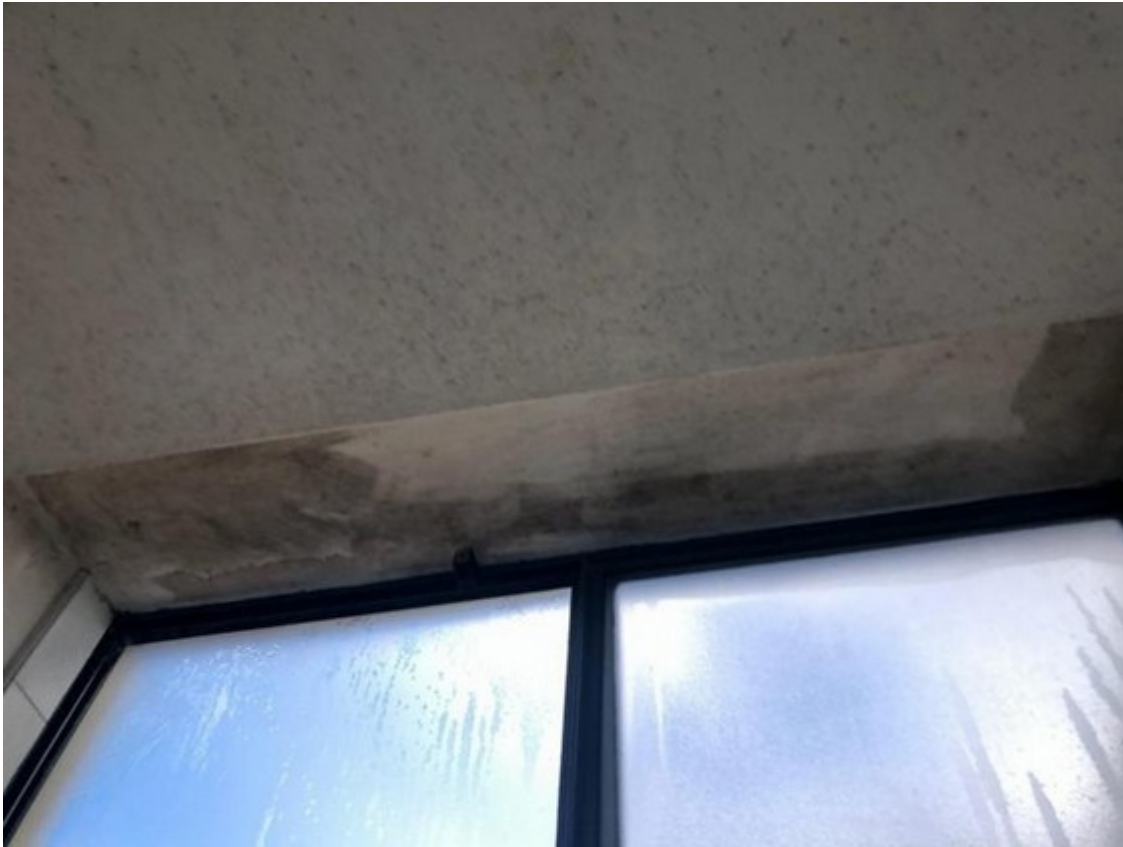
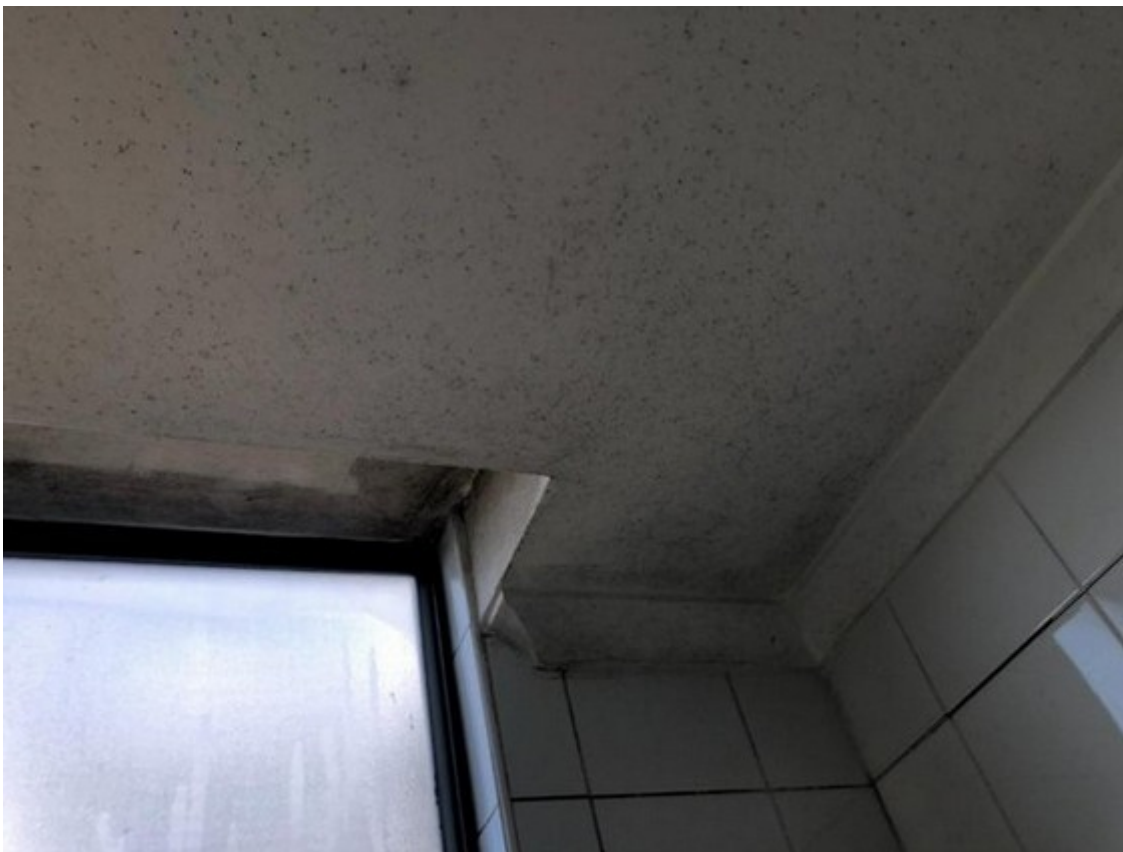
On 13th of June 2020, Lot 158 documented problems with water leaks and dampness in bathrooms of Lot 43 (top floor in Block B), which created not only serious health risks, but also dangers of water entering electrical installations.

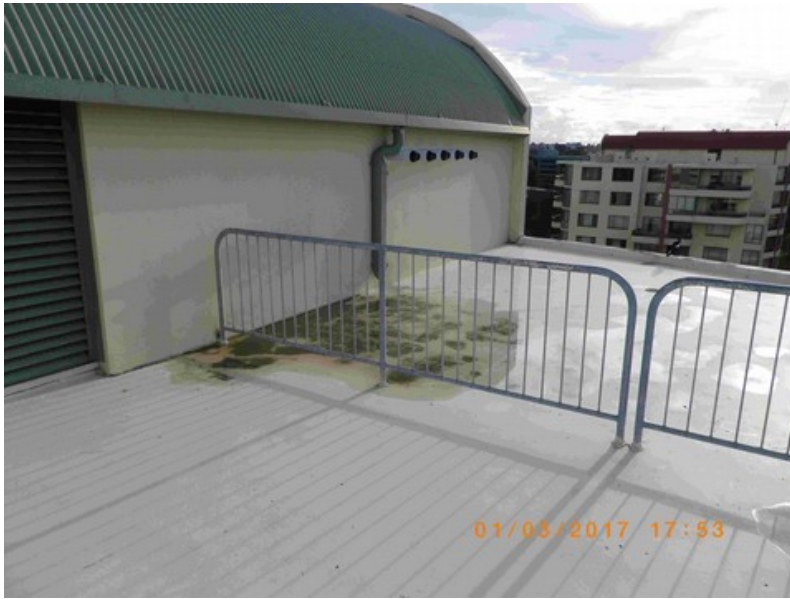
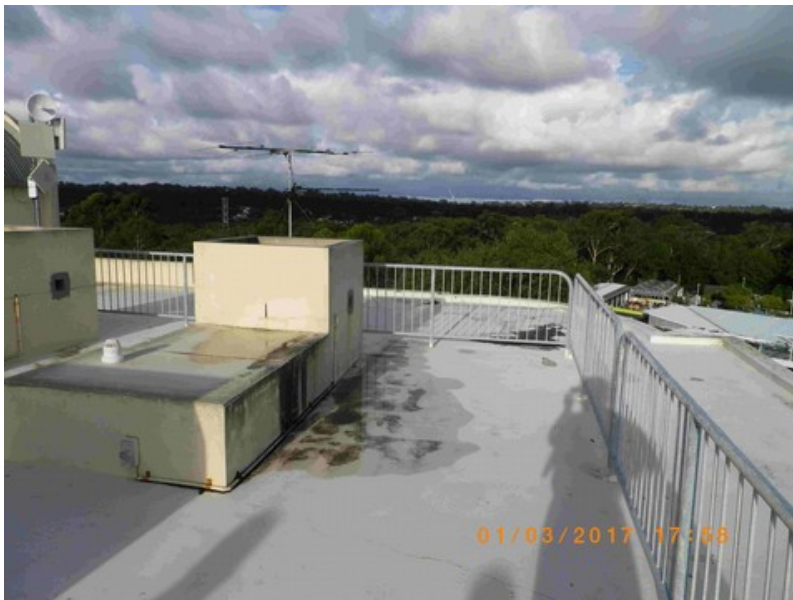
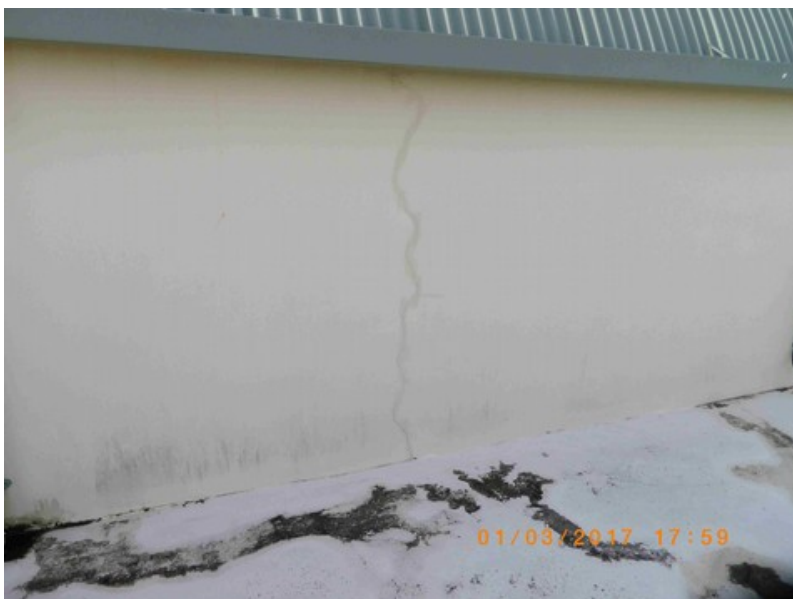
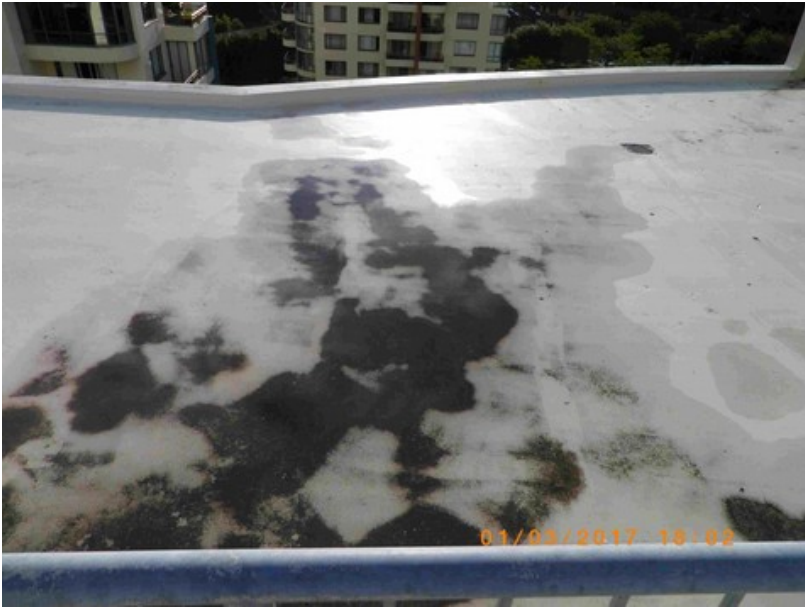
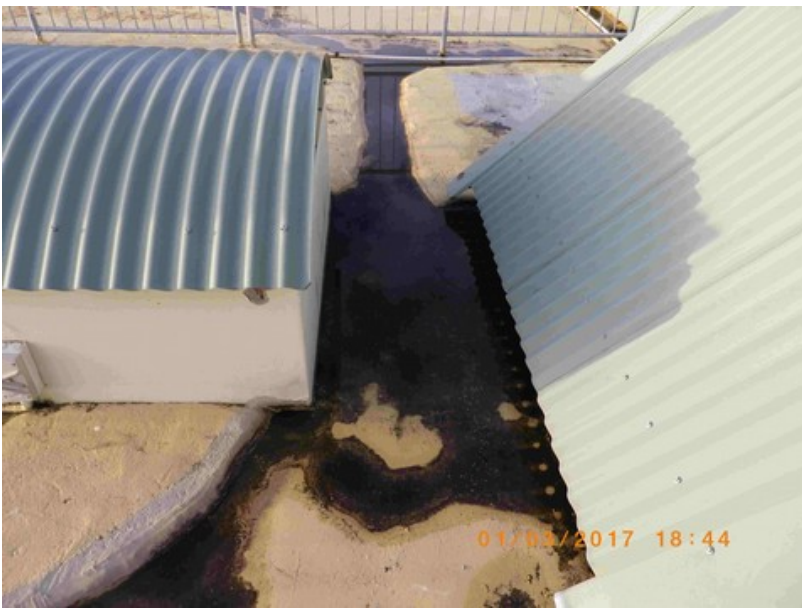
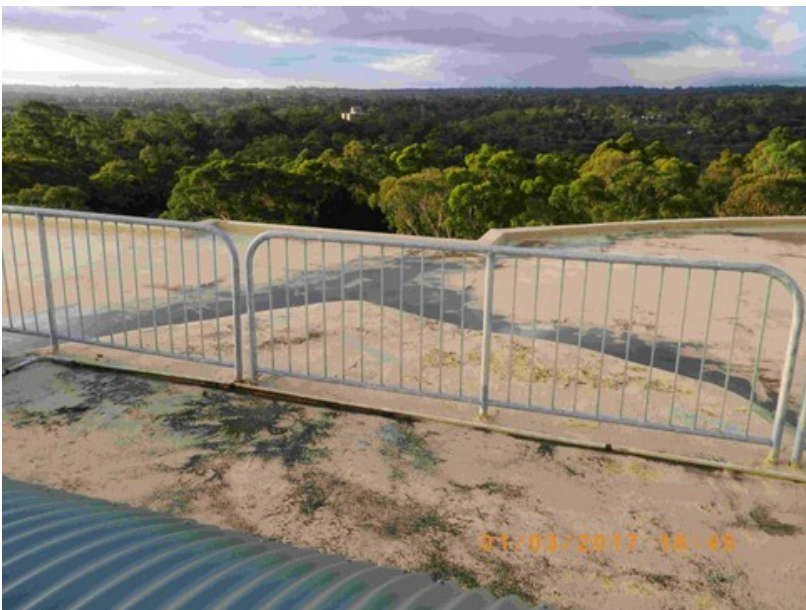
The flat concrete deck roof areas to Blocks A, B, C and D contain large areas of standing water. A number of previous patch repairs have been carried out. The surfaces require preparing and recovering with a liquid applied waterproof membrane within the short to medium term (1-5 years). Block C was observed to be in good overall condition with Block D suffering the most standing water.

On 1 March 2017, Lot 158 joint visit with Waratah Strata Management and Uniqueco Property Services to roof areas of the four building showed significant damages and water ponding.

On 1st of March 2017, joint visit with Waratah Strata Management and Uniqueco Property Services to roof areas of the four building showed the following status:
