## Table of Contents

This document lists just some of the problems in the complex that can cause injury, health problems, or even death in dire circumstances.

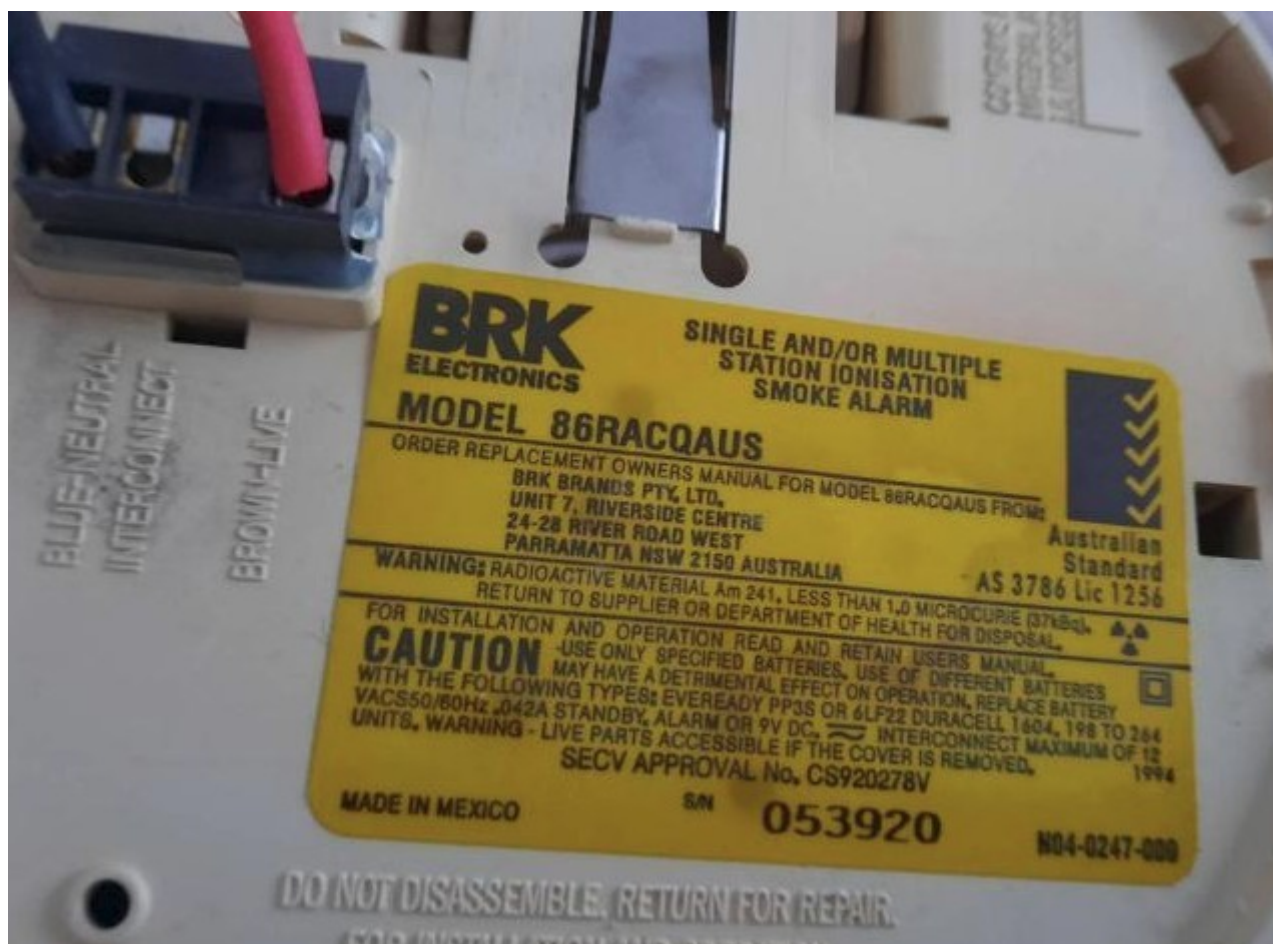
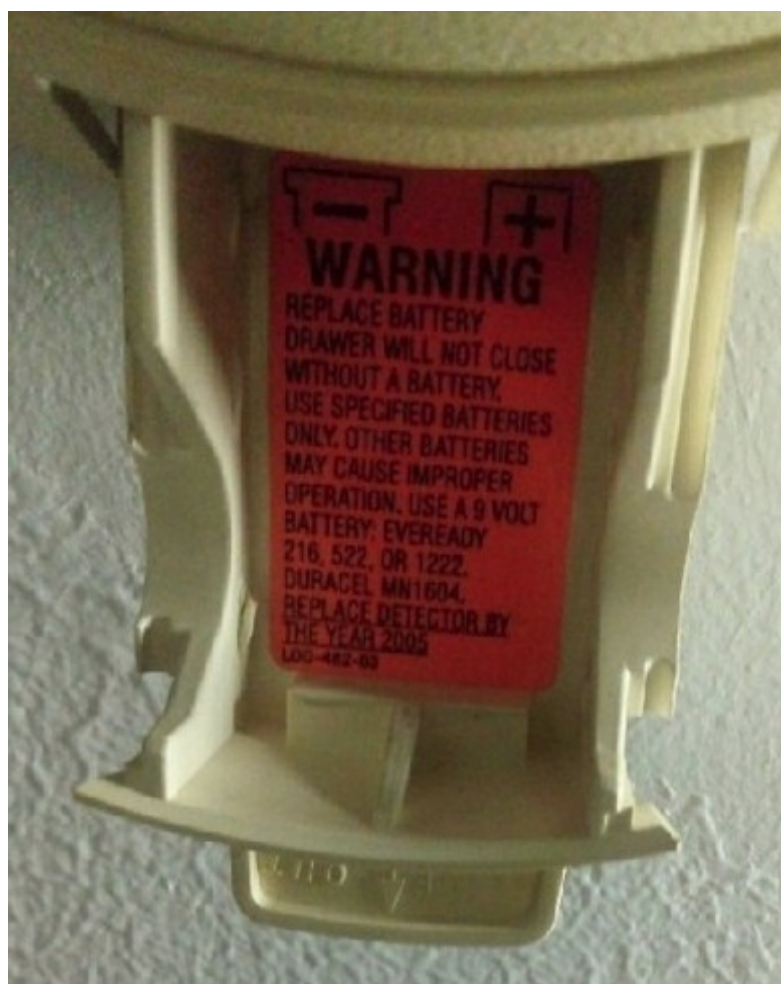
En-suite bedroom (manufacture date 1994, expired in 2005):

**9 One smoke alarm in Lot 158 expired in 2005 and other in 2019, both declared faulty in 2019 and 2020 in fire inspections, and not replaced as of June 2021**

As of June 2021, both smoke alarms in Lot 158 are not yet replaced.

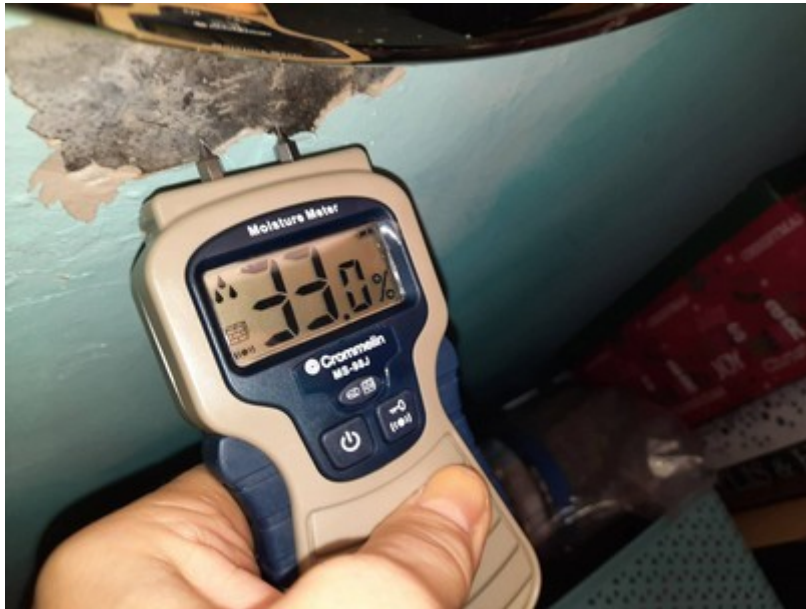
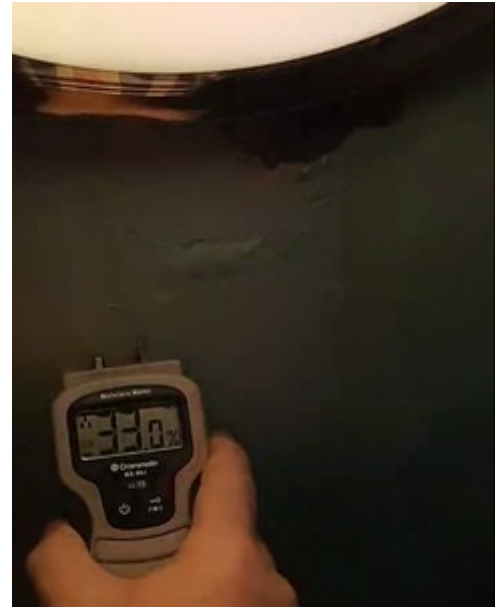
## 11 Lot 158 water leaks near electrical installation (lighting) on ceiling in sun-room

Photos and videos taken on 11<sup>th</sup> and 12<sup>th</sup> of May 2021 show that the ceiling is moist and full of water residue in certain areas near lighting, creating high risk of fire hazard and electrocution.

Lot 158 took moisture meter readings in various areas of the ceiling and it is obvious that water damage near electrical lighting is a major problem, with disaster just waiting to happen.

Typically, moisture content in percent (%MC) above around 17-18% is considered to be a significant problem. Readings on some areas on the ceiling near electrical lighting was 33% in Lot 158 whilst others were perfect.

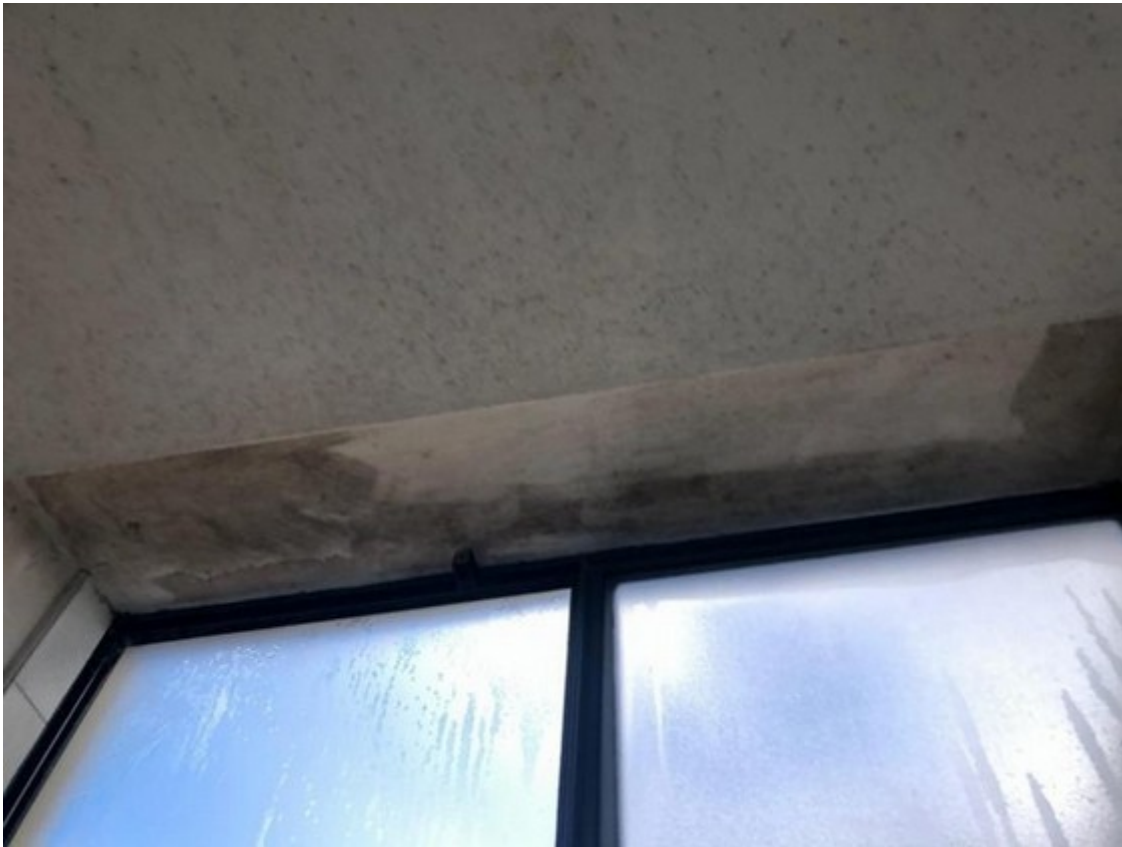
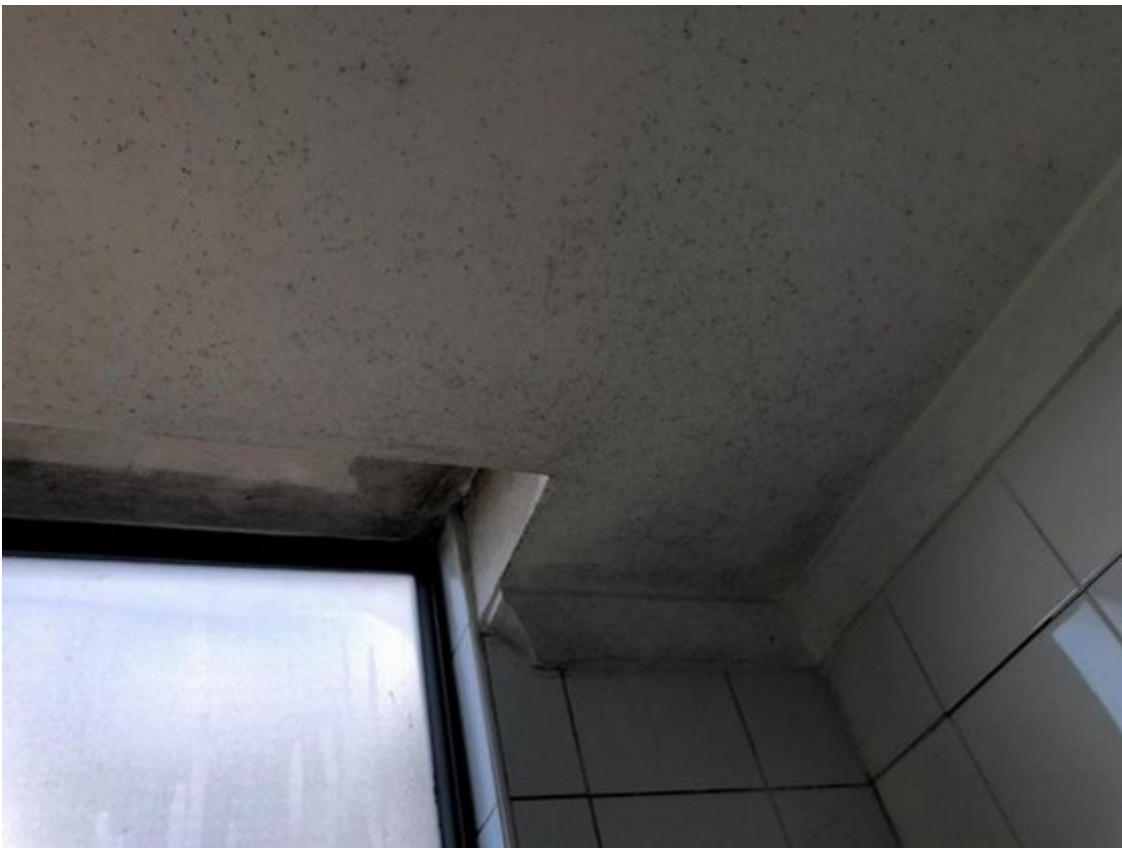
**13 Lot 43 poor ventilation in bathrooms and increased health and safety risks, as reported in June 2020**

On 13<sup>th</sup> of June 2020, Lot 158 documented problems with water leaks and dampness in bathrooms of Lot 43 (top floor in Block B), which created not only serious health risks, but also dangers of water entering electrical installations.

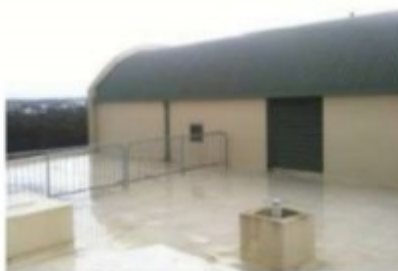
Block C roof coverings

The falls to the drainage are insufficient and improving the existing falls should also be considered. The internal units were not inspected for any water penetration via the roof slab.

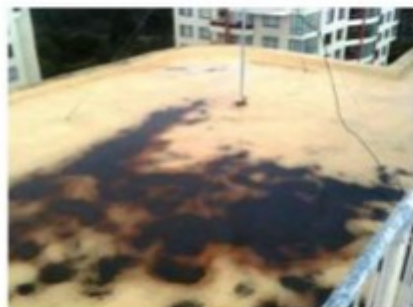
Standing water to flat roof deck, Block A

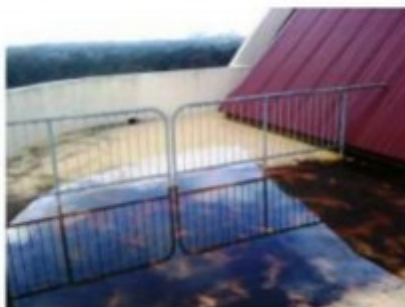
Standing water to flat roof deck, Block B

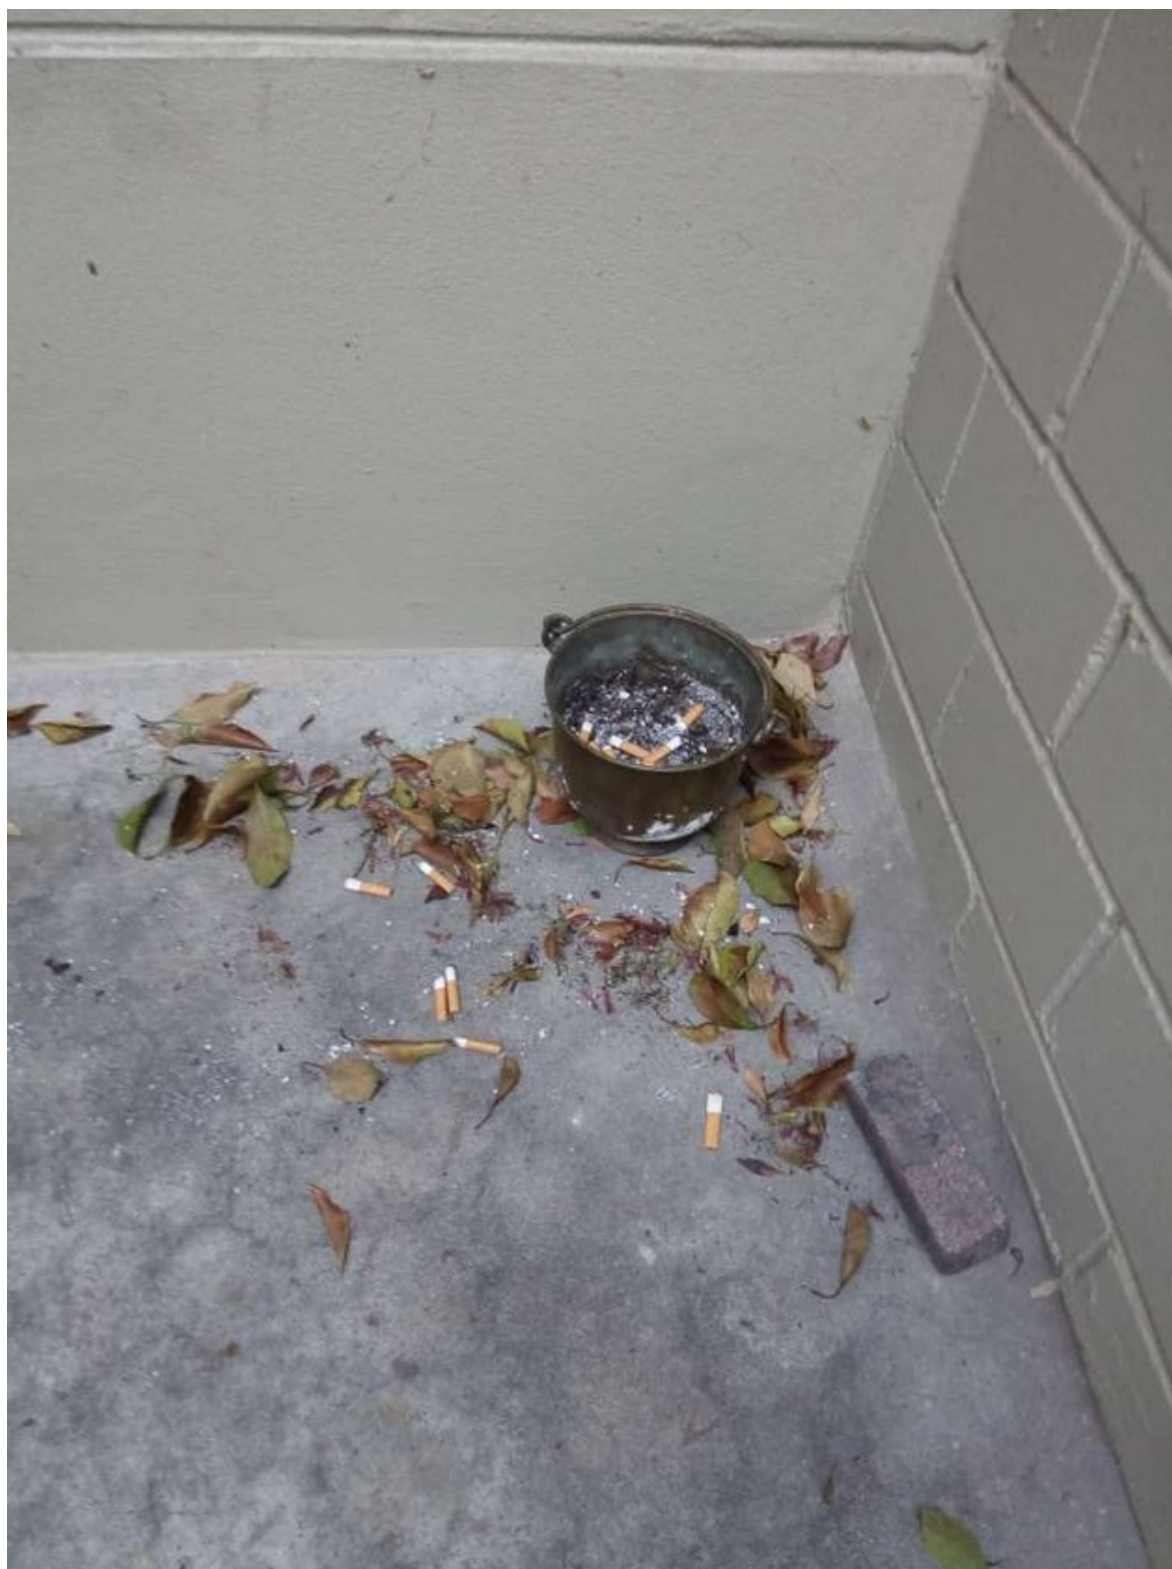
Example of smoking near fire door 2 below Block A in November 2018:

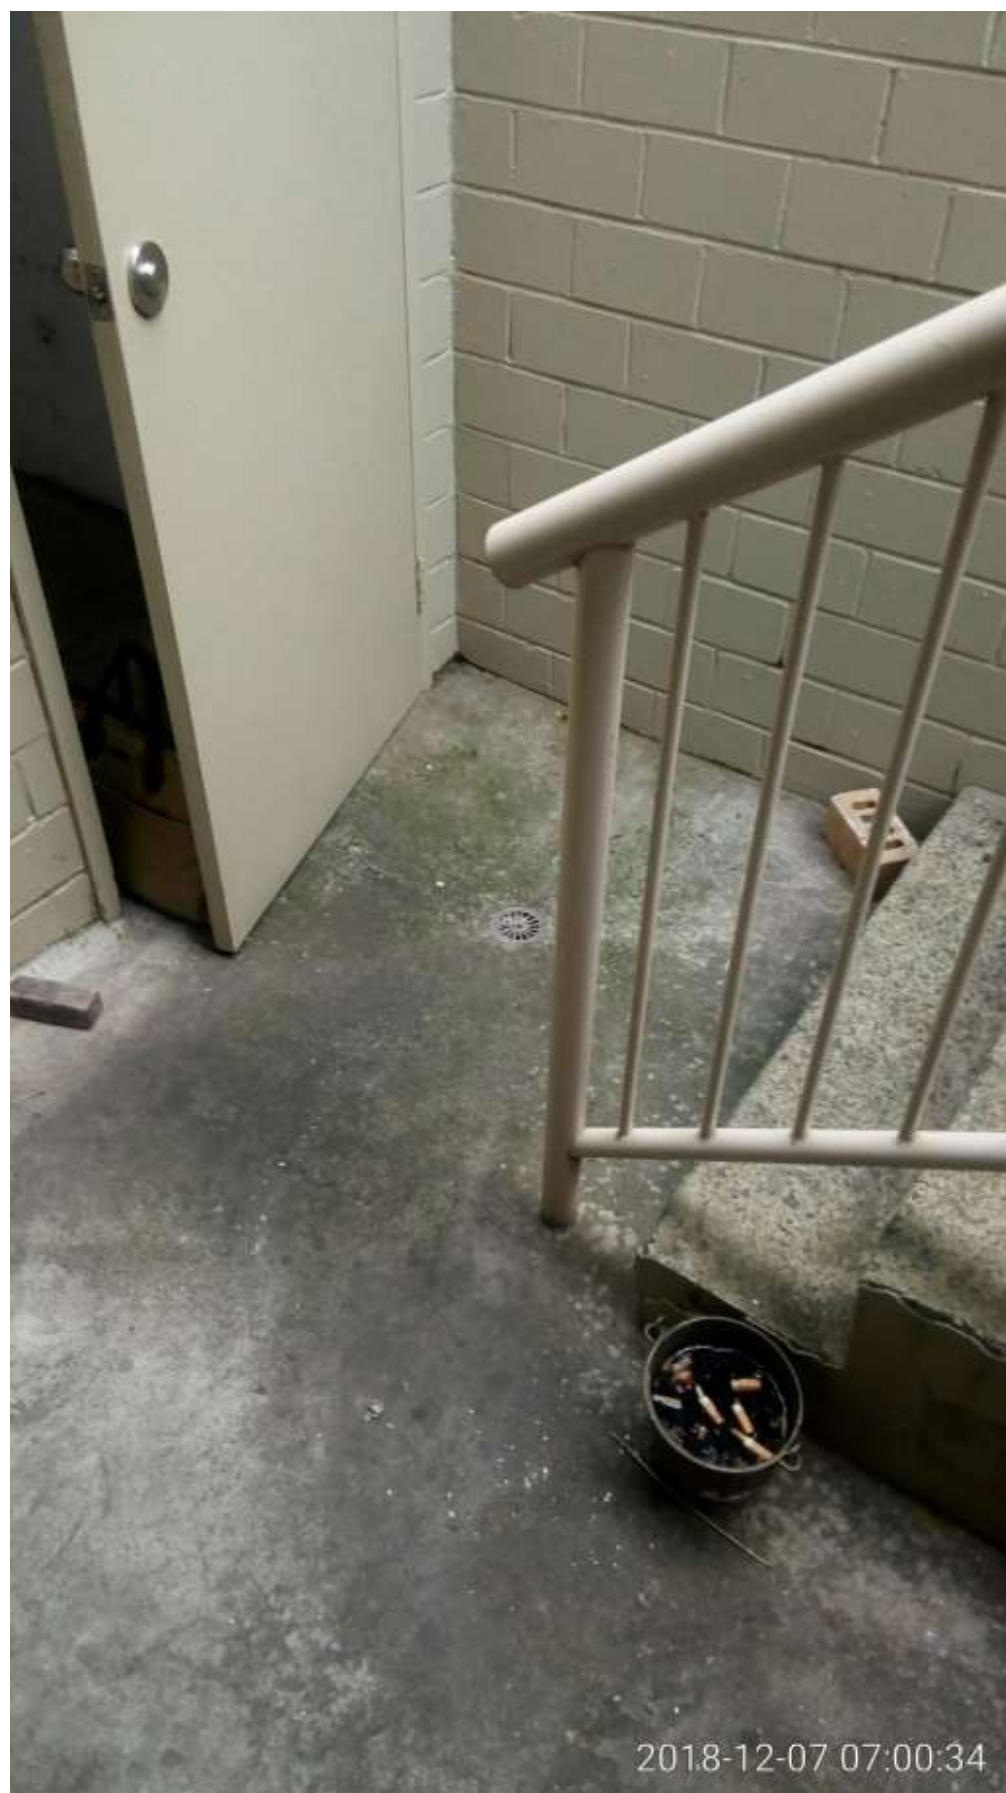
Example of smoking and keeping fire door 2 below Block A open in December 2018:

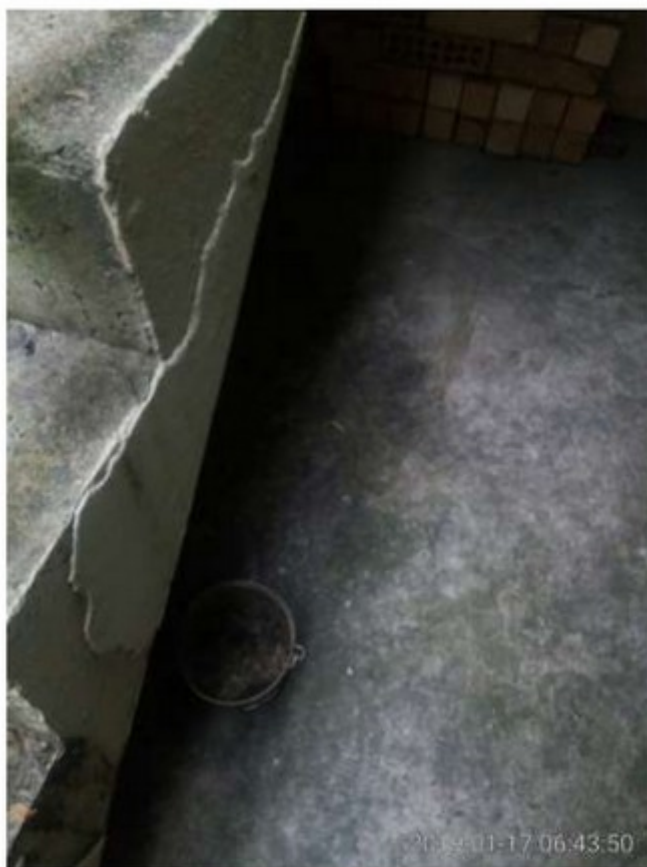
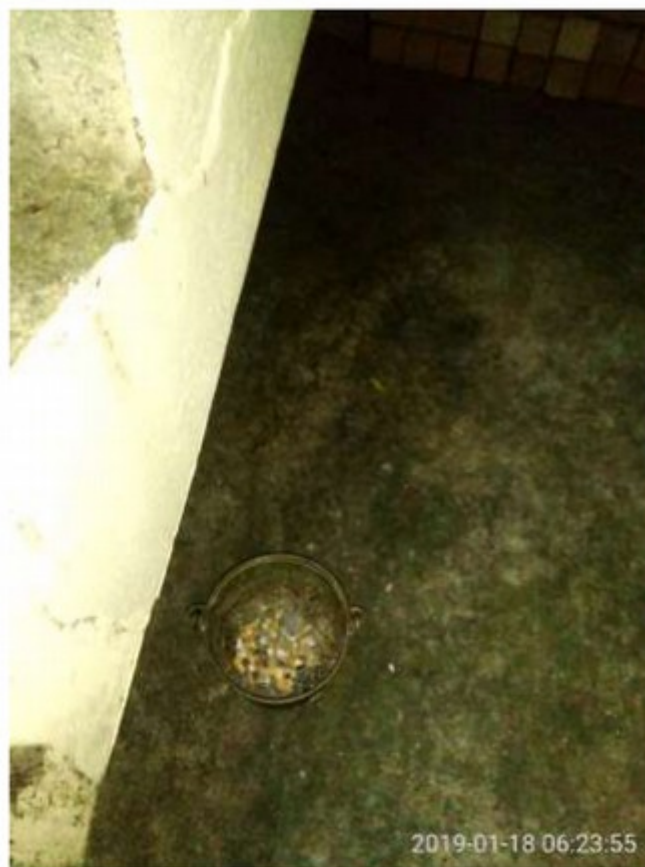
Fire door 2 below Block A was kept open in non-compliance with fire safety regulations almost every day for many months in 2018/2019 and smoking allowed. Example of what one day of smoking created between dates of 17<sup>th</sup> and 18<sup>th</sup> of January 2019:

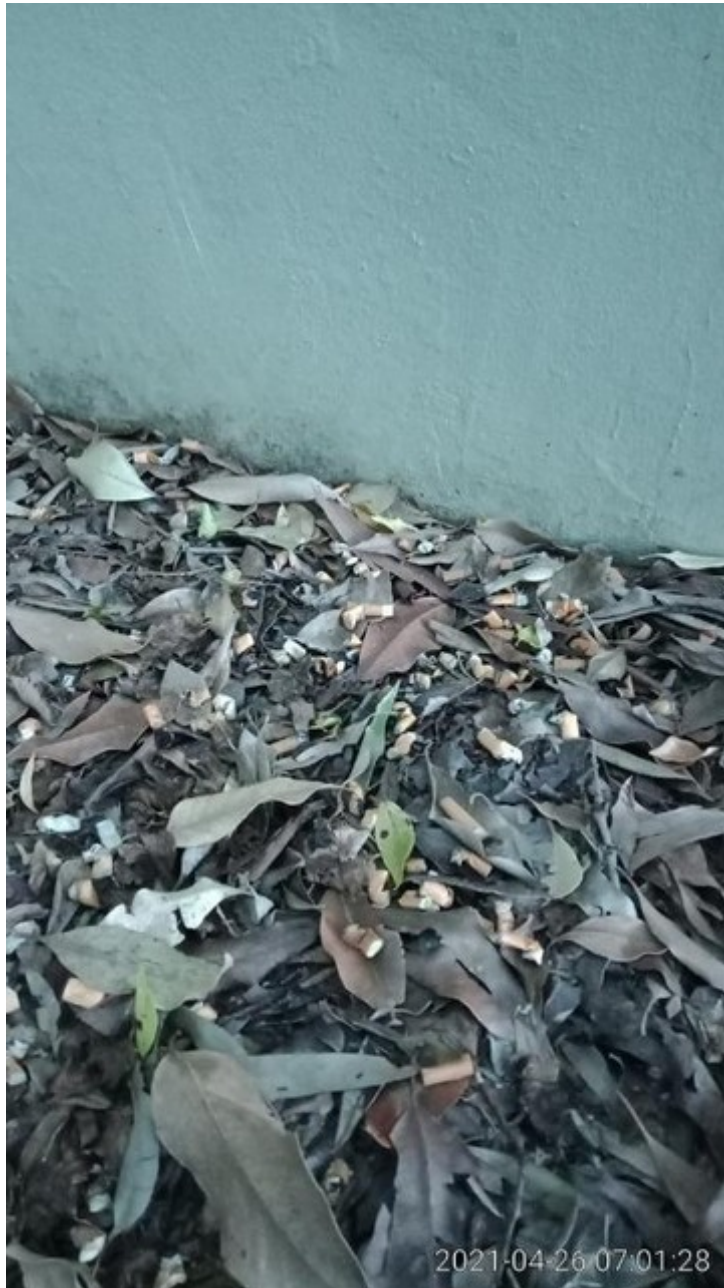
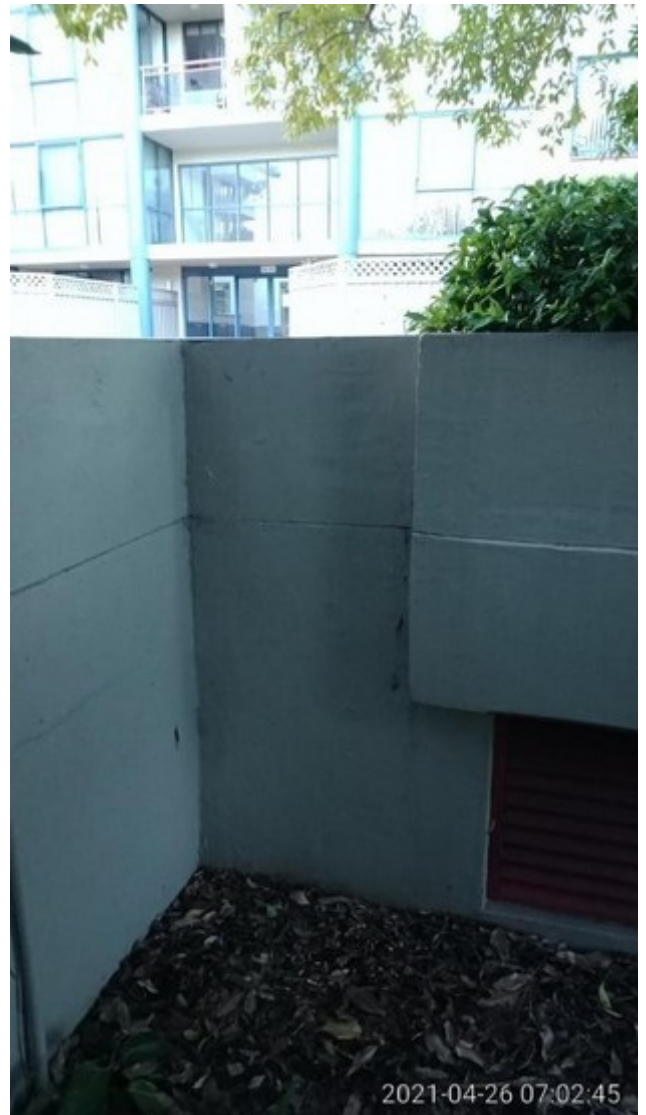
Garden area near Block D, flooded with cigarette butts and not cleaned. Apart from obvious pollution to the nature, dry leaves and branches can easily start the unintentional fire as well.

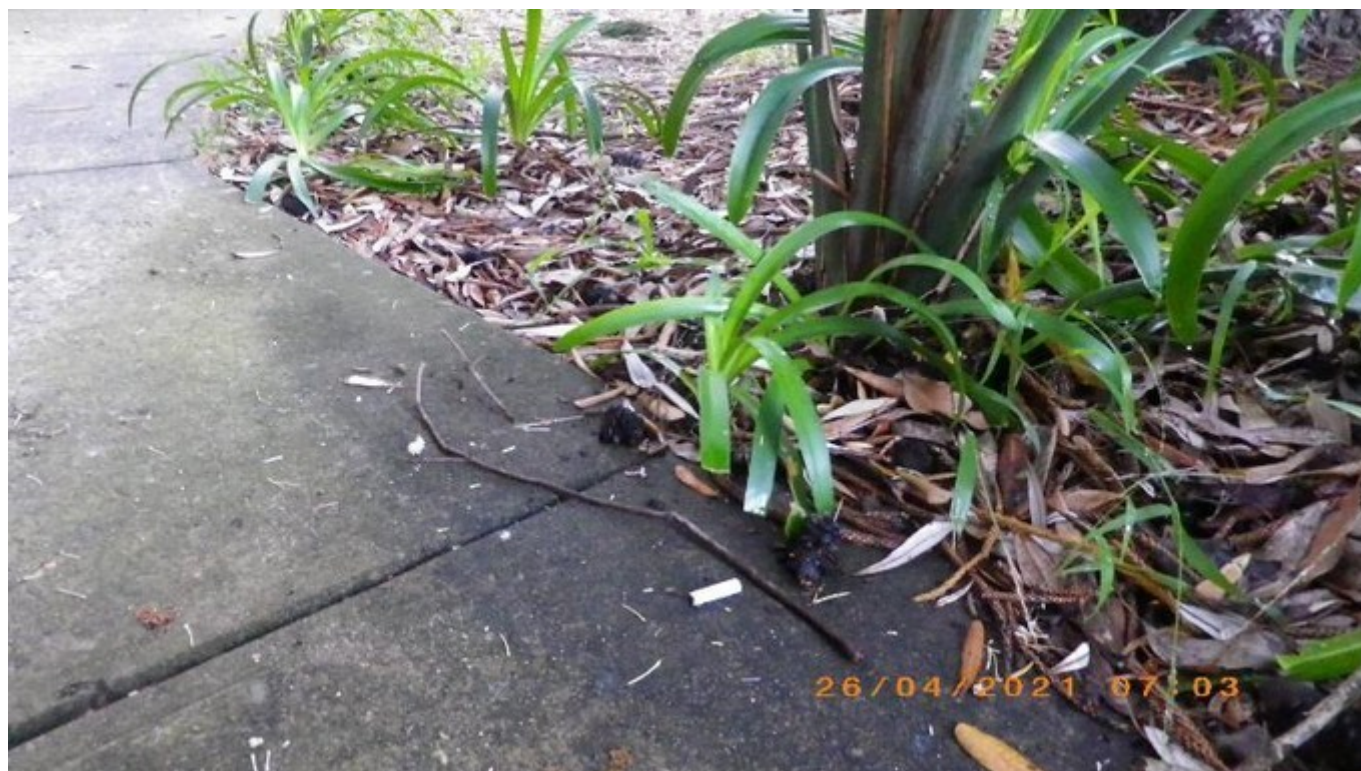
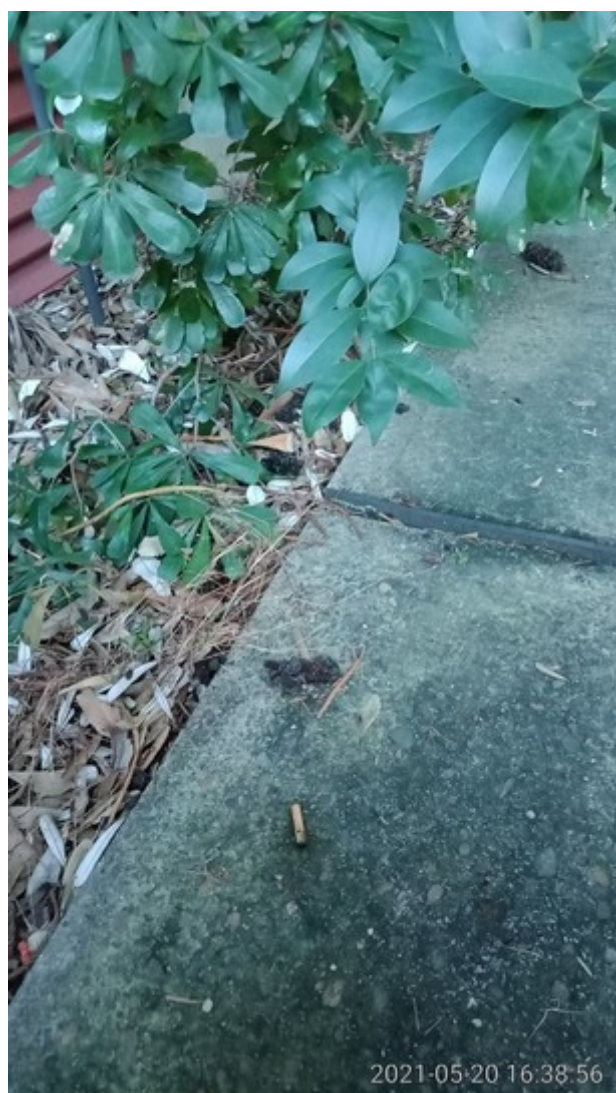
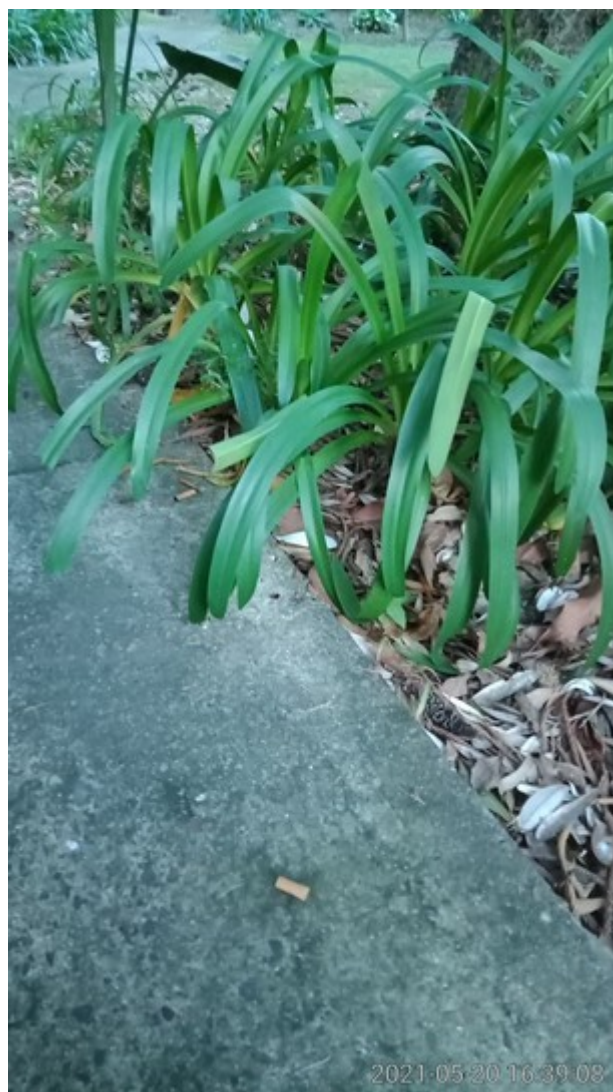
17 Smoking in the complex continue to be a serious fire safety risk – Block D garden pathway where lot of dry barks and leaves cover the grounds

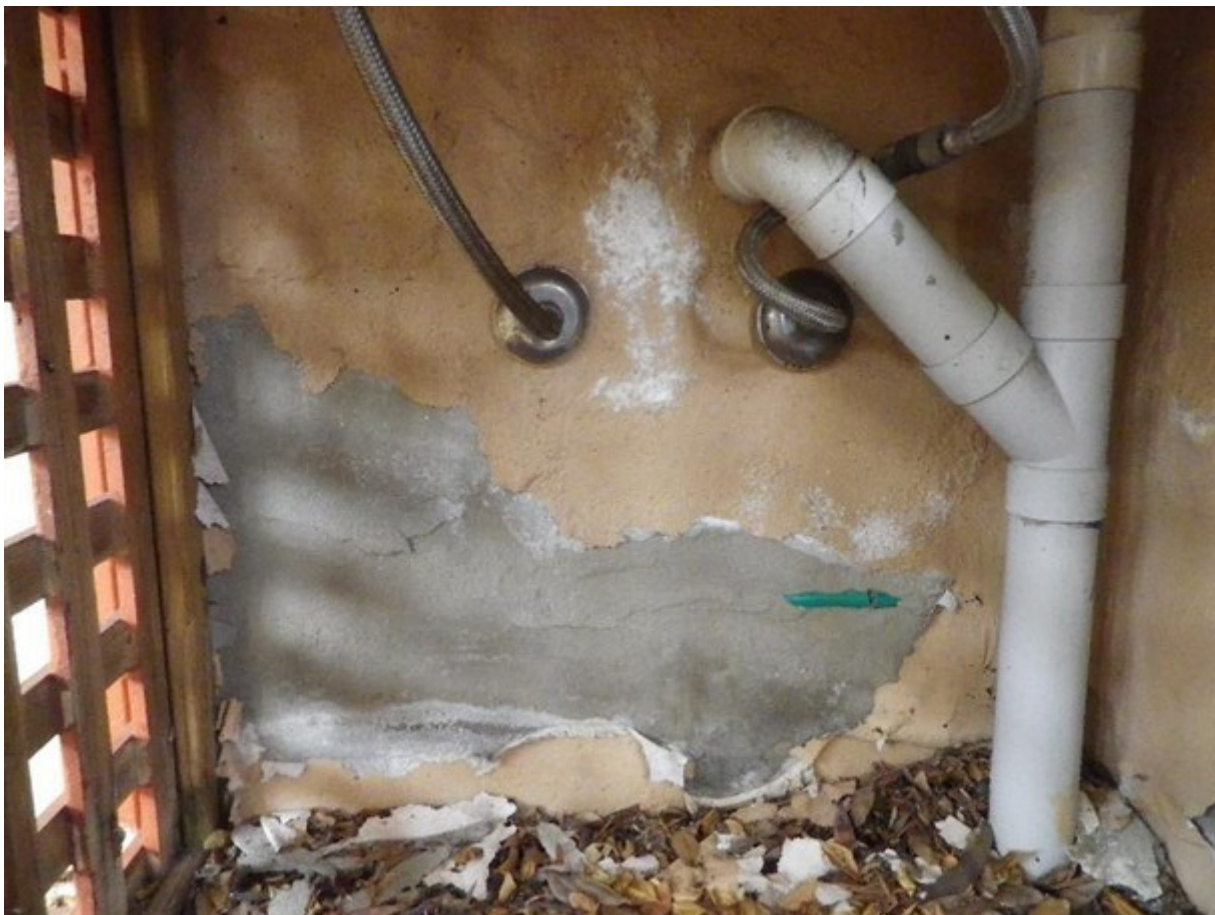
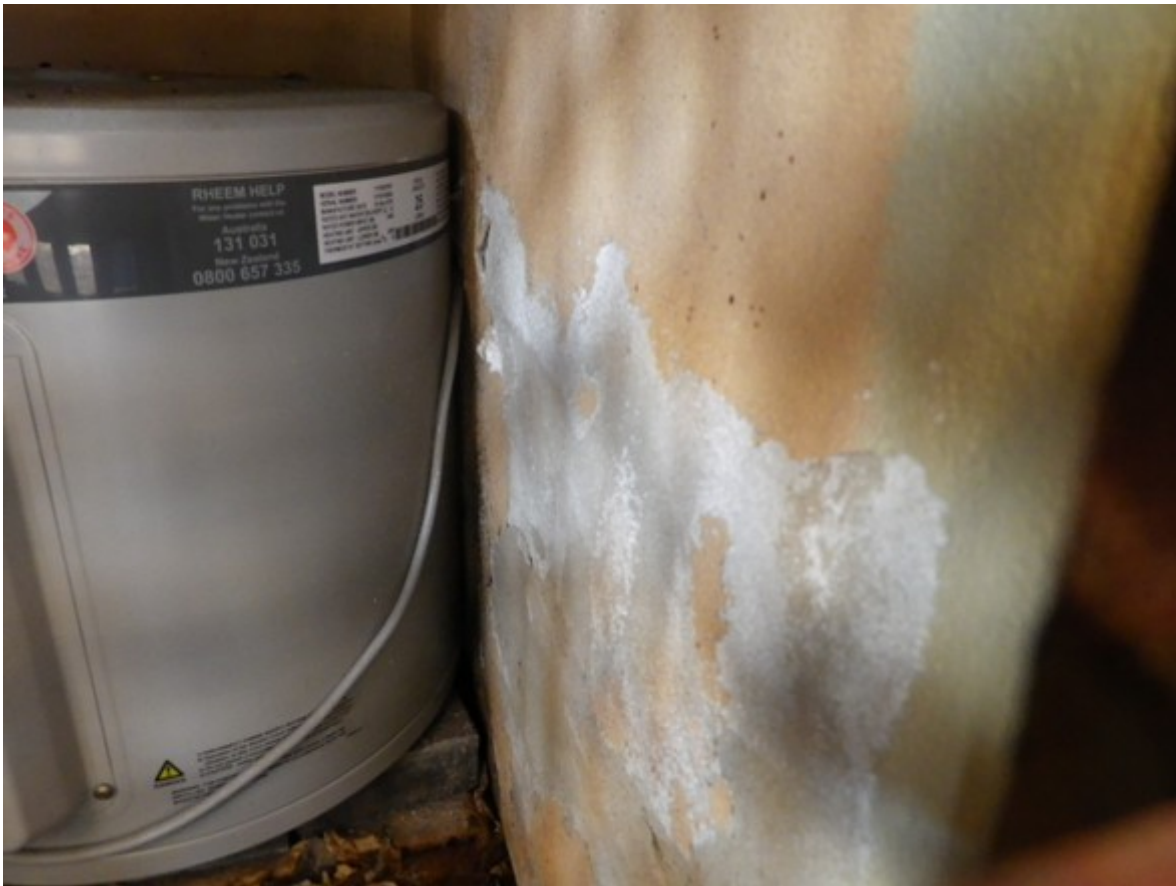
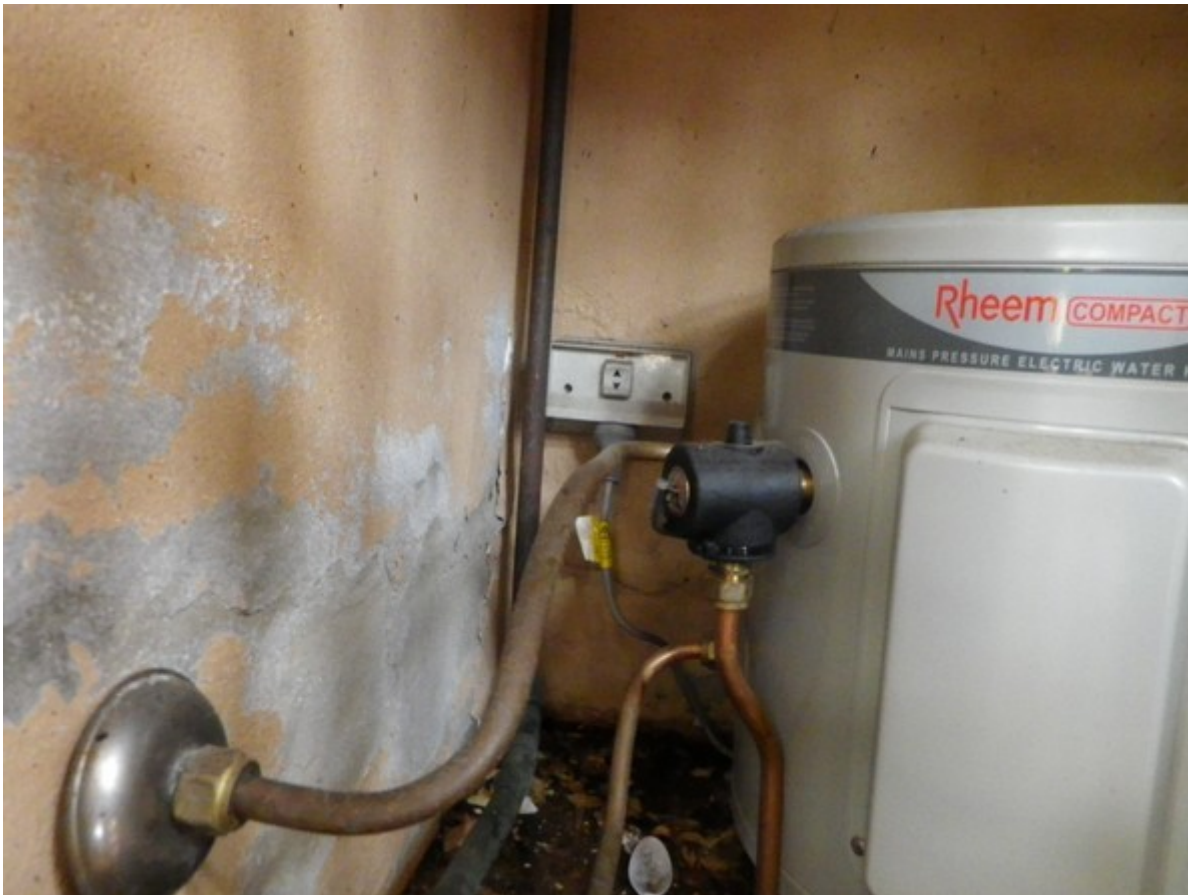
## 18 BBQ area below sink high fire safety risks for four years

For the last four years, ever since alleged major upgrades in the complex, the BBQ area has been repeatedly repainted, repaired, and allegedly "maintained with high quality of services without evidence of warranties". This was reported numerous times.

- a) Walls damaged by long-term water penetration and leaks,
- b) Piece of PVC pipe protruding through the wall,
- c) Rusted hoses,
- d) Rusted pipes,
- e) Potential for electrical hazards because water leakages and wall damages appear to be close to wall socket,
- f) Dry leaves could create fire hazard,
- g) Water wastage?

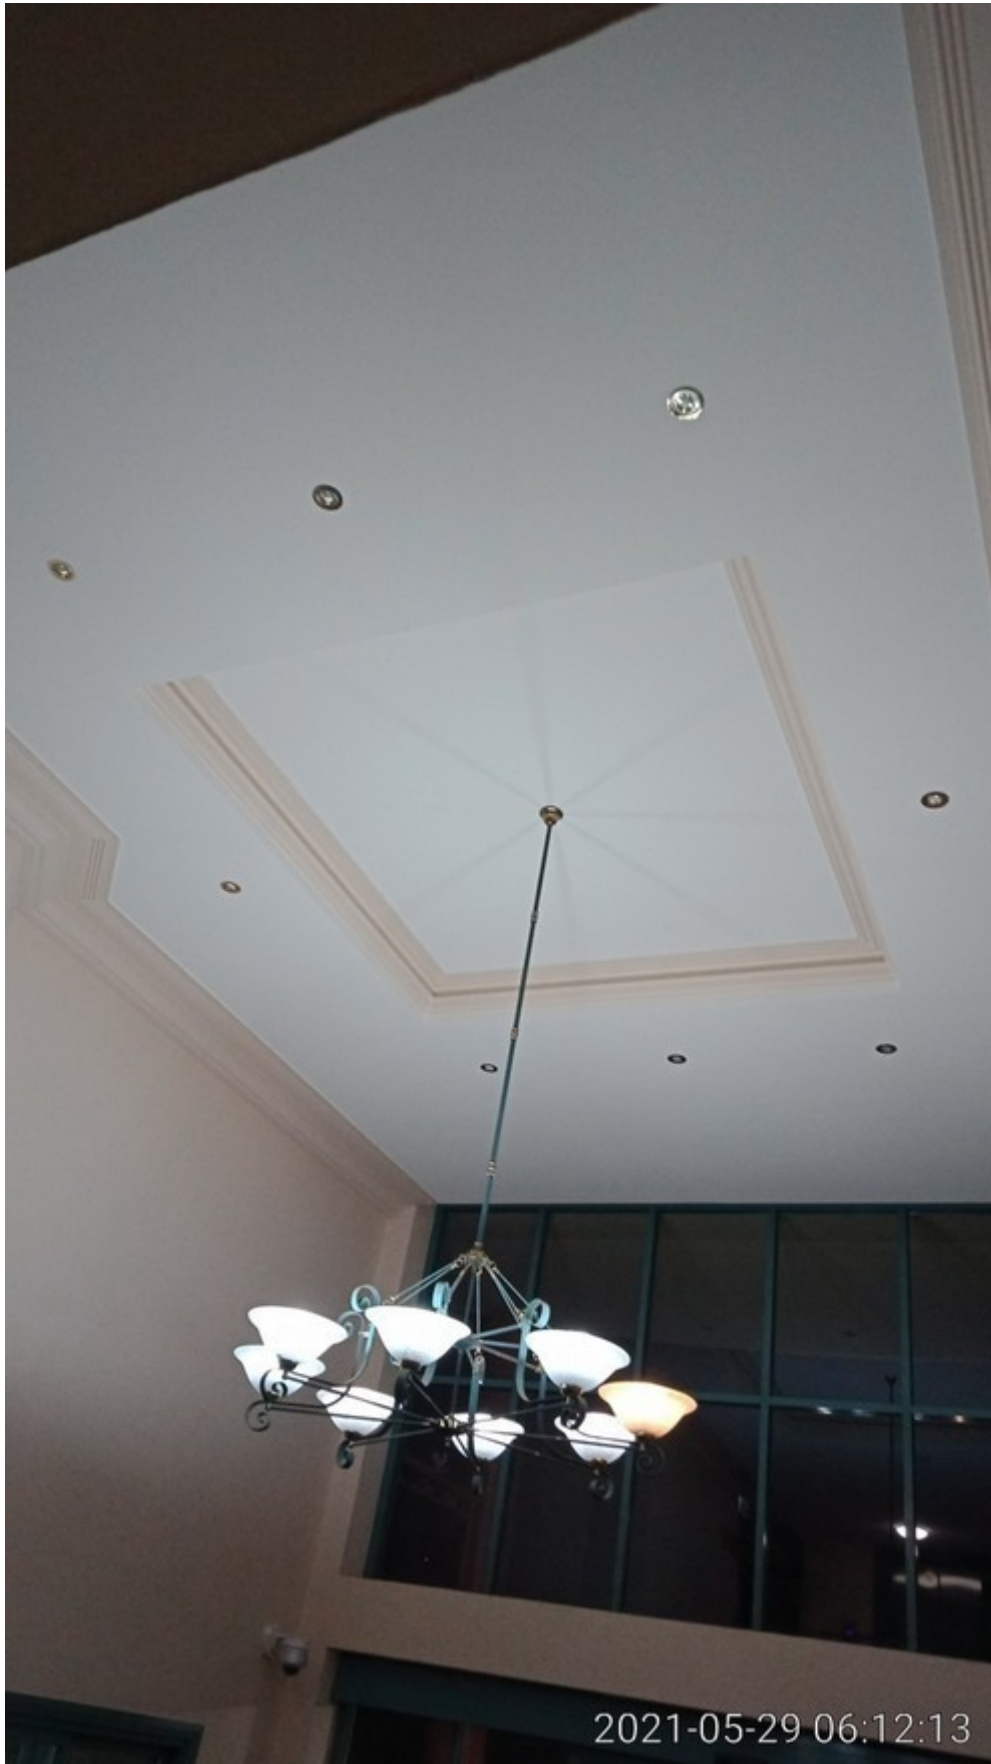
a) Block A, none of eight down-lights operational

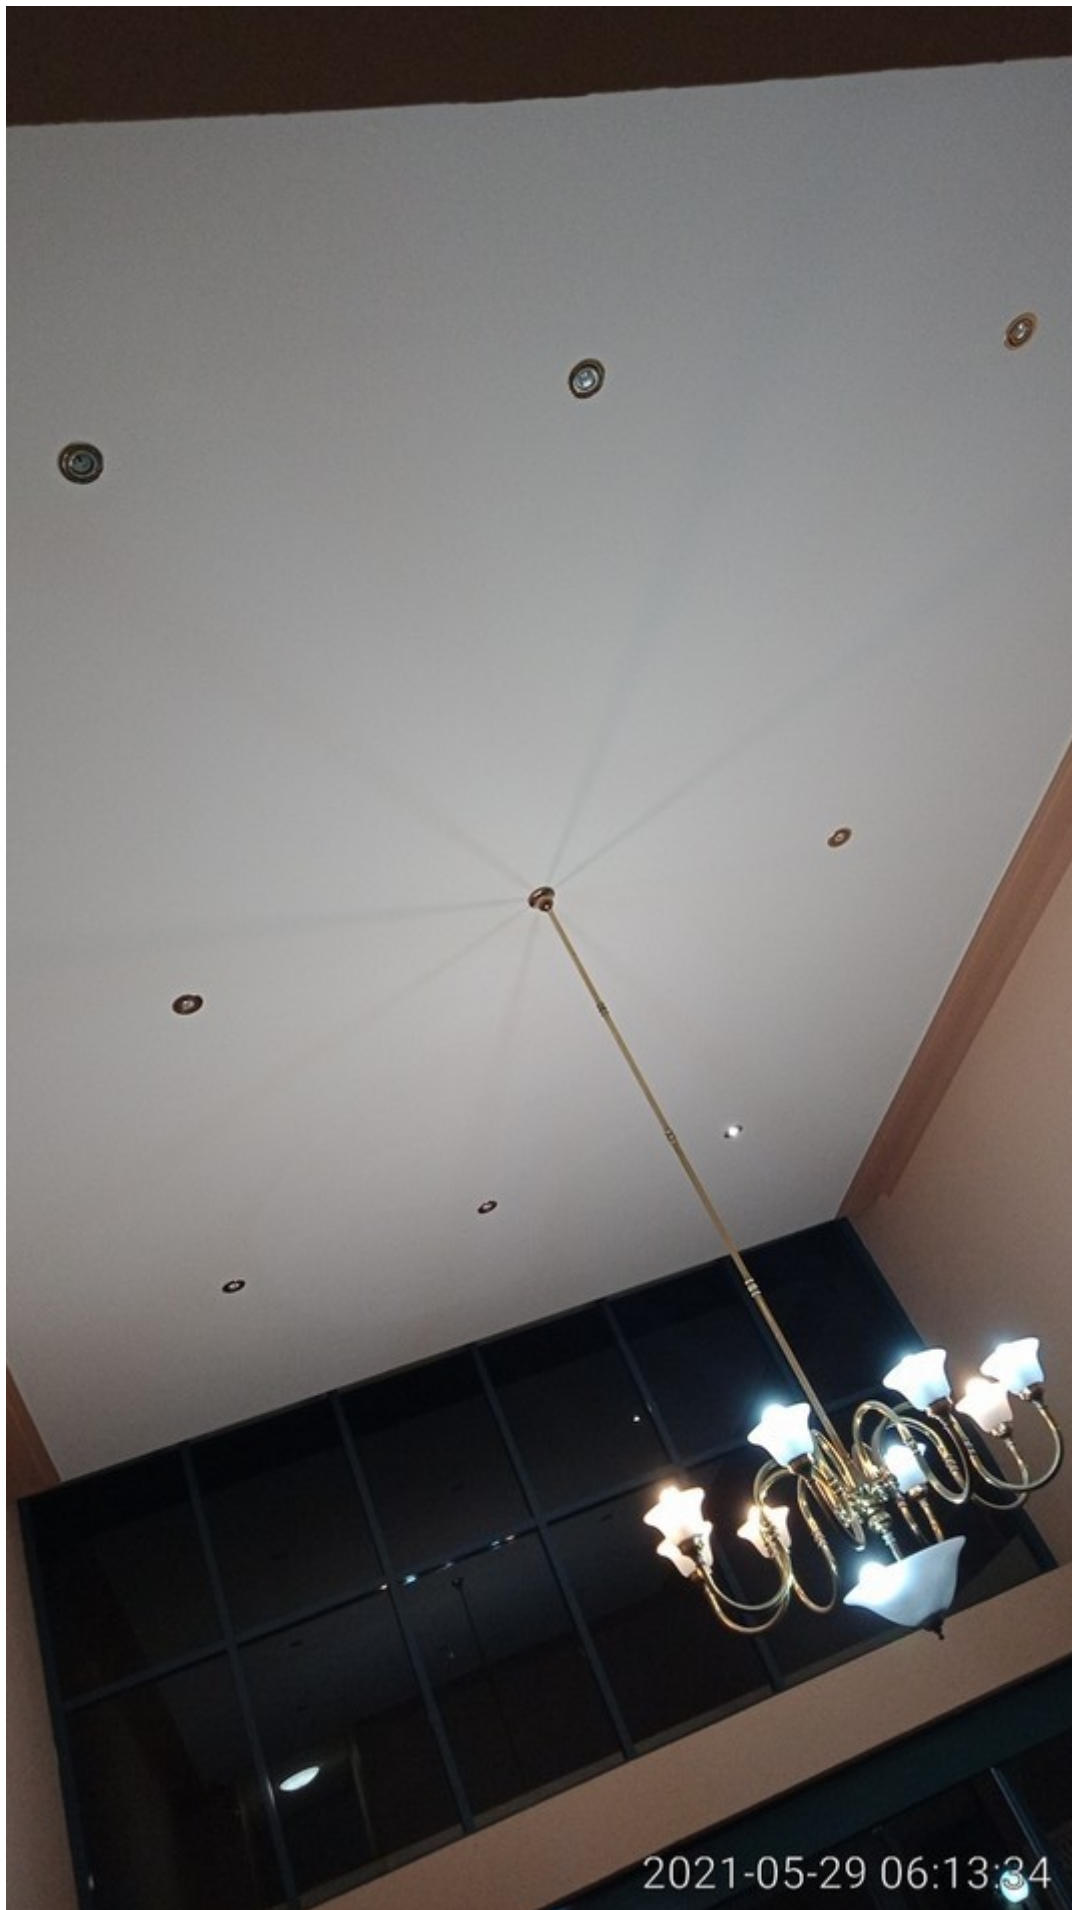
b) Block B, none of eight down-lights operational
