## Table of Contents

This document lists just some of the problems in the complex that can cause injury, health problems, or even death in dire circumstances.

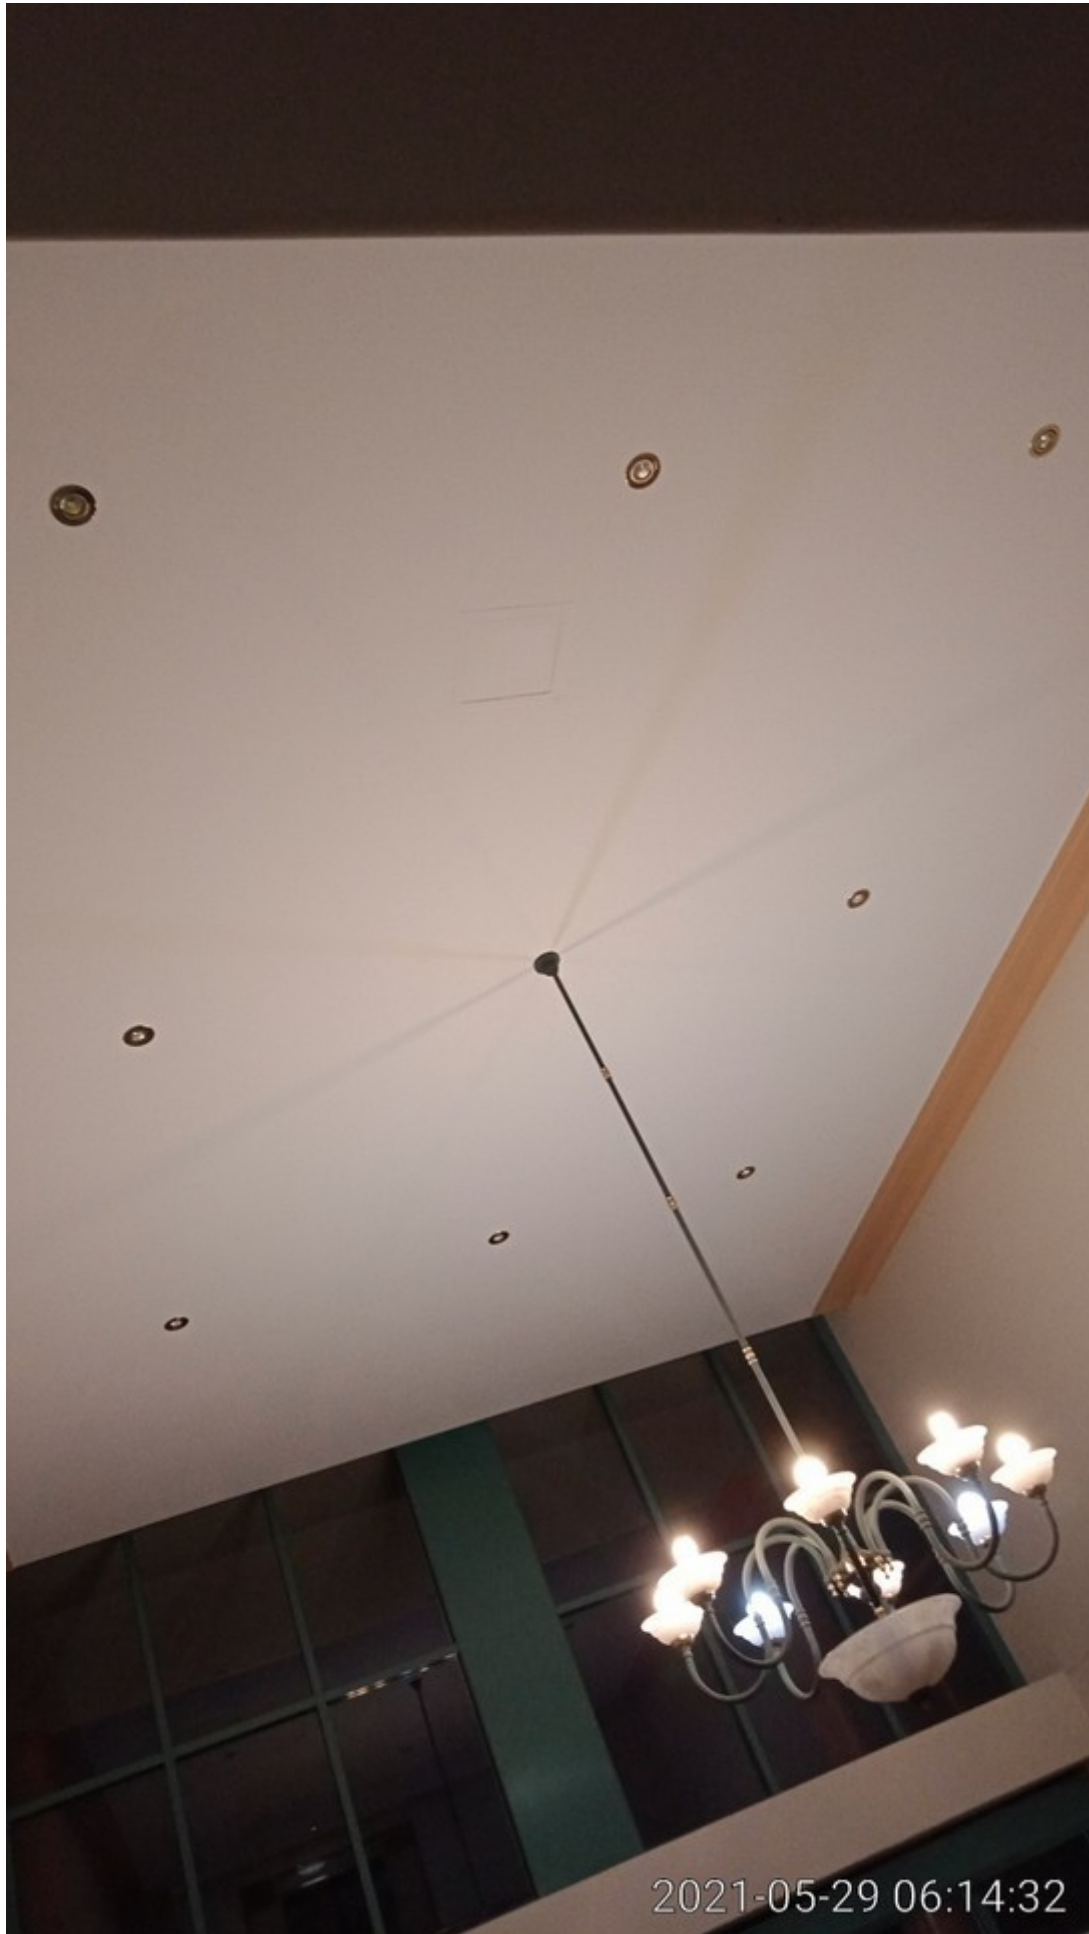
c) Block C, none of eight down-lights operational

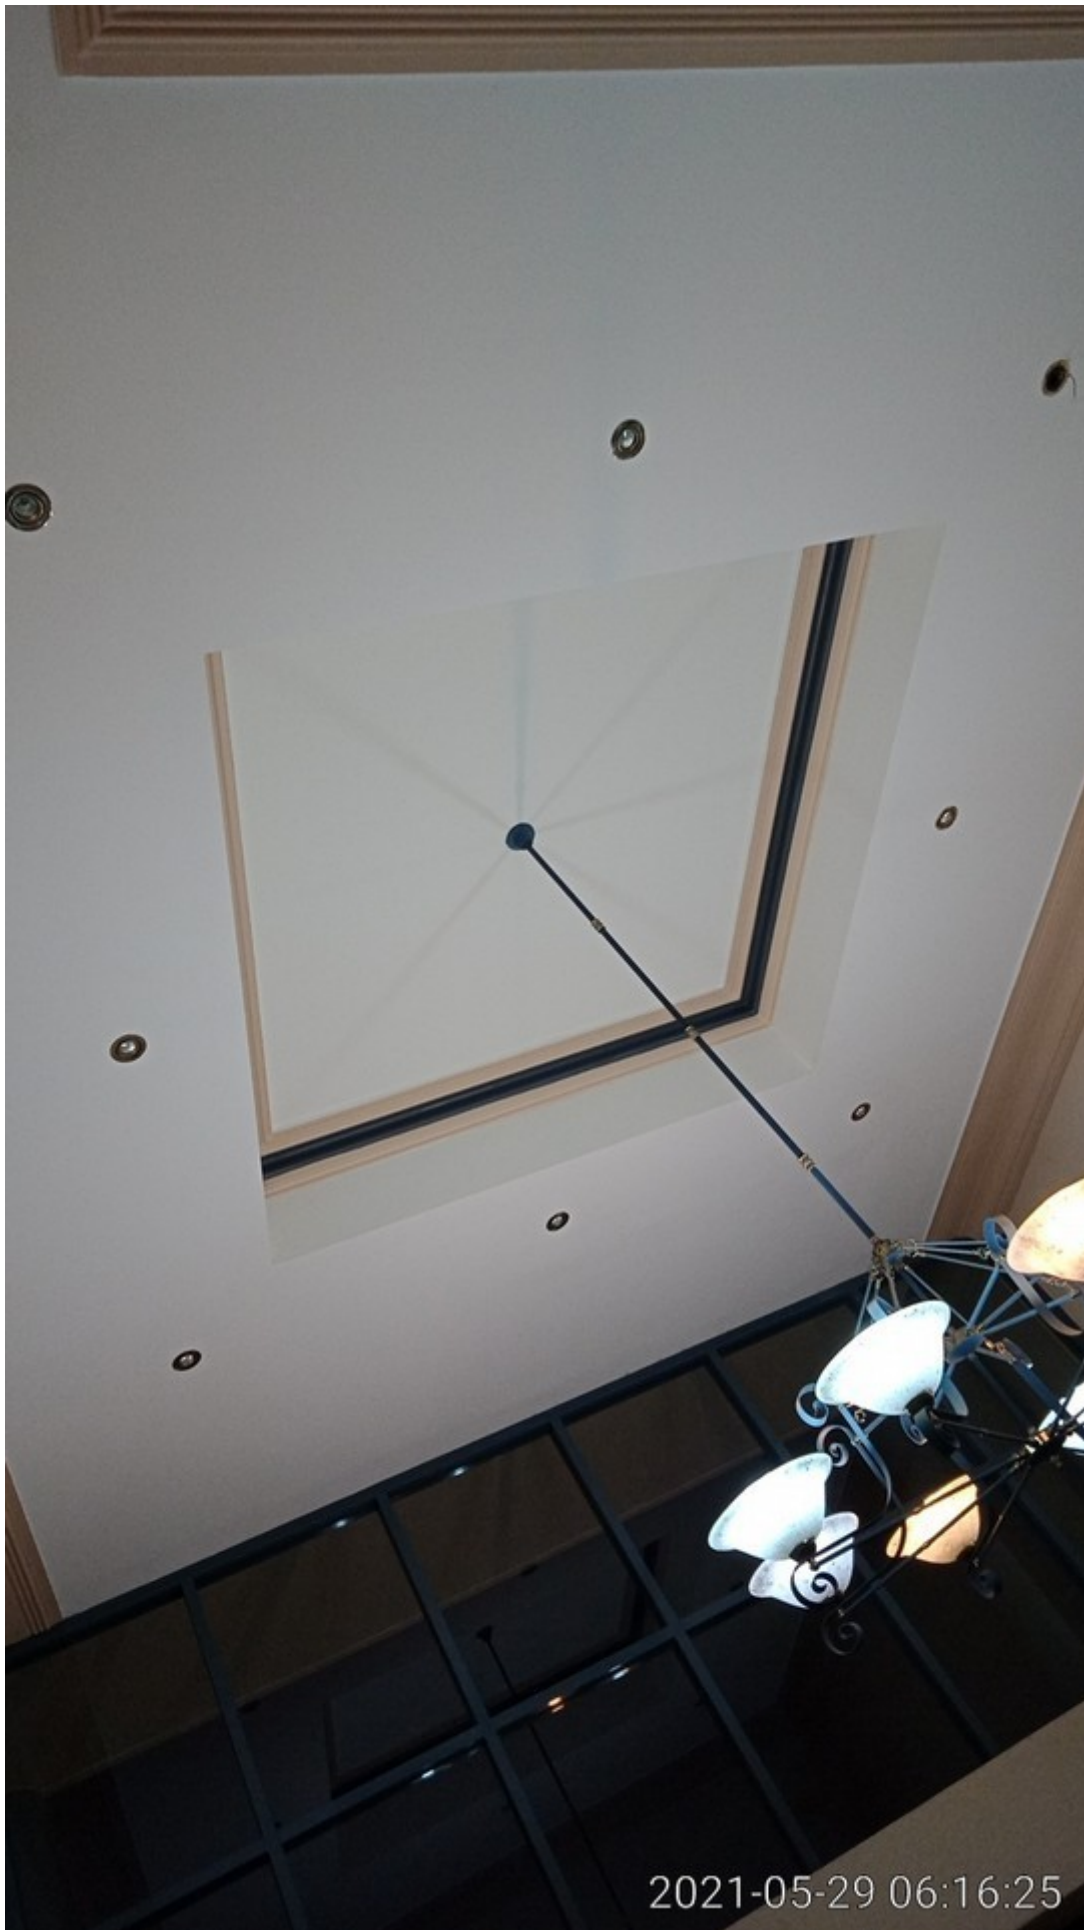
d) Block D, none of eight down-lights operational

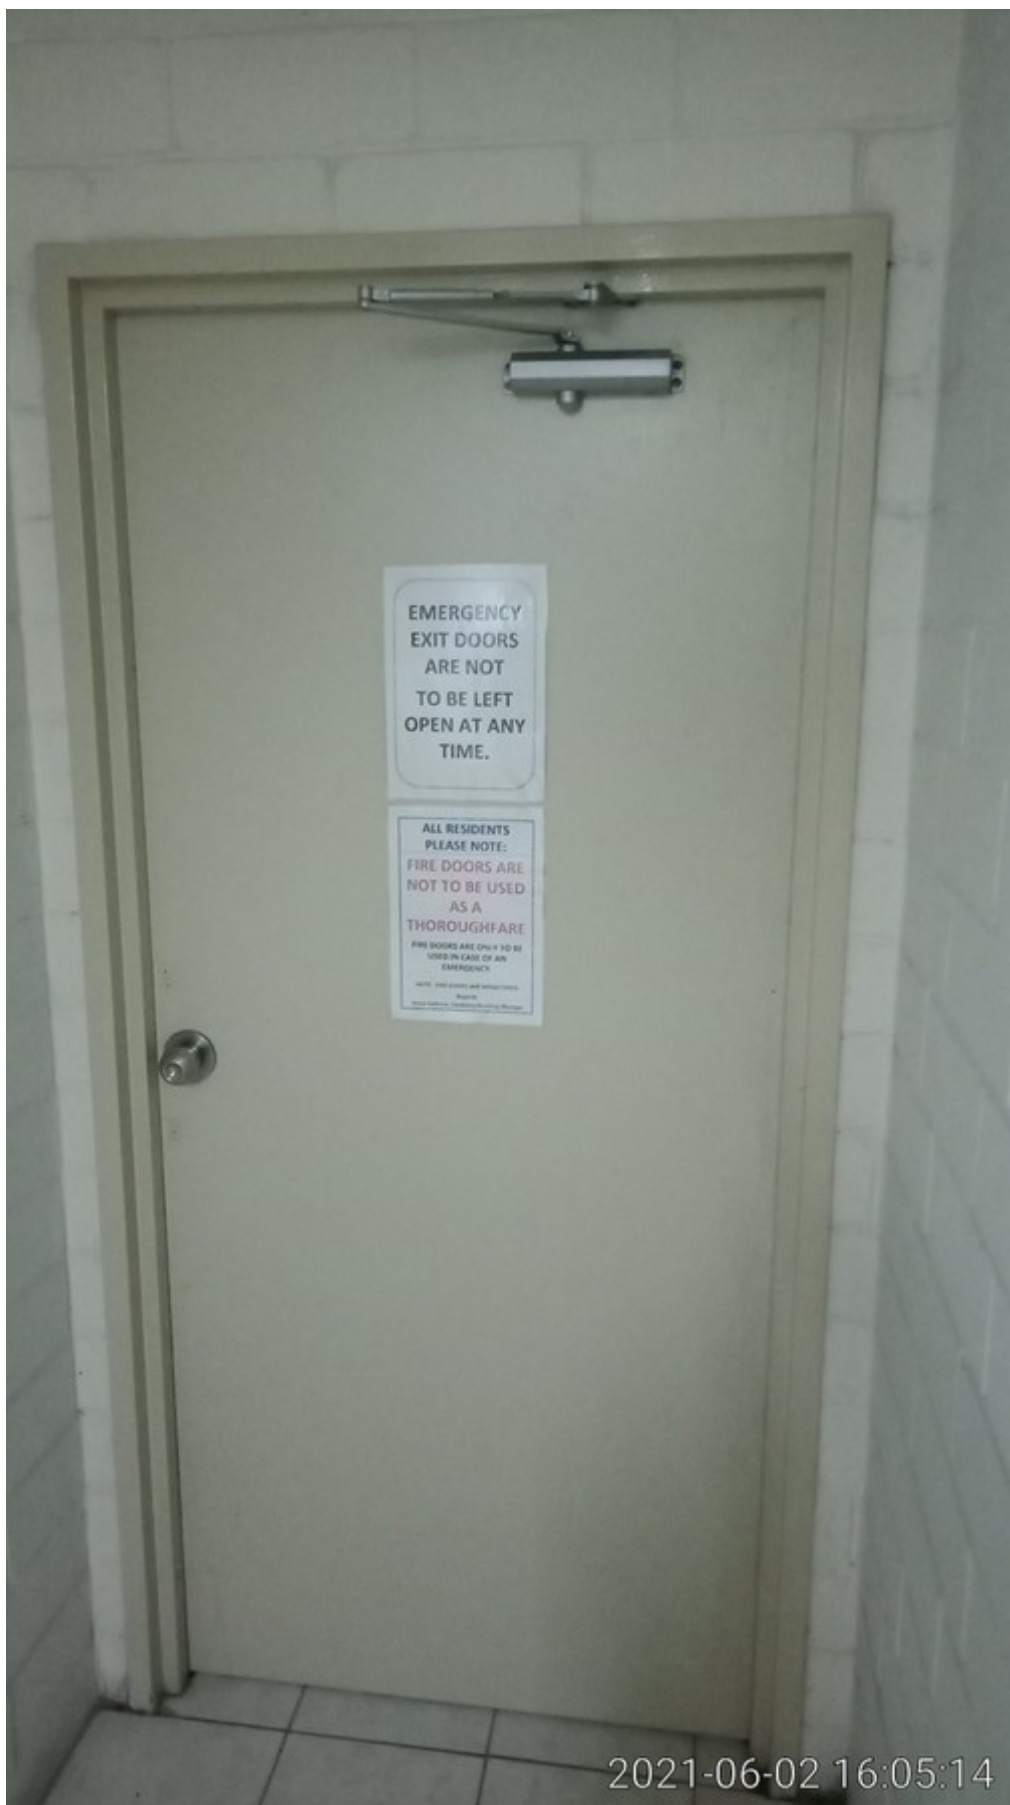
a) Block A, with notice about thoroughfare and exit

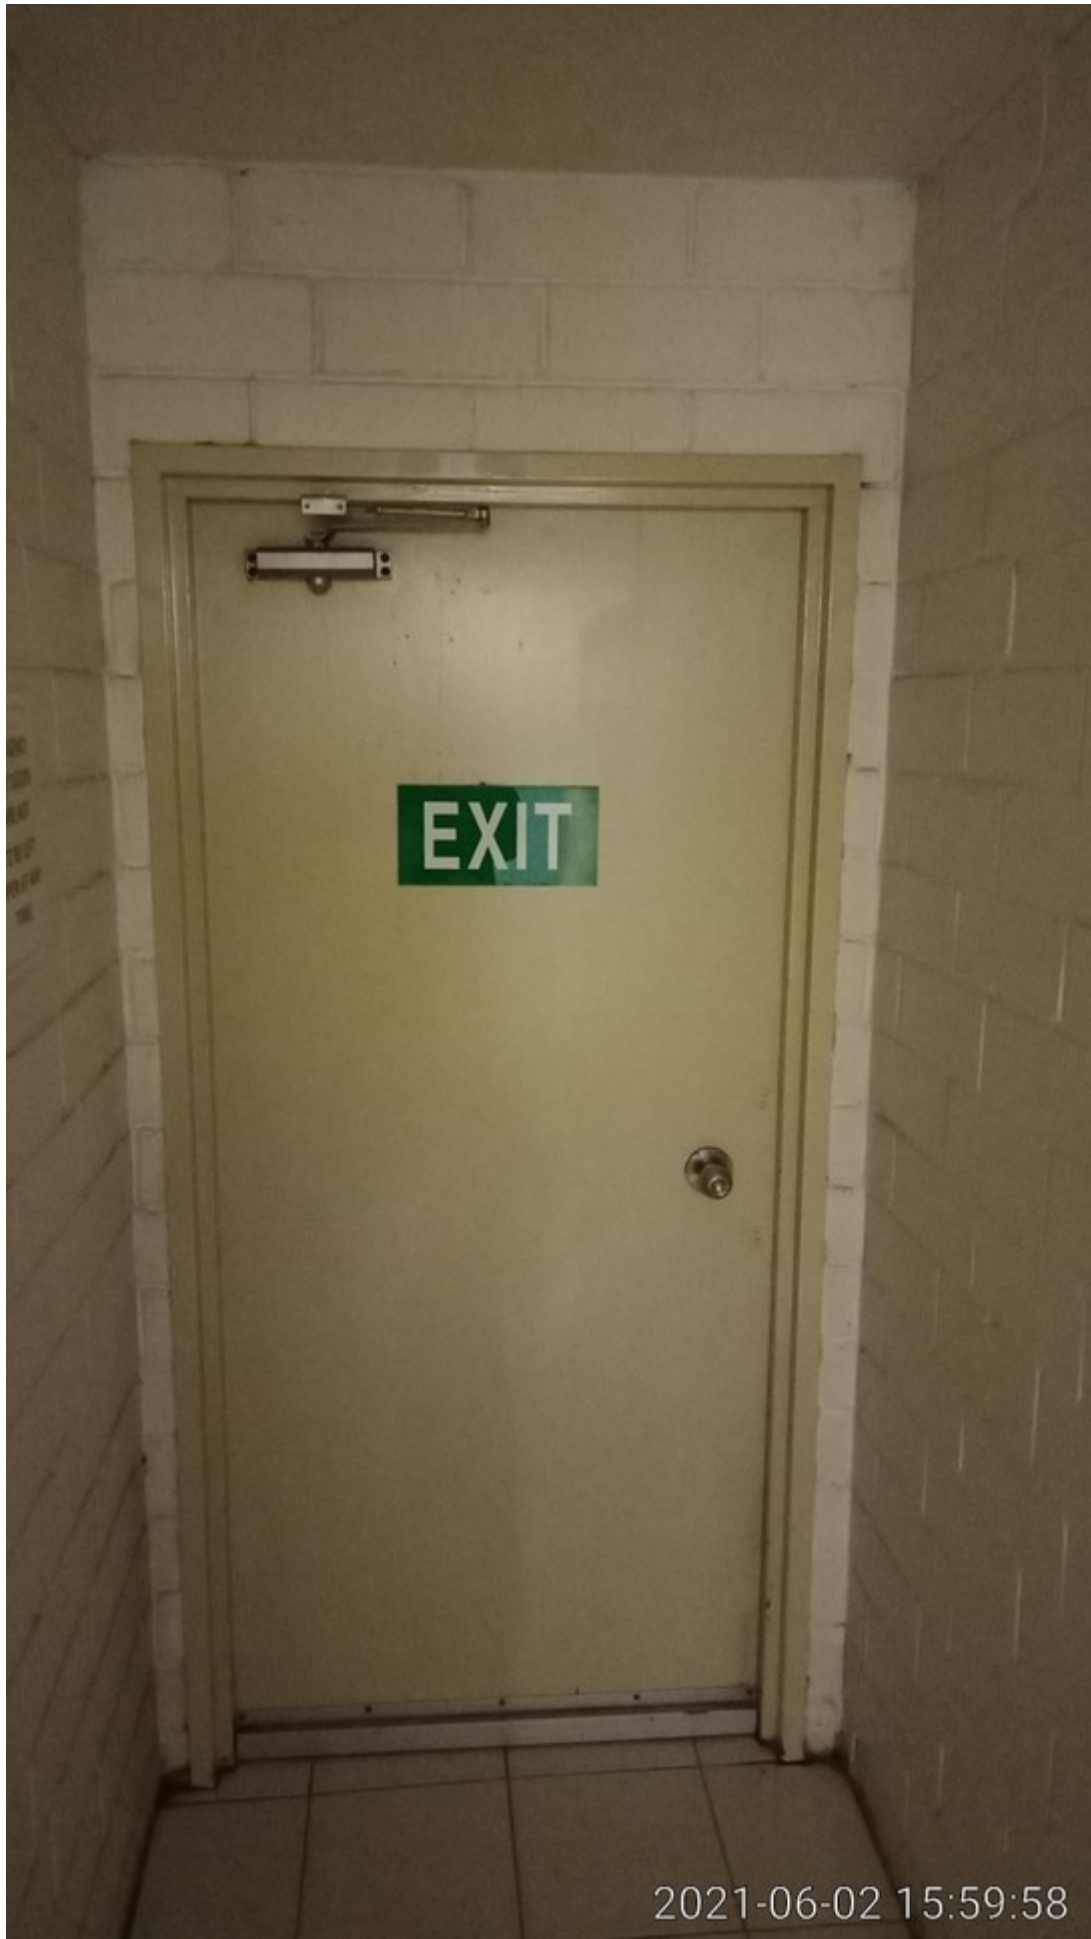
b) Block B, without signage for thoroughfare and keeping the door open

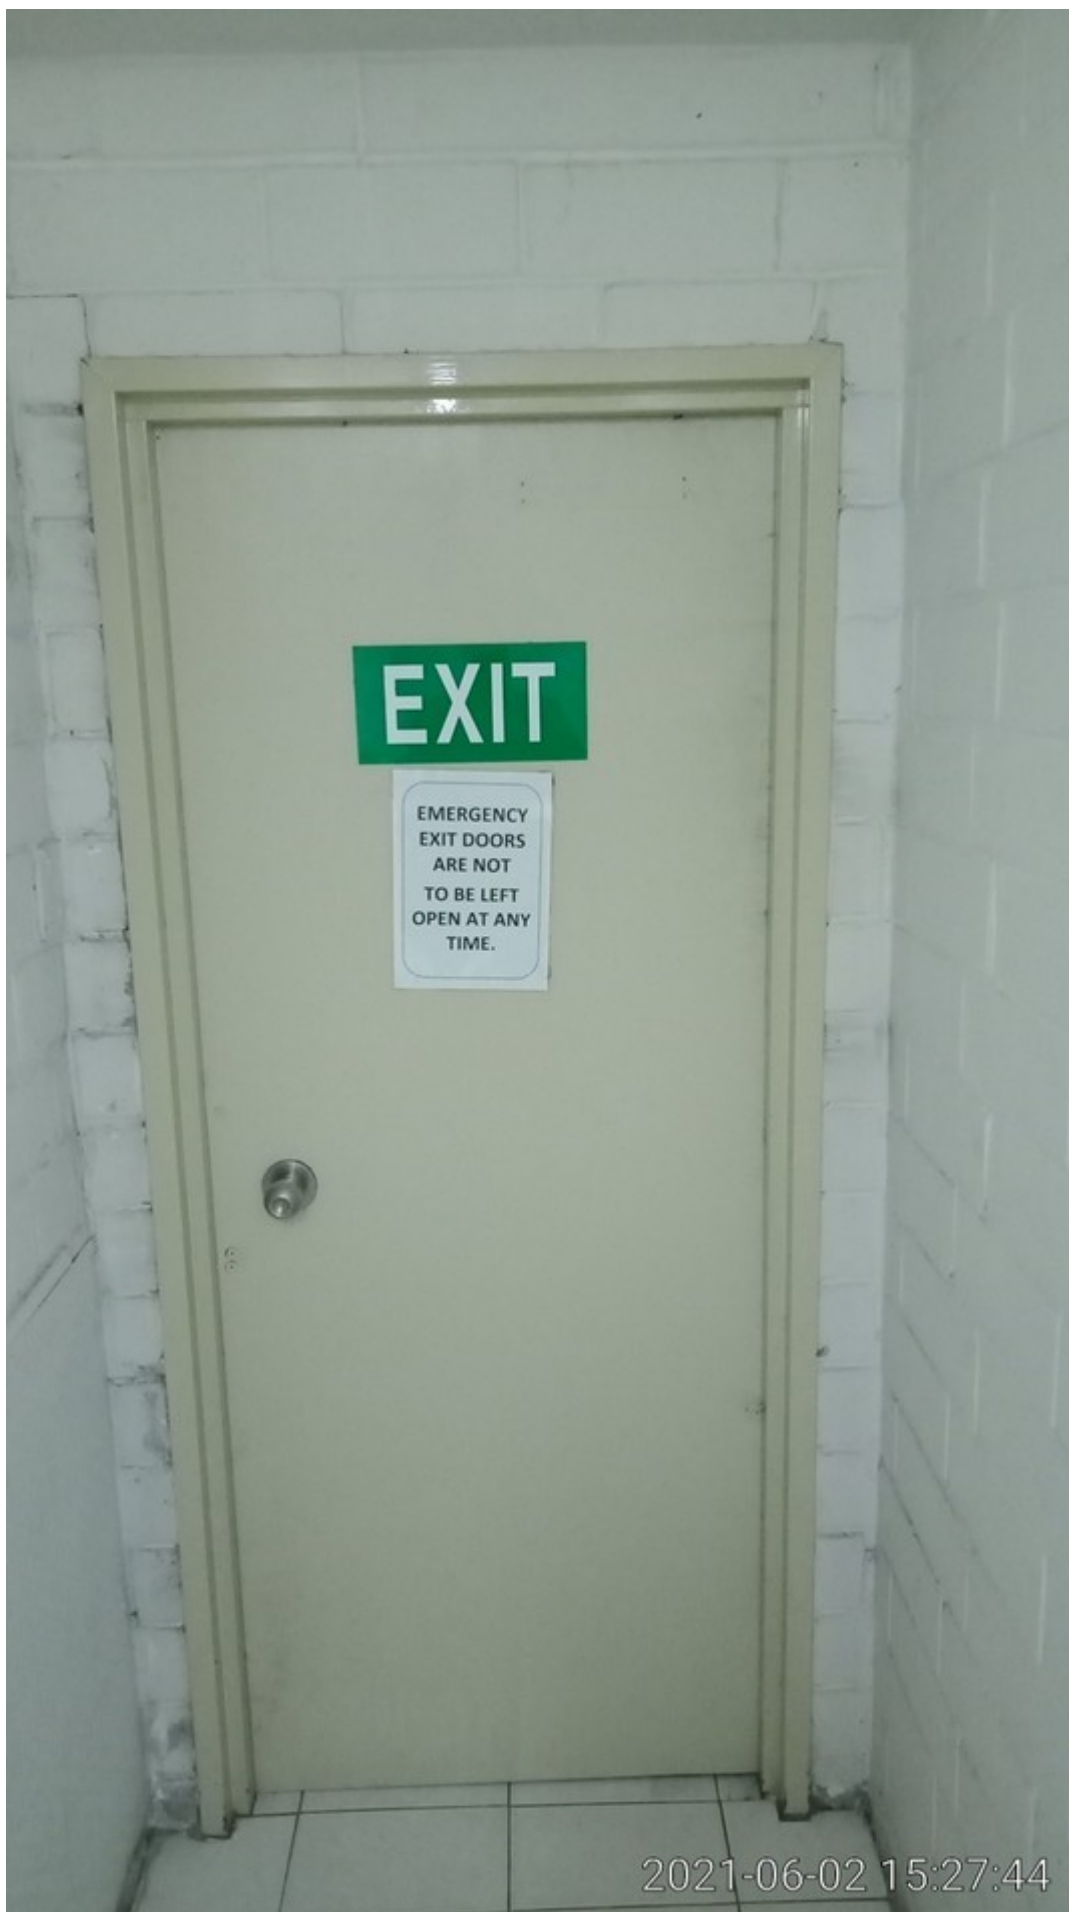
c) Block C, without notice for thoroughfare

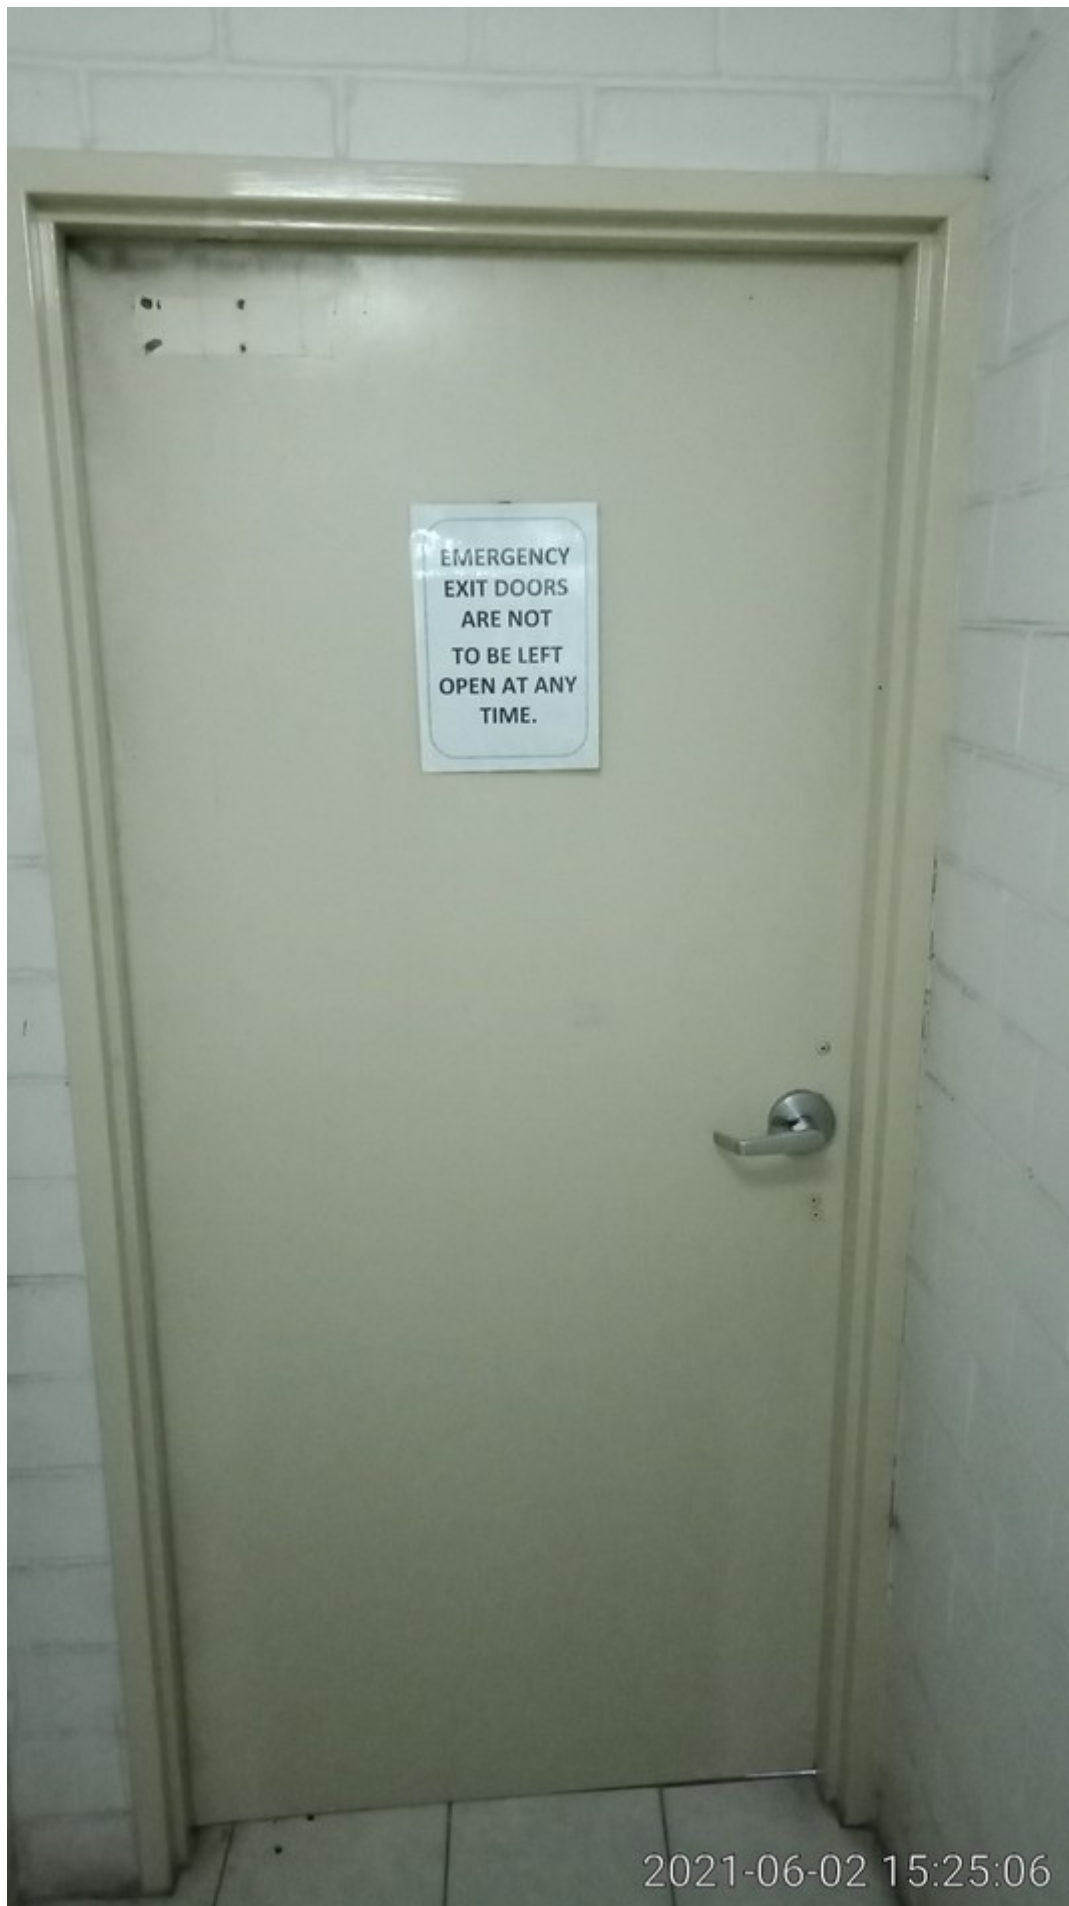
d) Block D, without signage for thoroughfare and exit

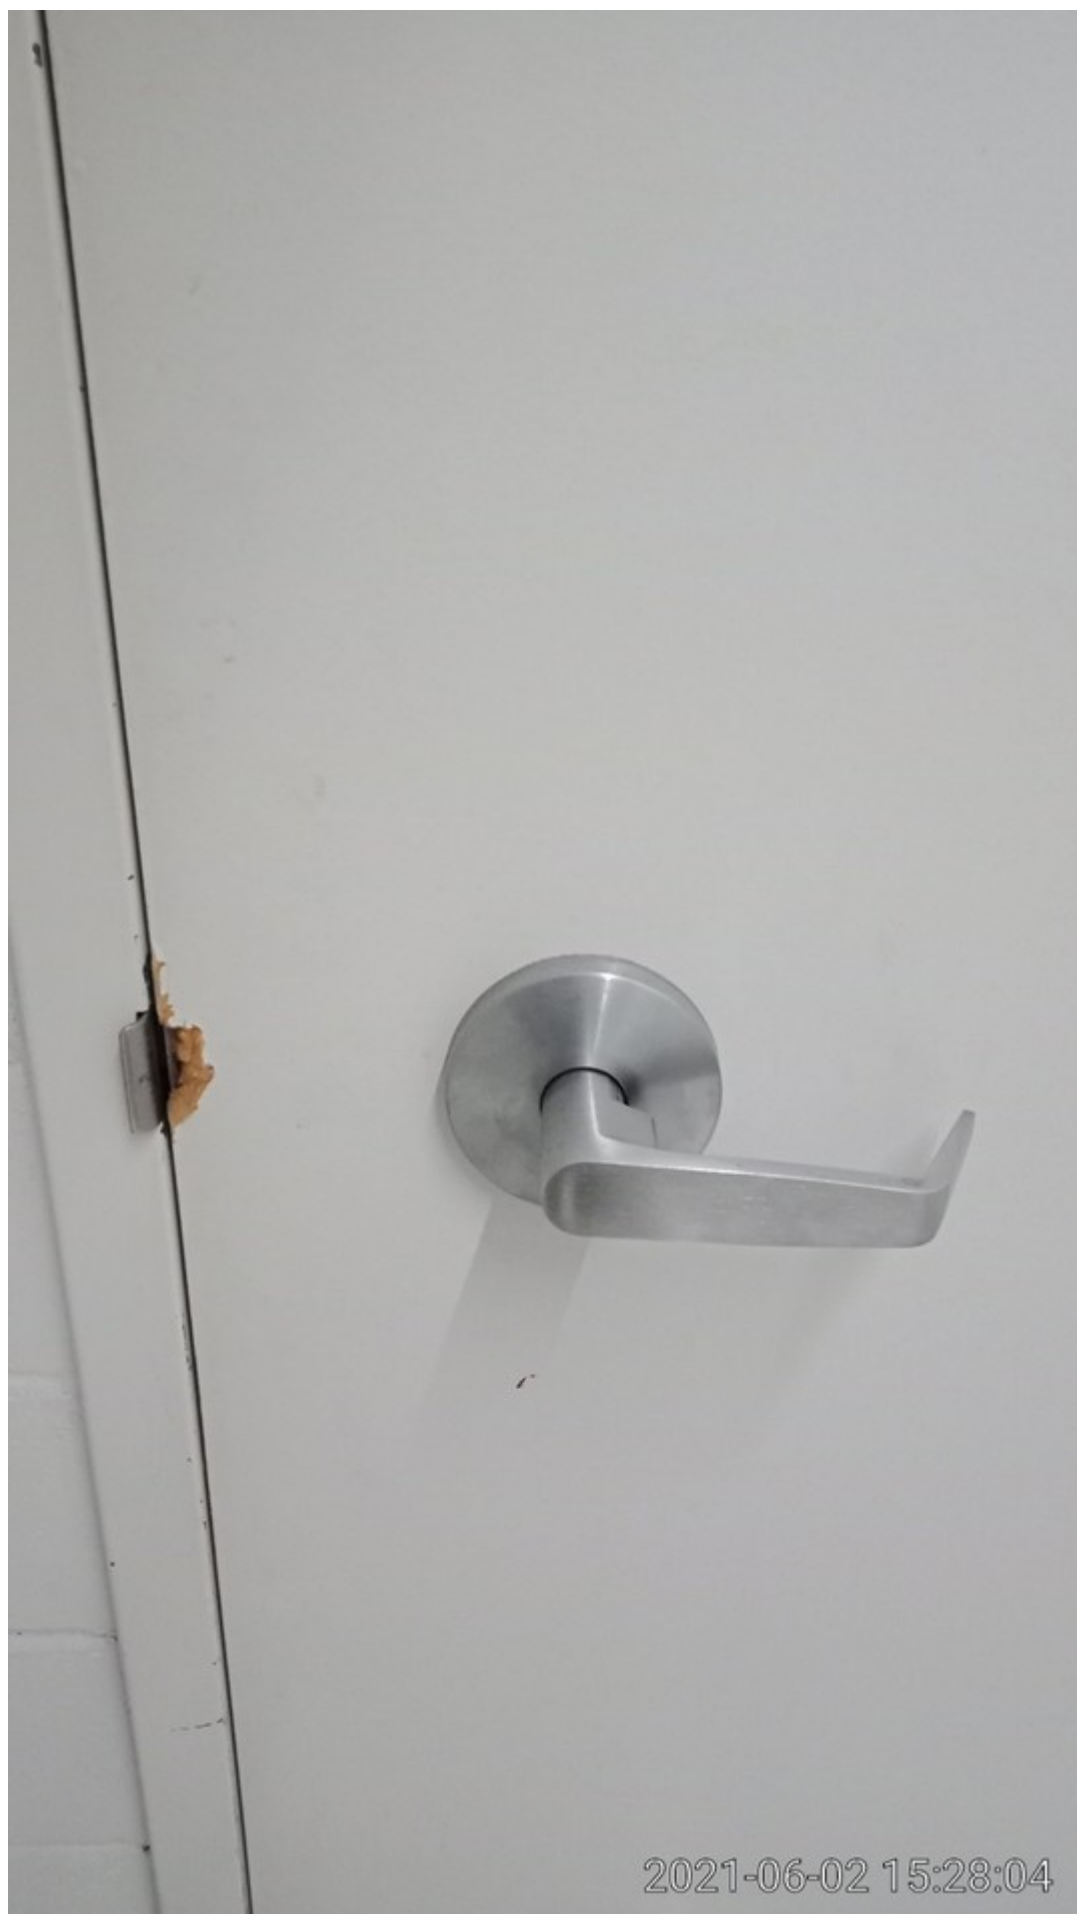
22 Damaged lock mechanism on fire door for two years – Block C ground floor

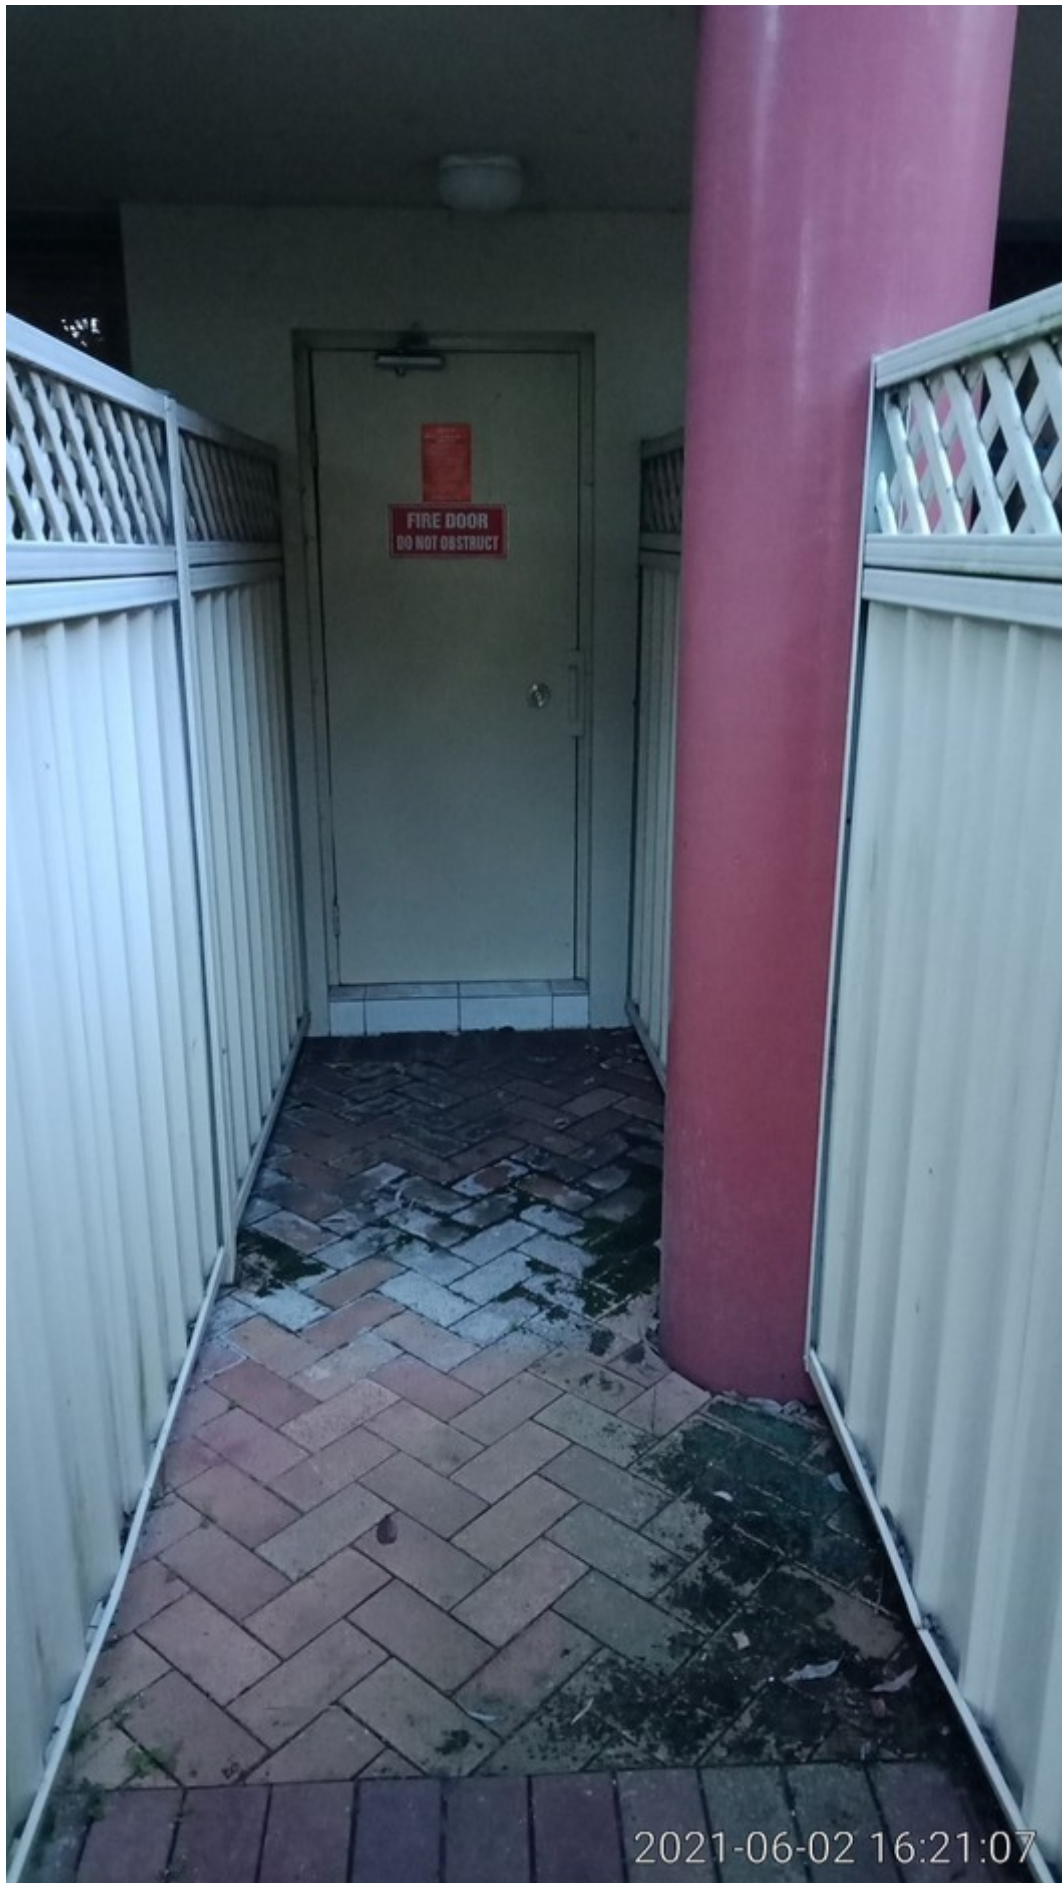
23 Appearance of pathway outside Block C fire door – slippery and mouldy for 14 months

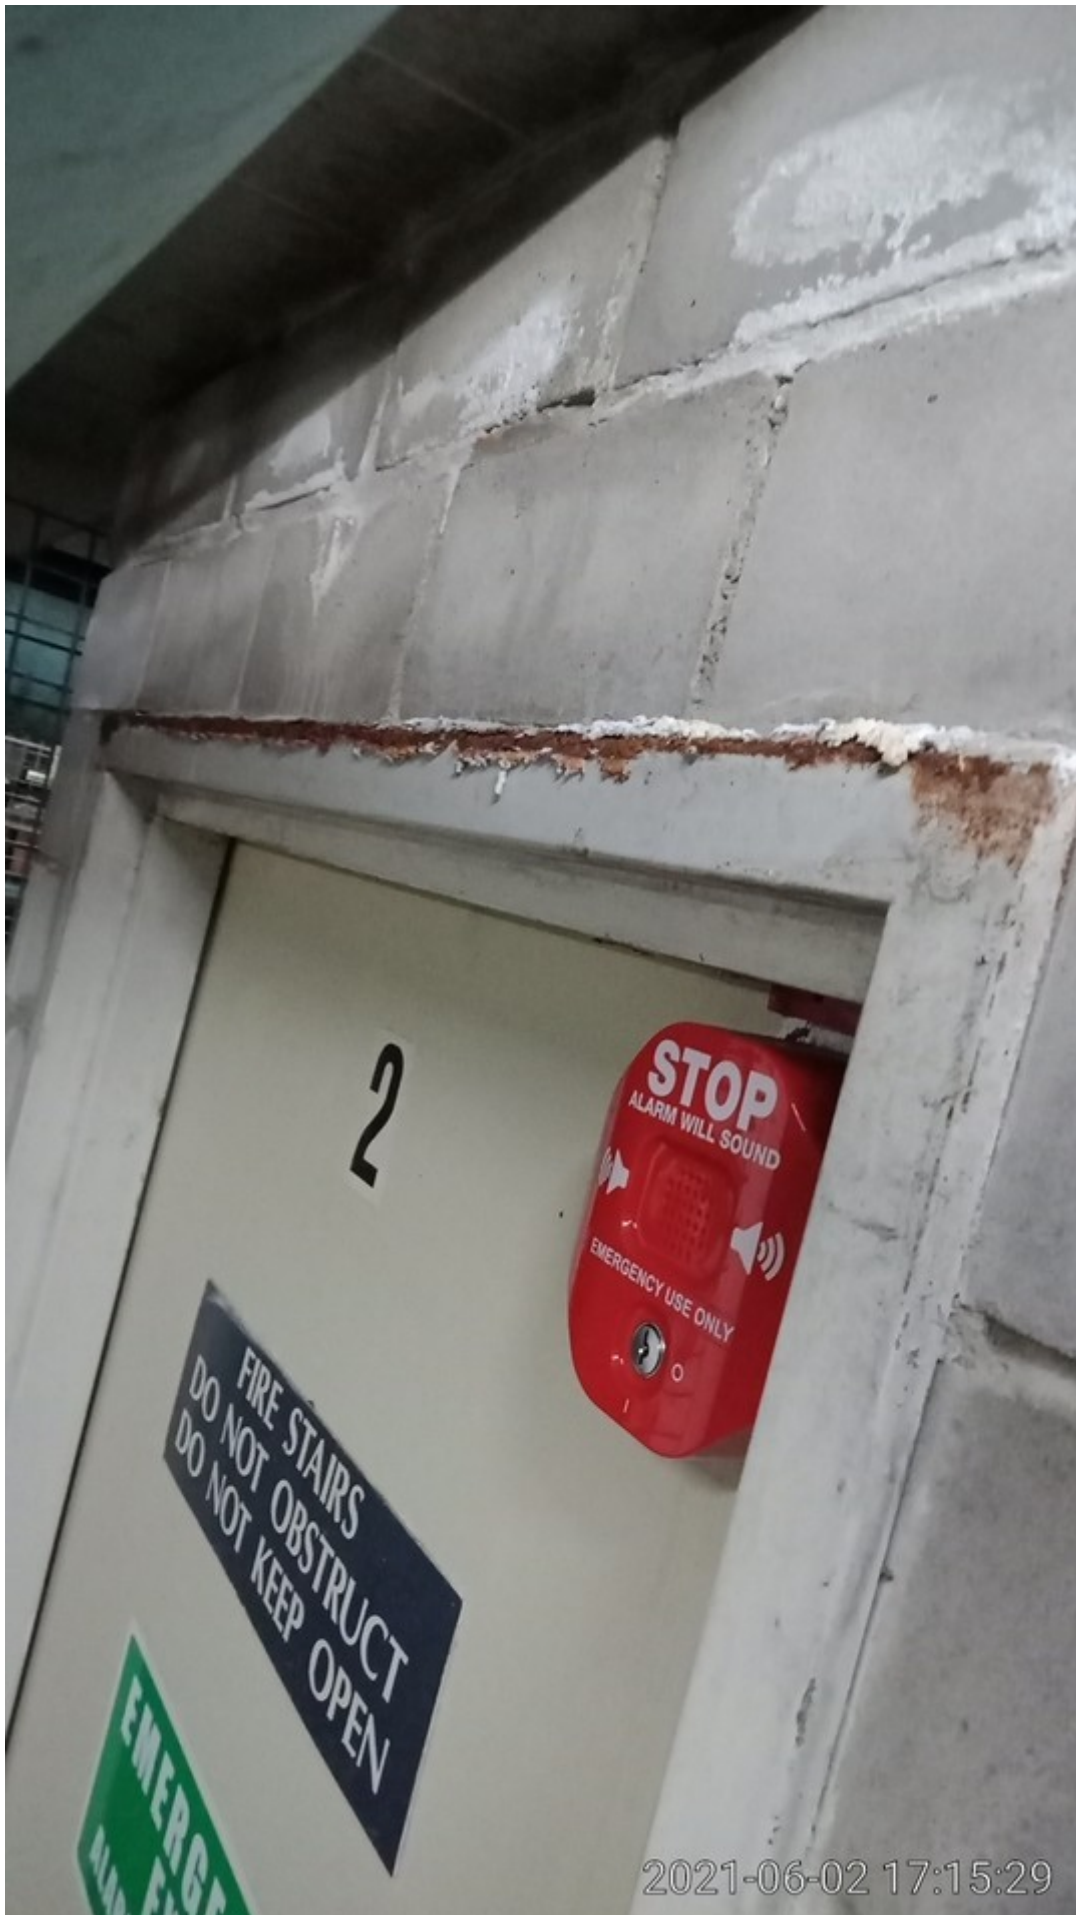
24    Rusted frame of fire door for six years – Block A basement
