## Table of Contents

This document lists just some of the problems in the complex that can cause injury, health problems, or even death in dire circumstances.

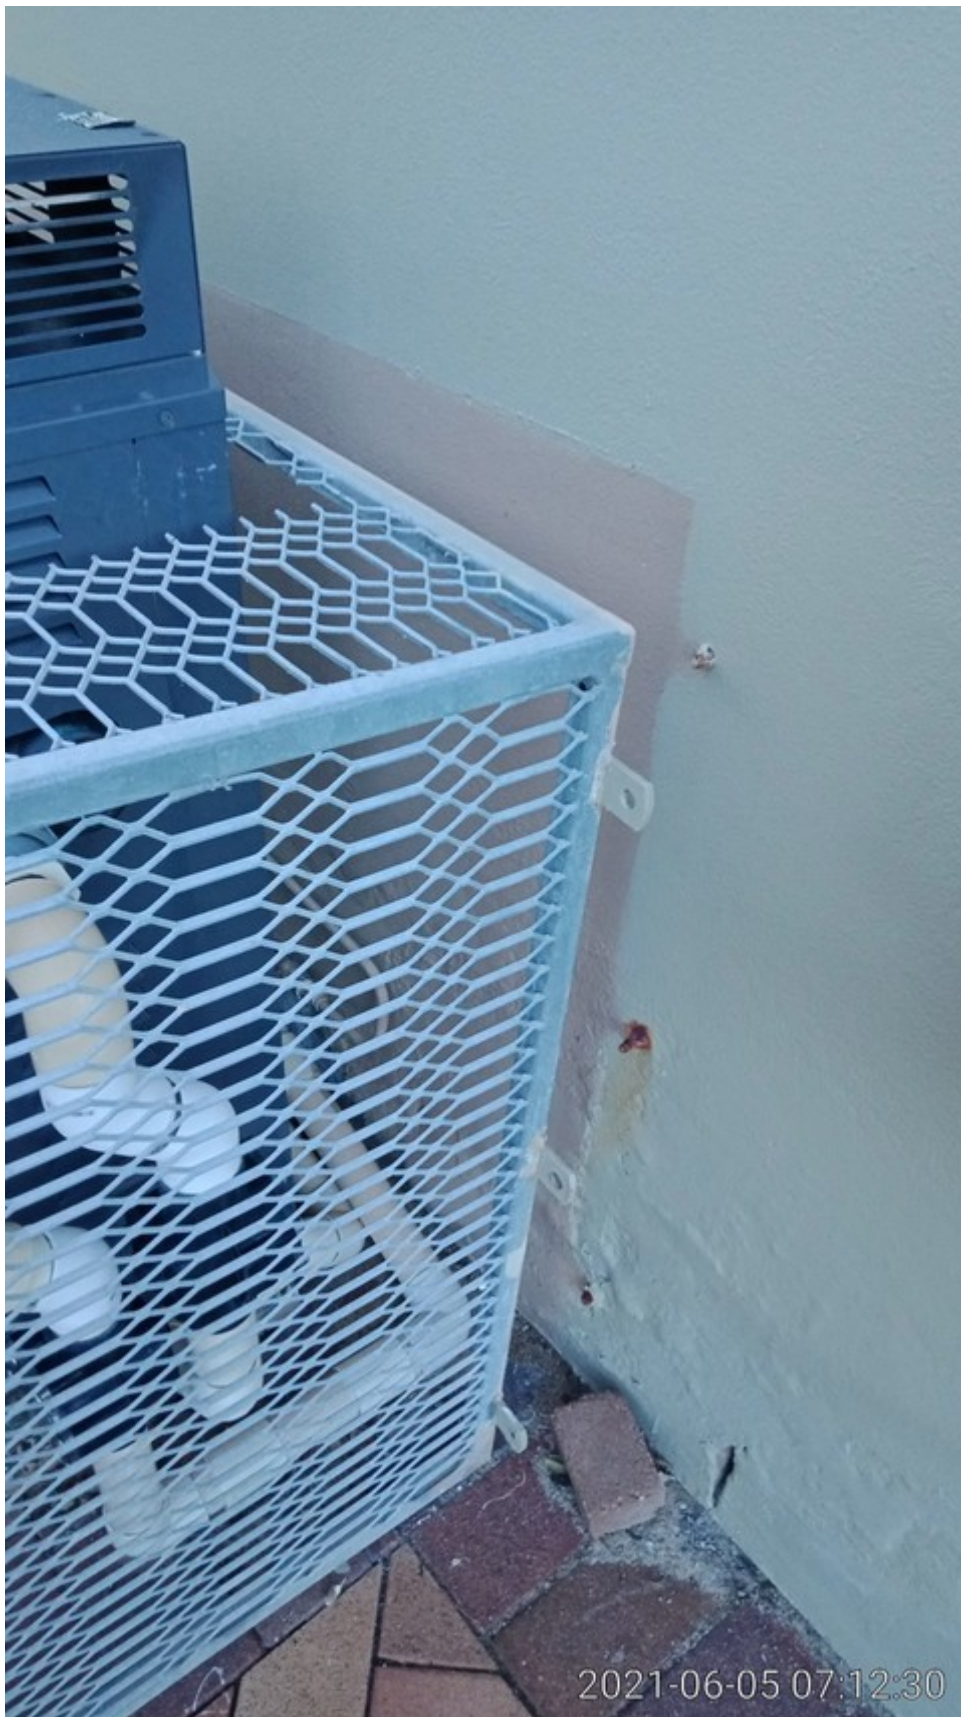
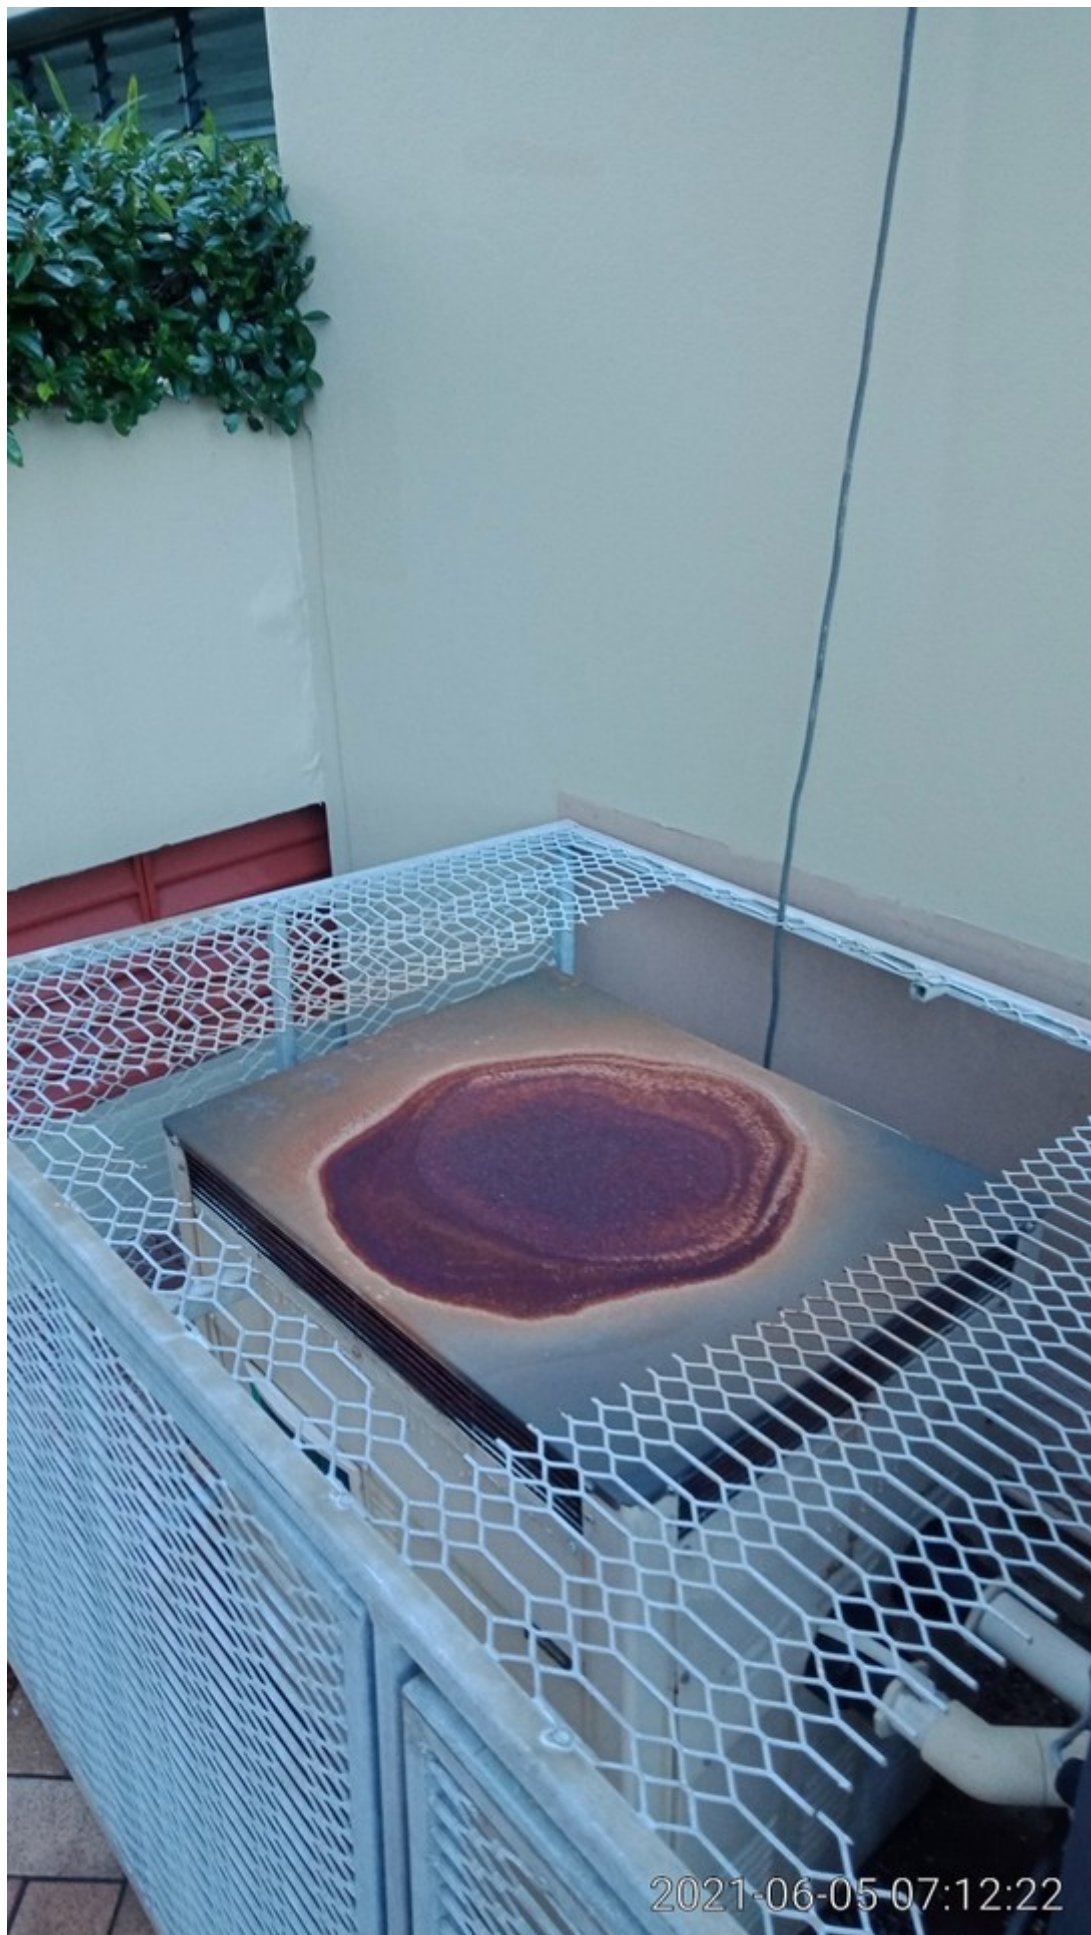
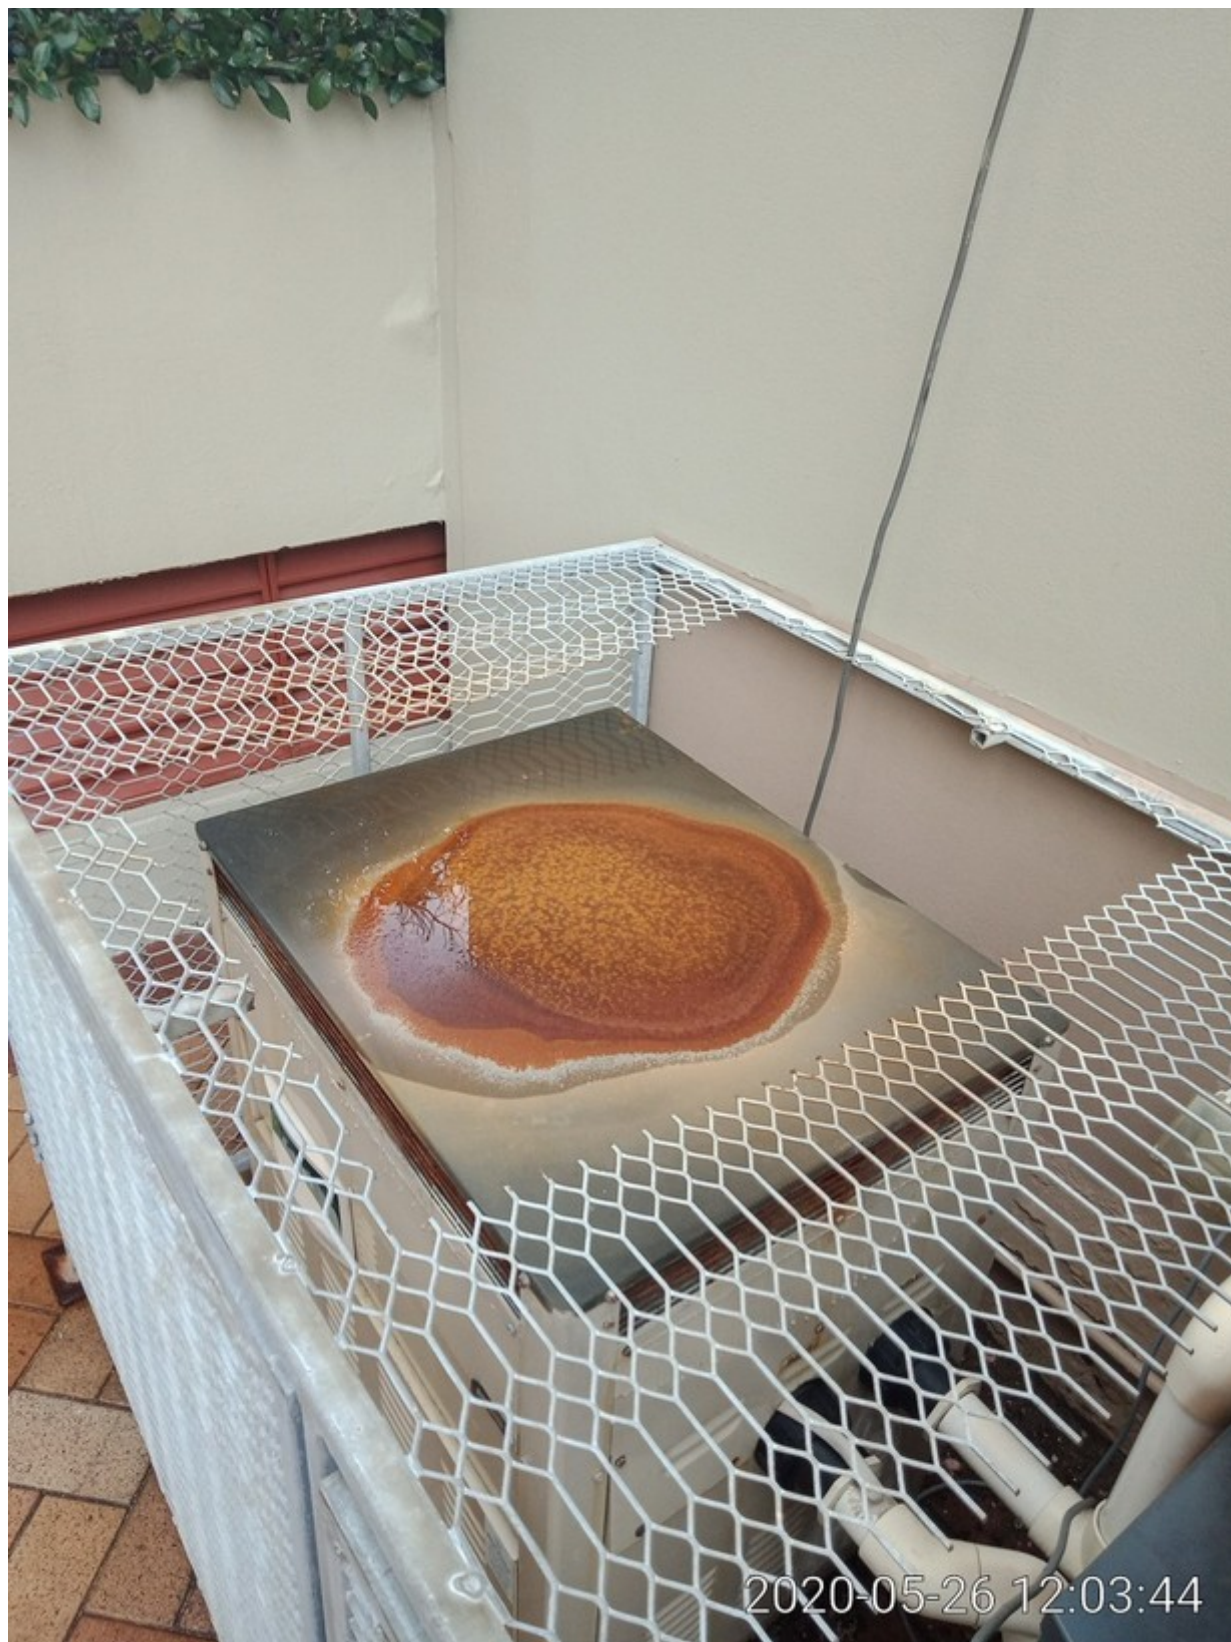
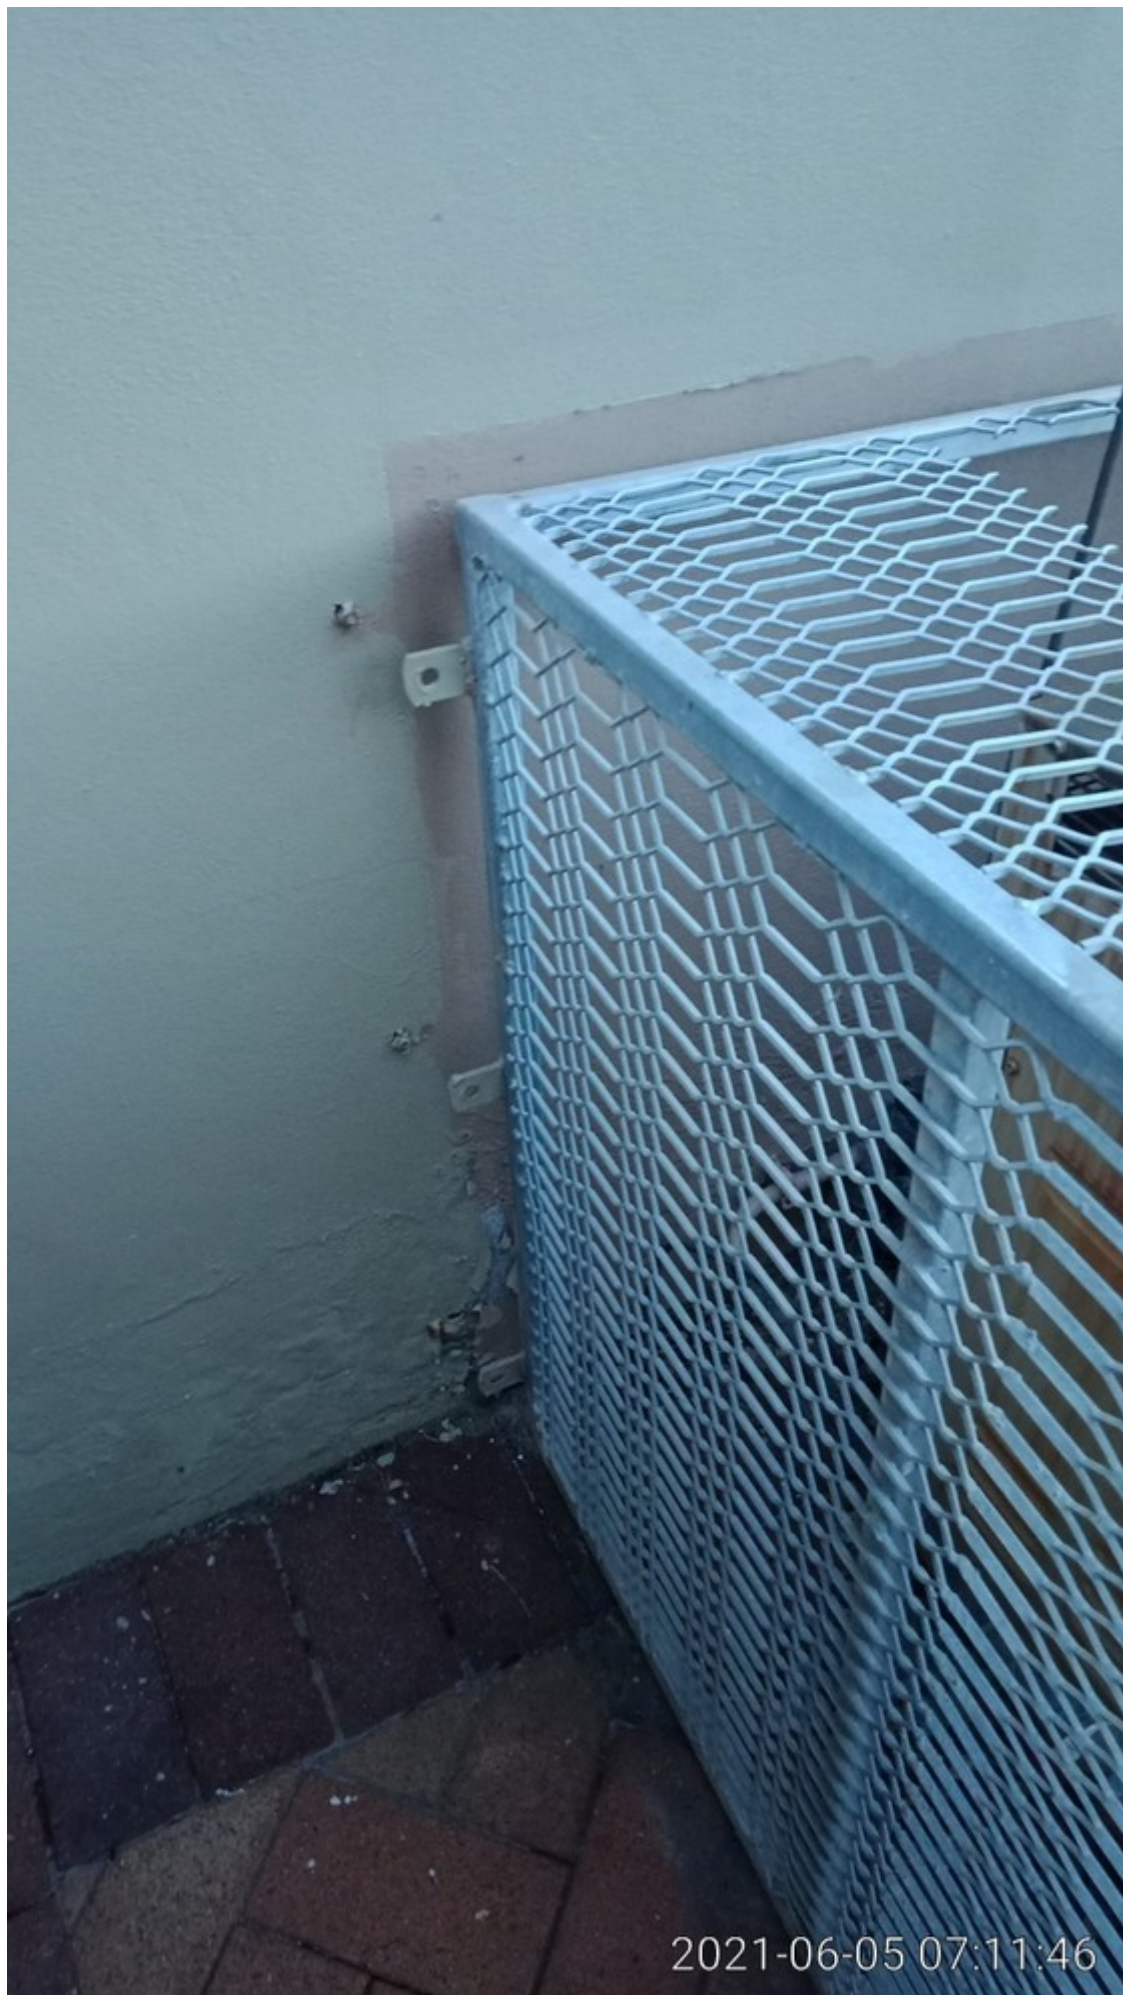
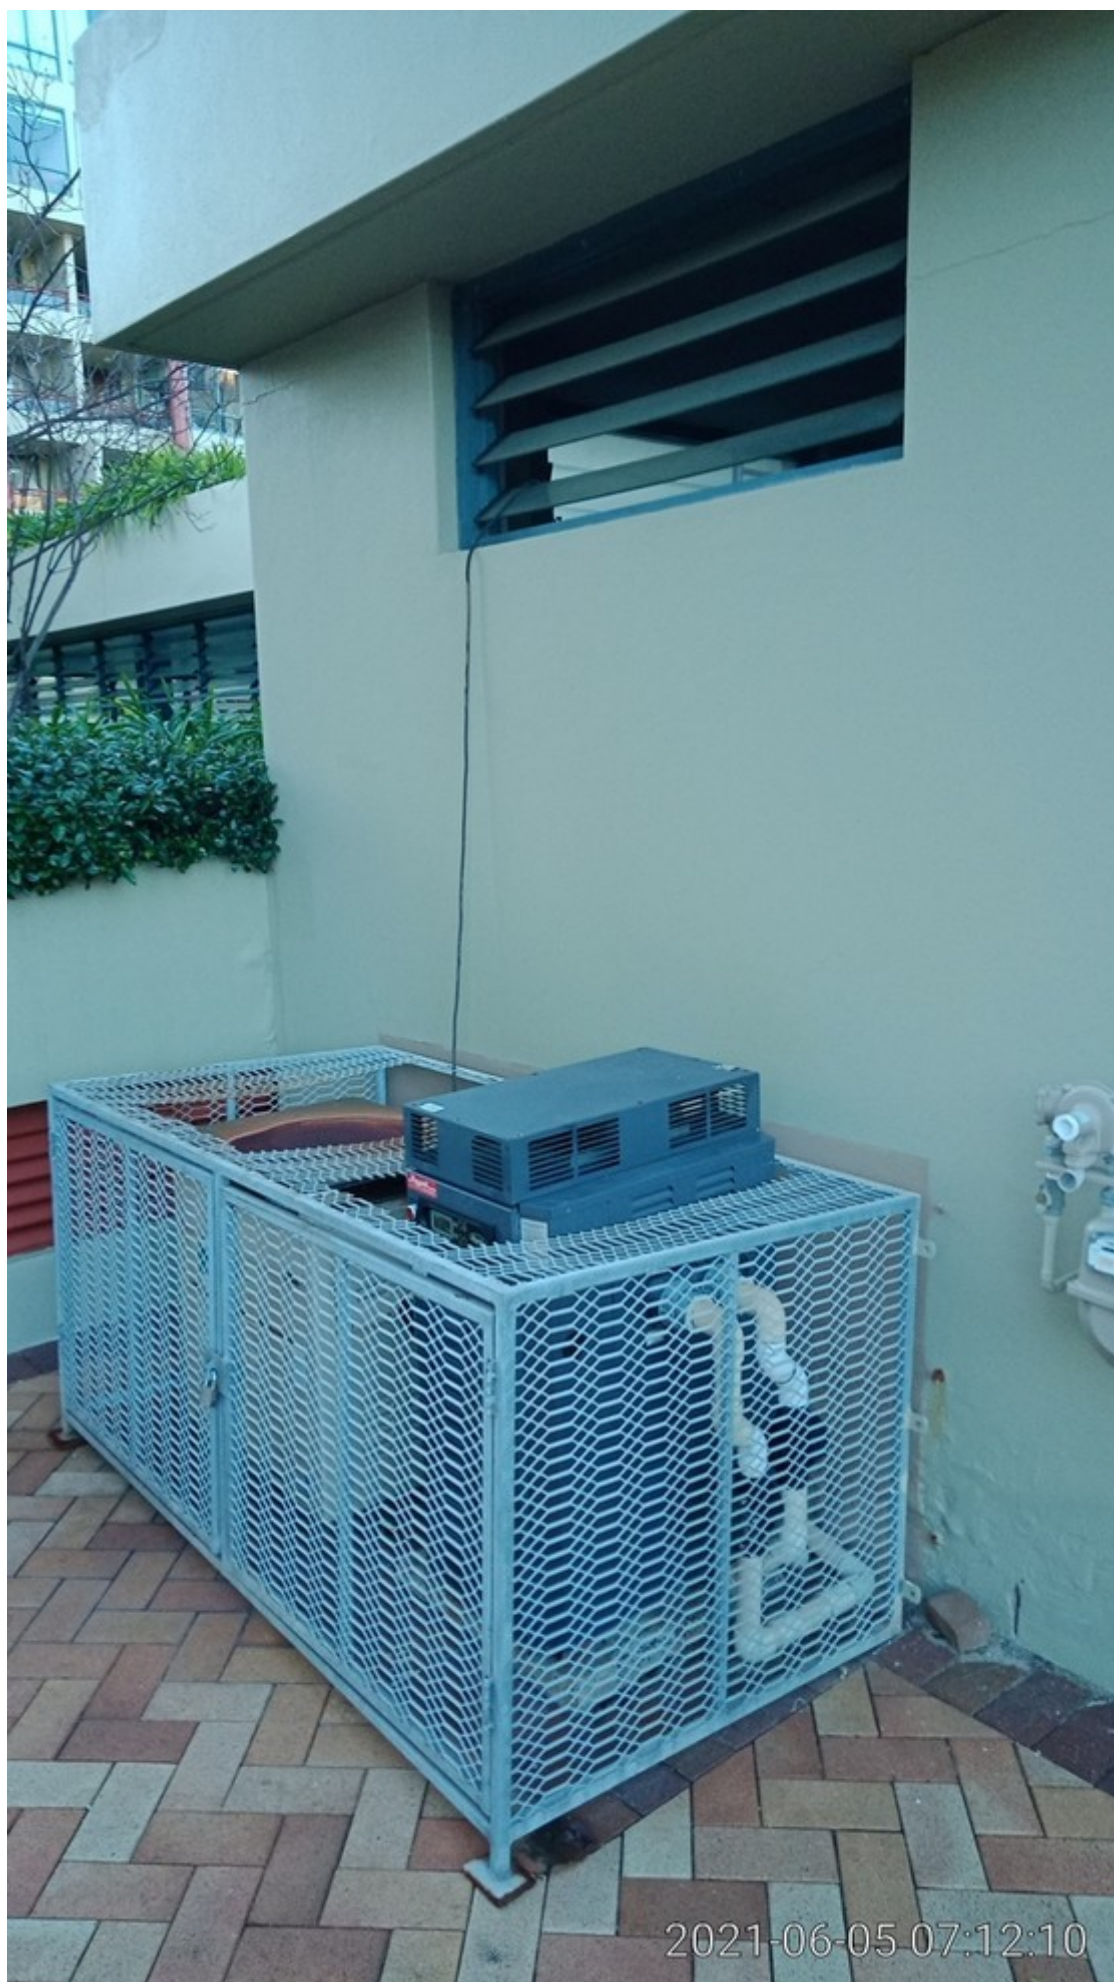
**27 Unanchored metal mesh frame on swimming pool plant and unprotected hot surface close to power cable for four years**

Metal frame not anchored to the wall, protruding and rusted bolts on unpainted swimming pool wall, hot and rusted surface not protected from weather elements and children who often play in the area, power cord located very close to hot surface which can create electrical hazard.

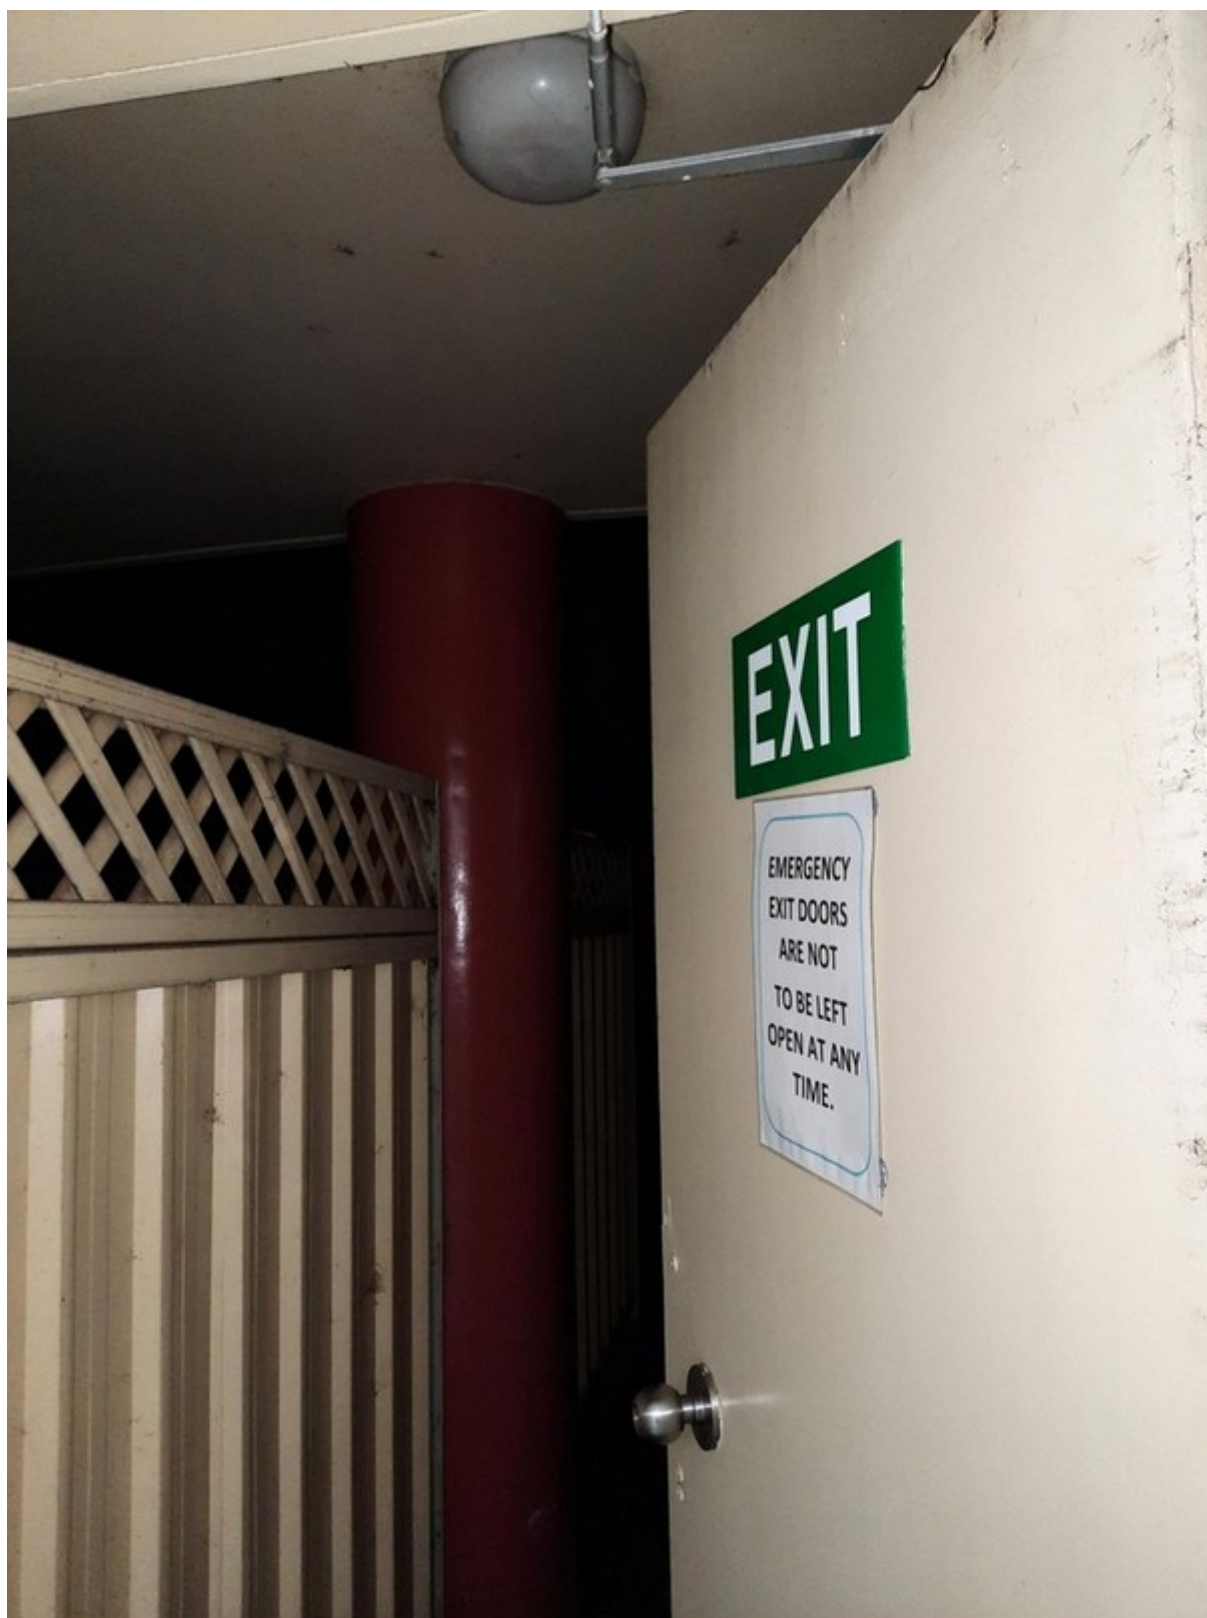
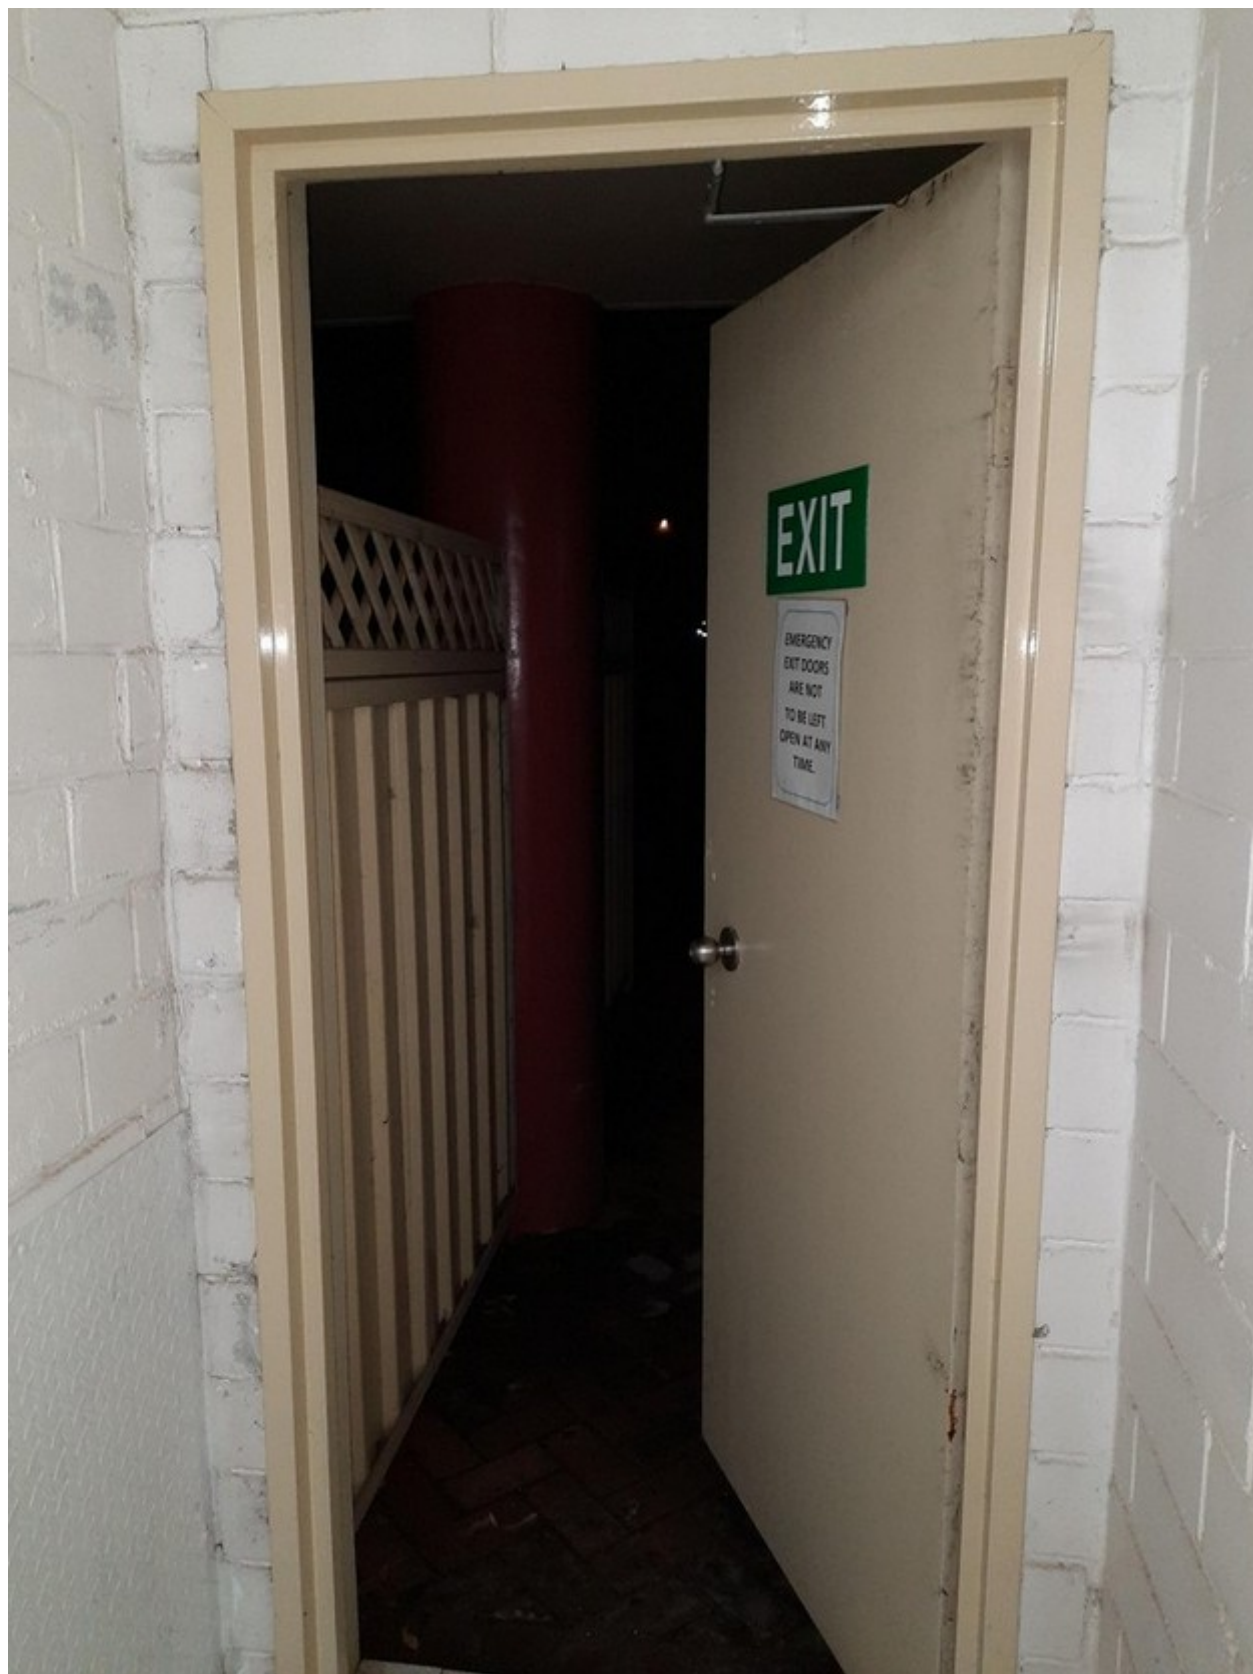
## 29 Example of fire exit lights out of order

Fire exit, ground floor behind Block C, light out of order since 31<sup>st</sup> of May 2021. Photo taken on 22<sup>nd</sup> of June 2021:

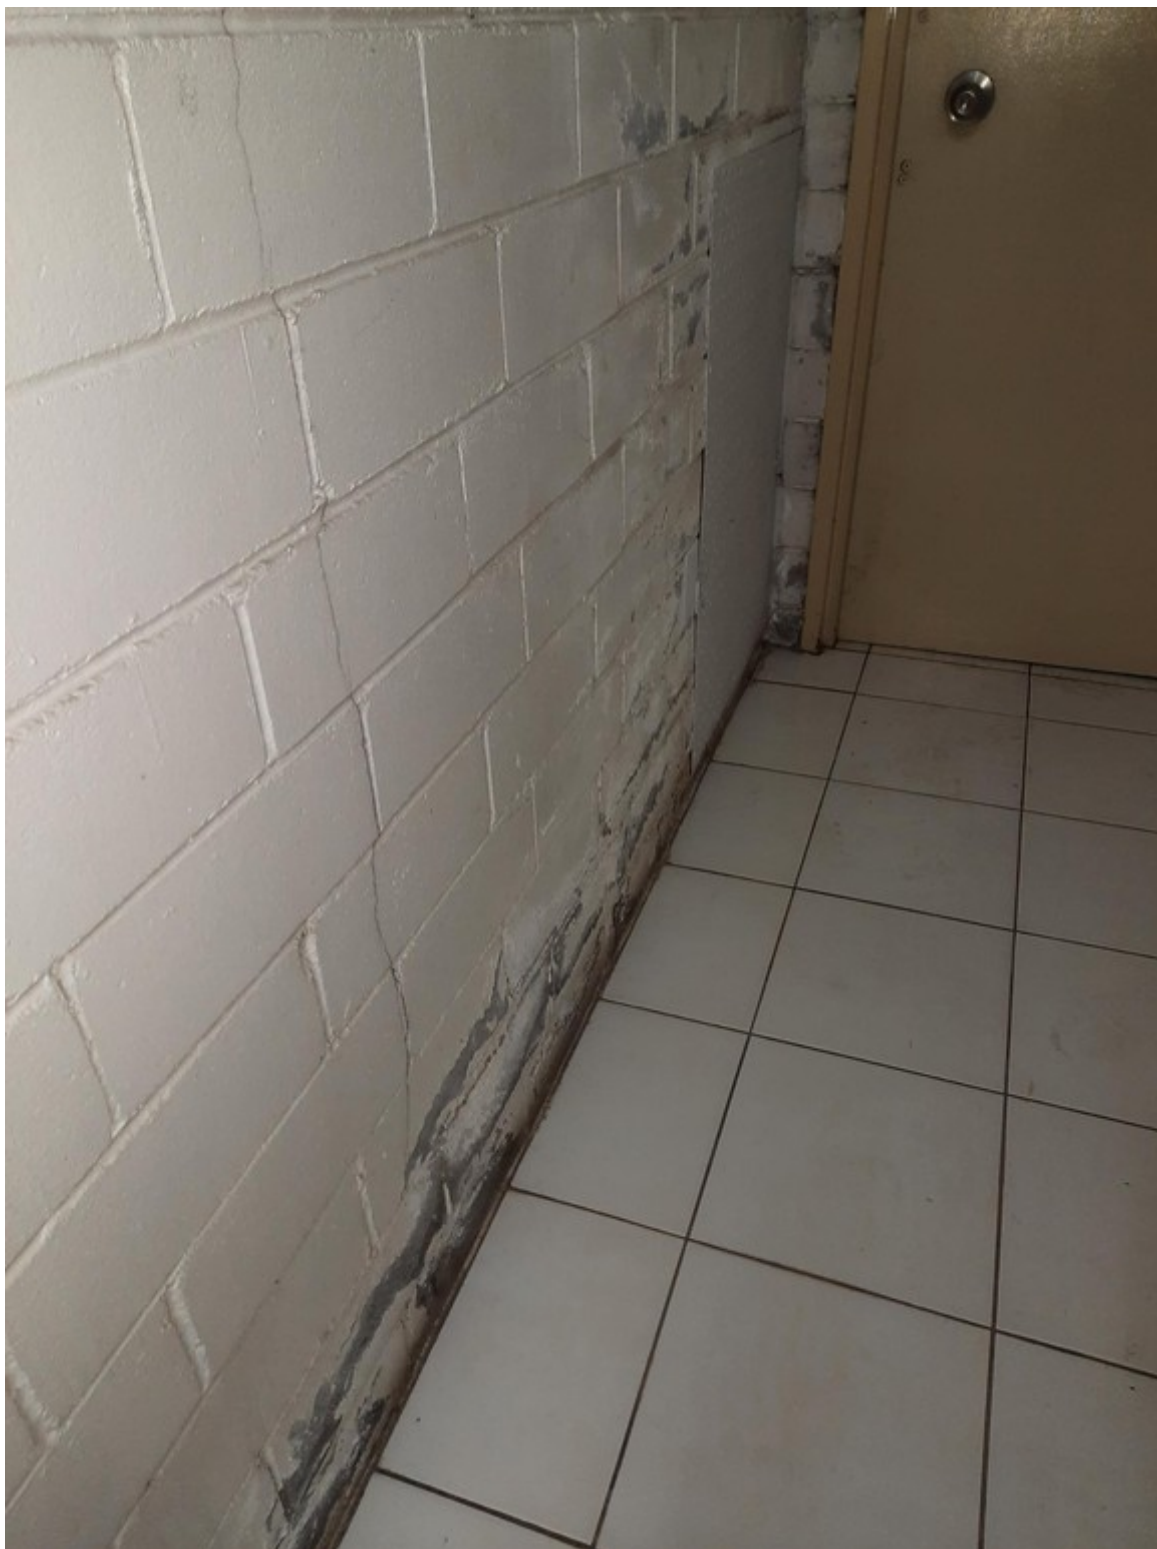
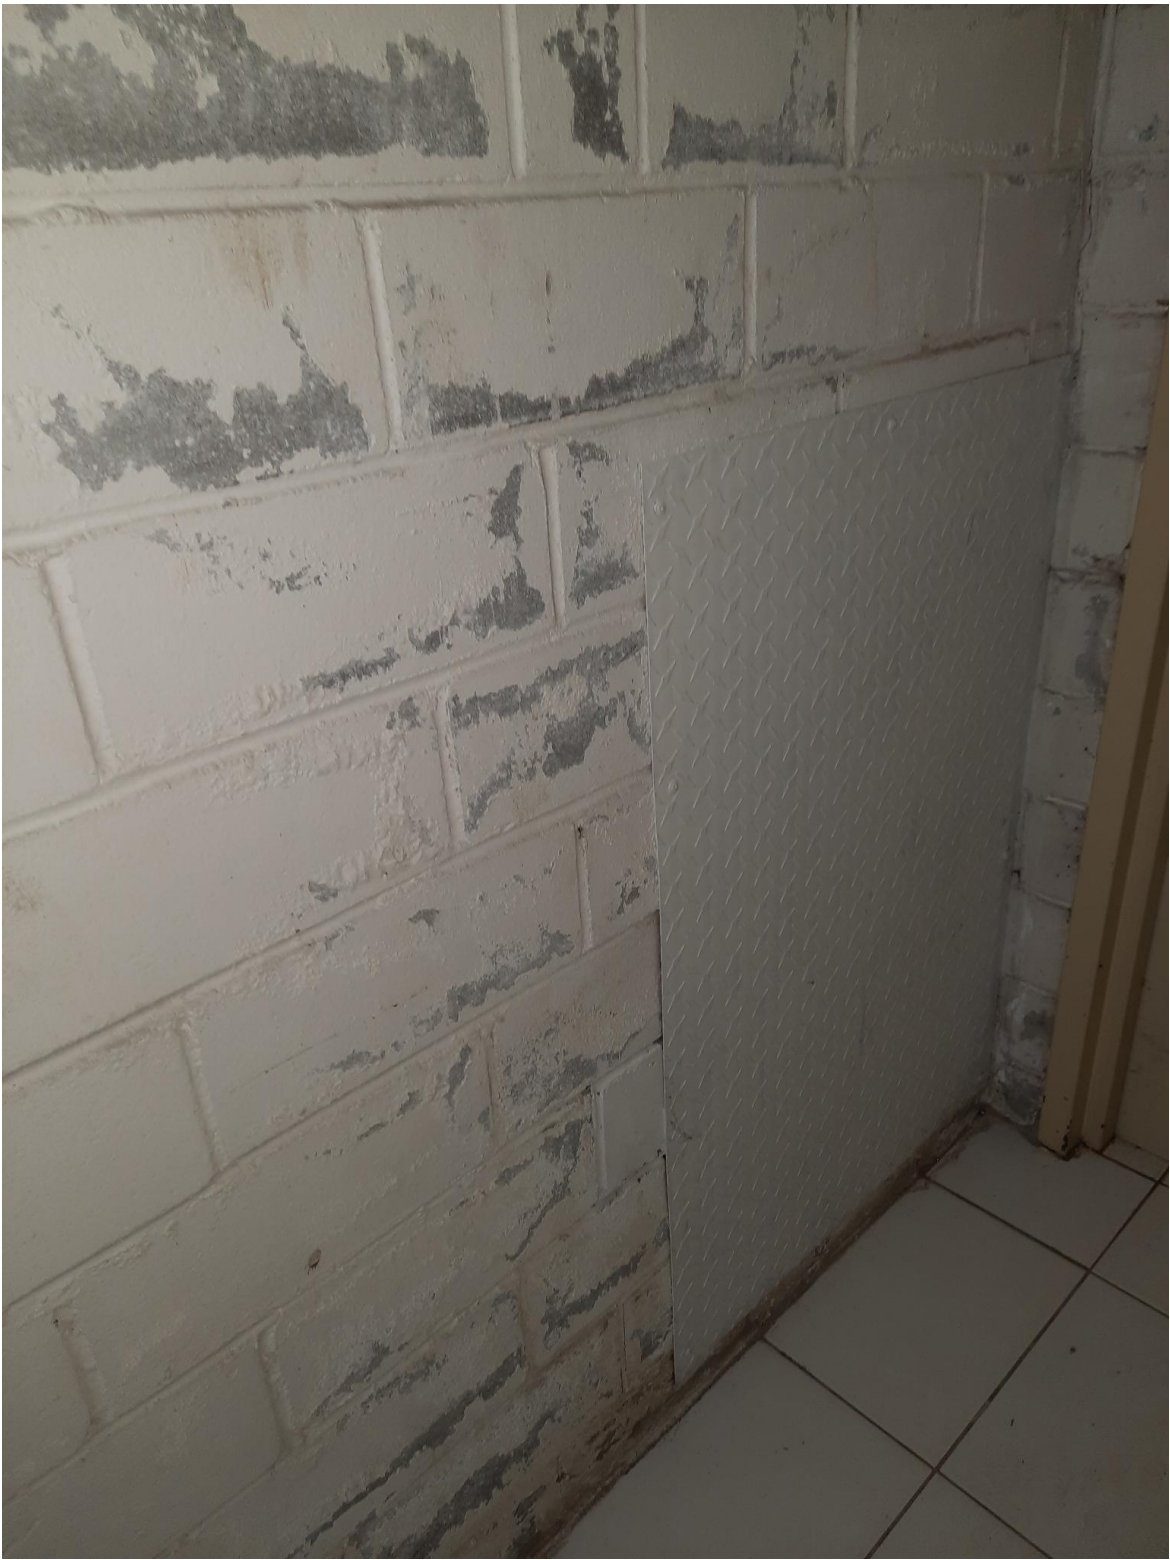
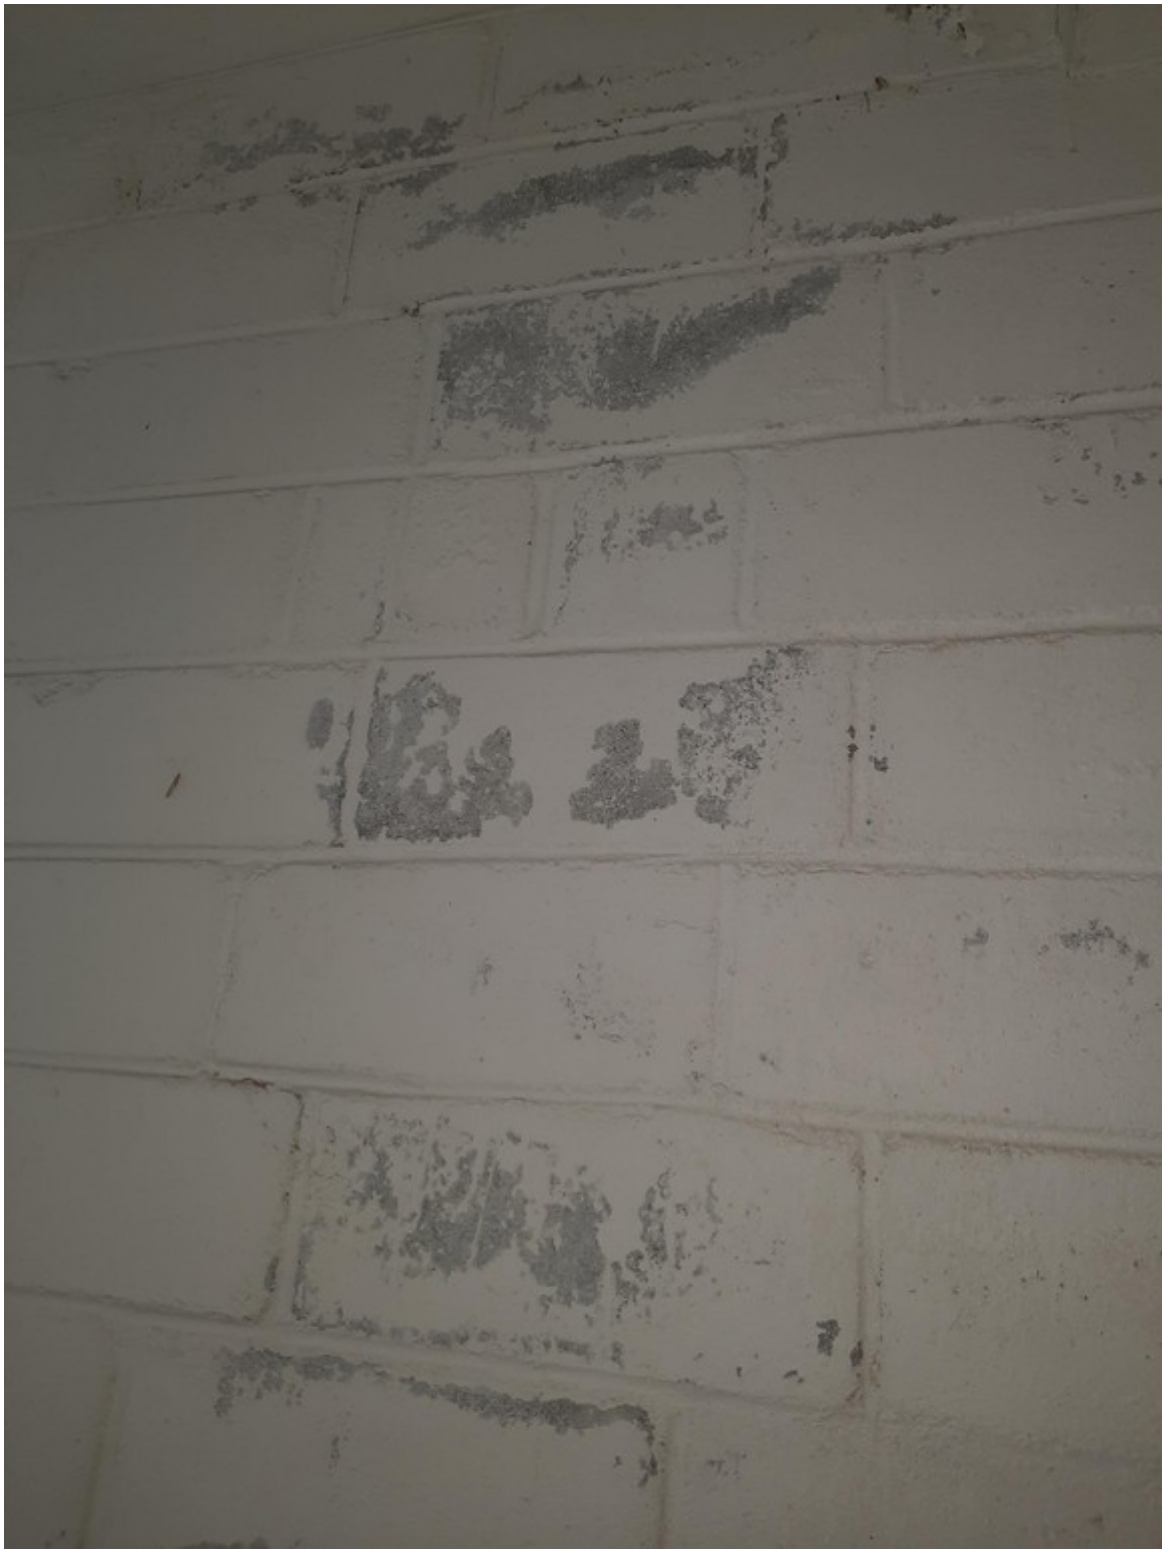
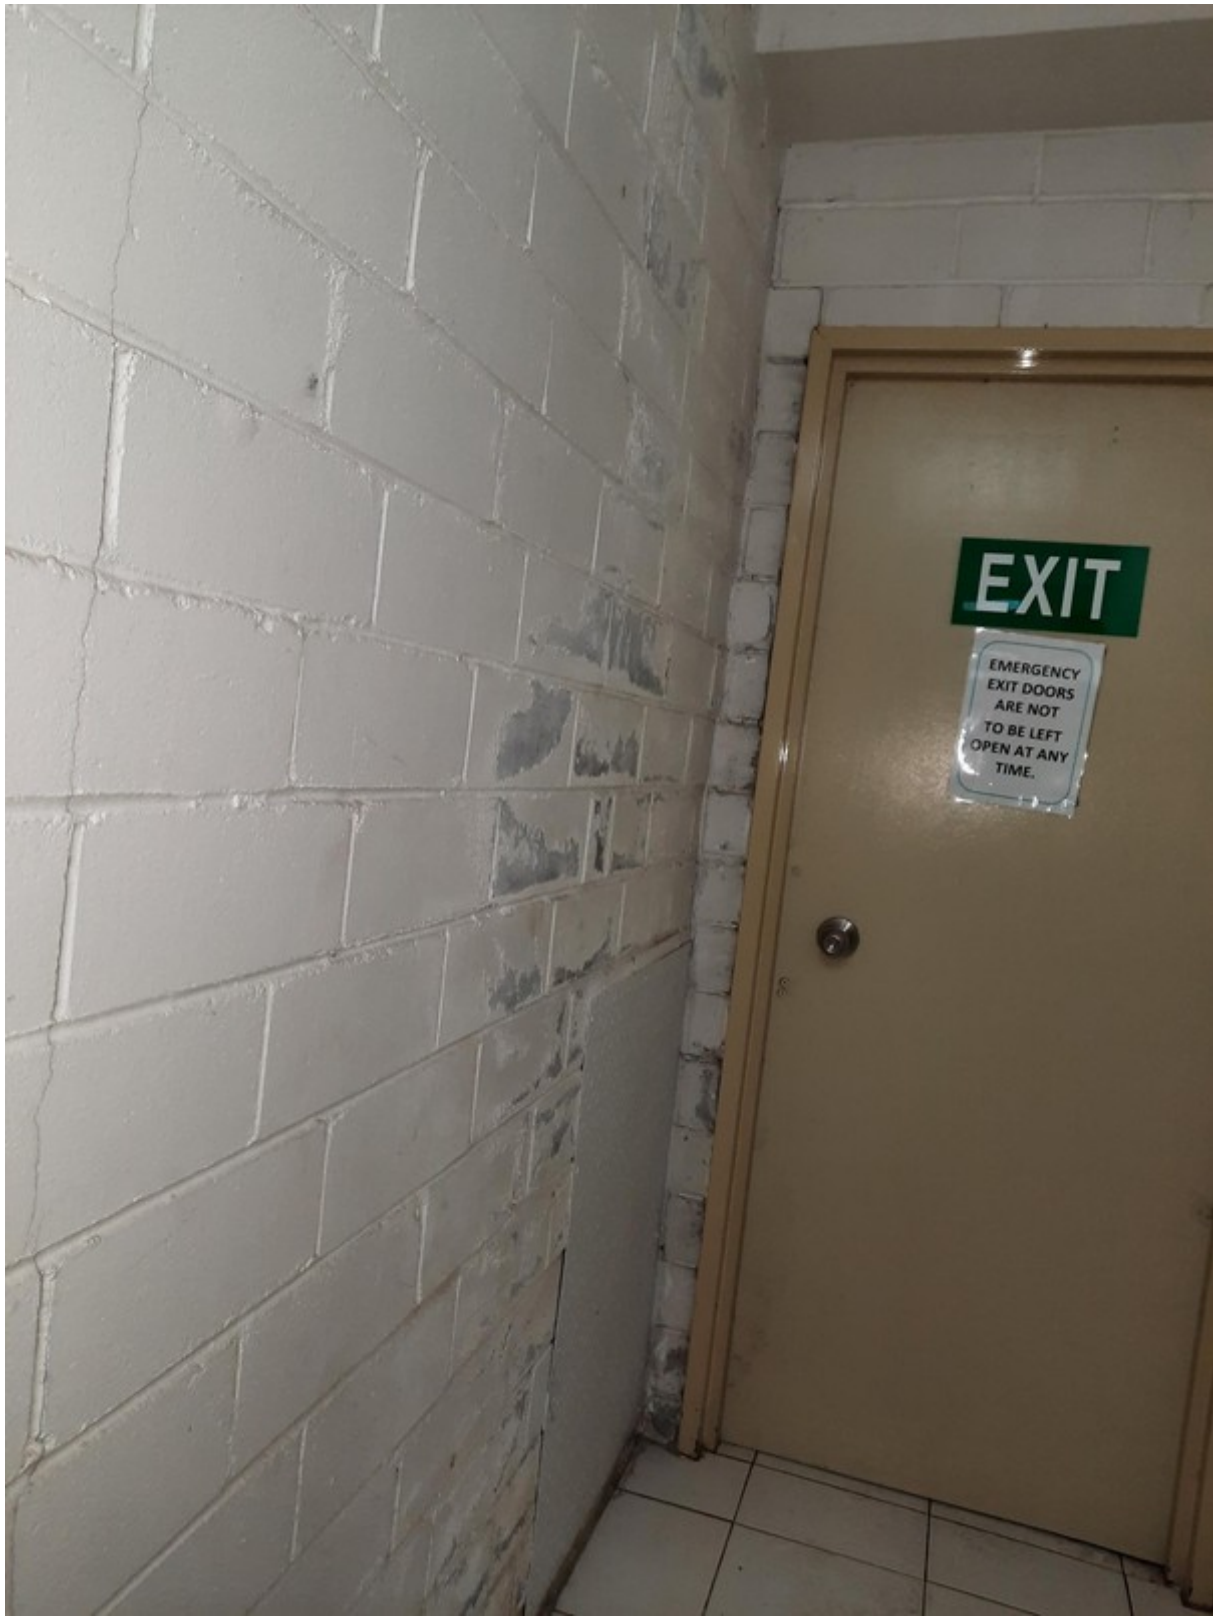
**31** Example of water leak damages near fire door exit in Block C ground floor in June 2021

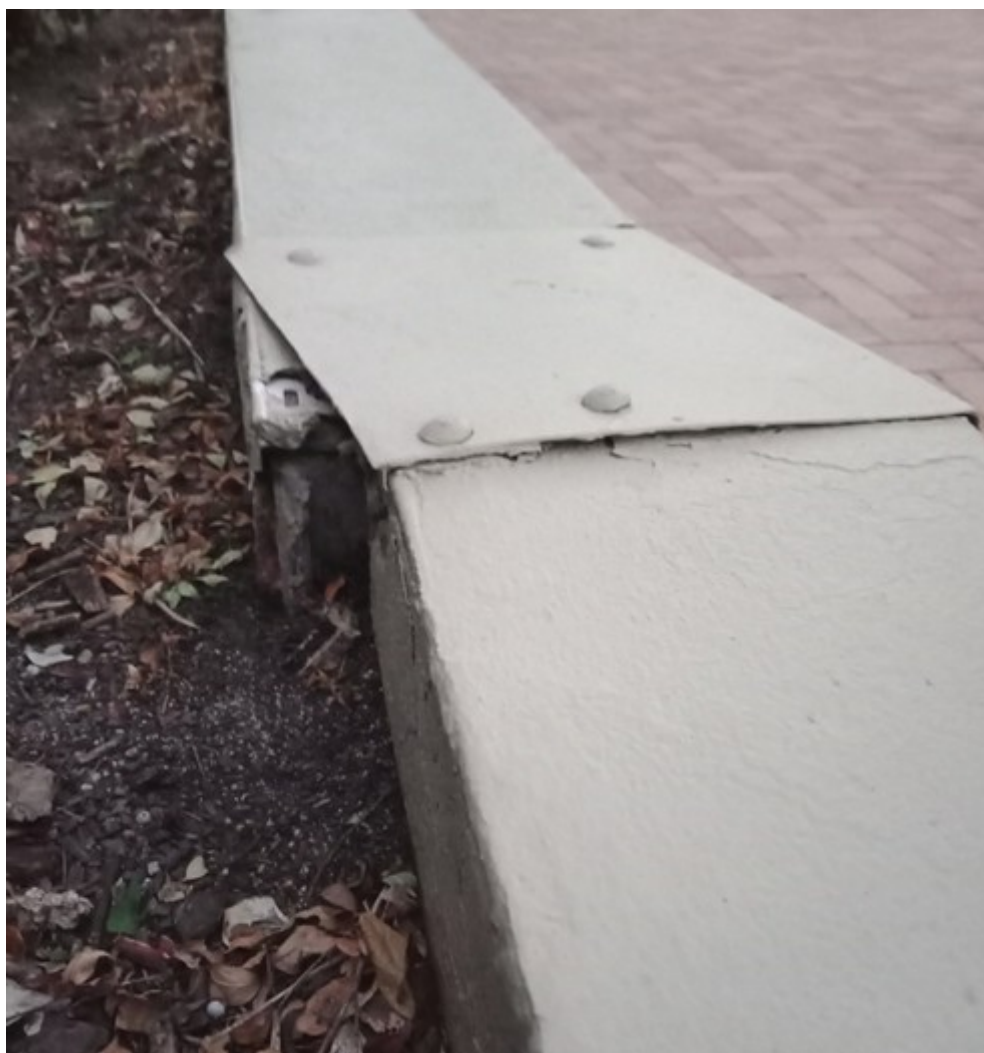
### 32 Example of garden bed collapse risk near Block D in June 2021

In June 2021, still a problem:
