## Table of Contents

This document lists just some of the problems in the complex that can cause injury, health problems, or even death in dire circumstances.

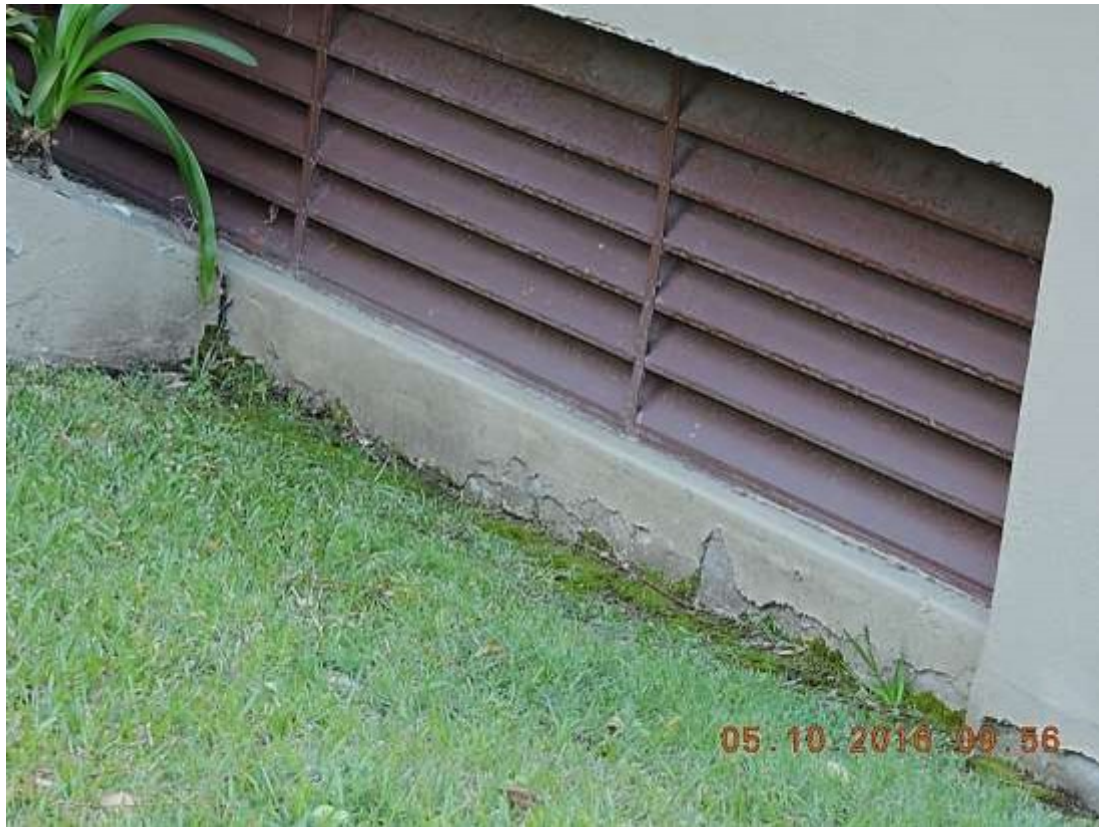
- Instead of repairing the concrete cancer and cracks, simply cover it by piece of wood:

Initial status:

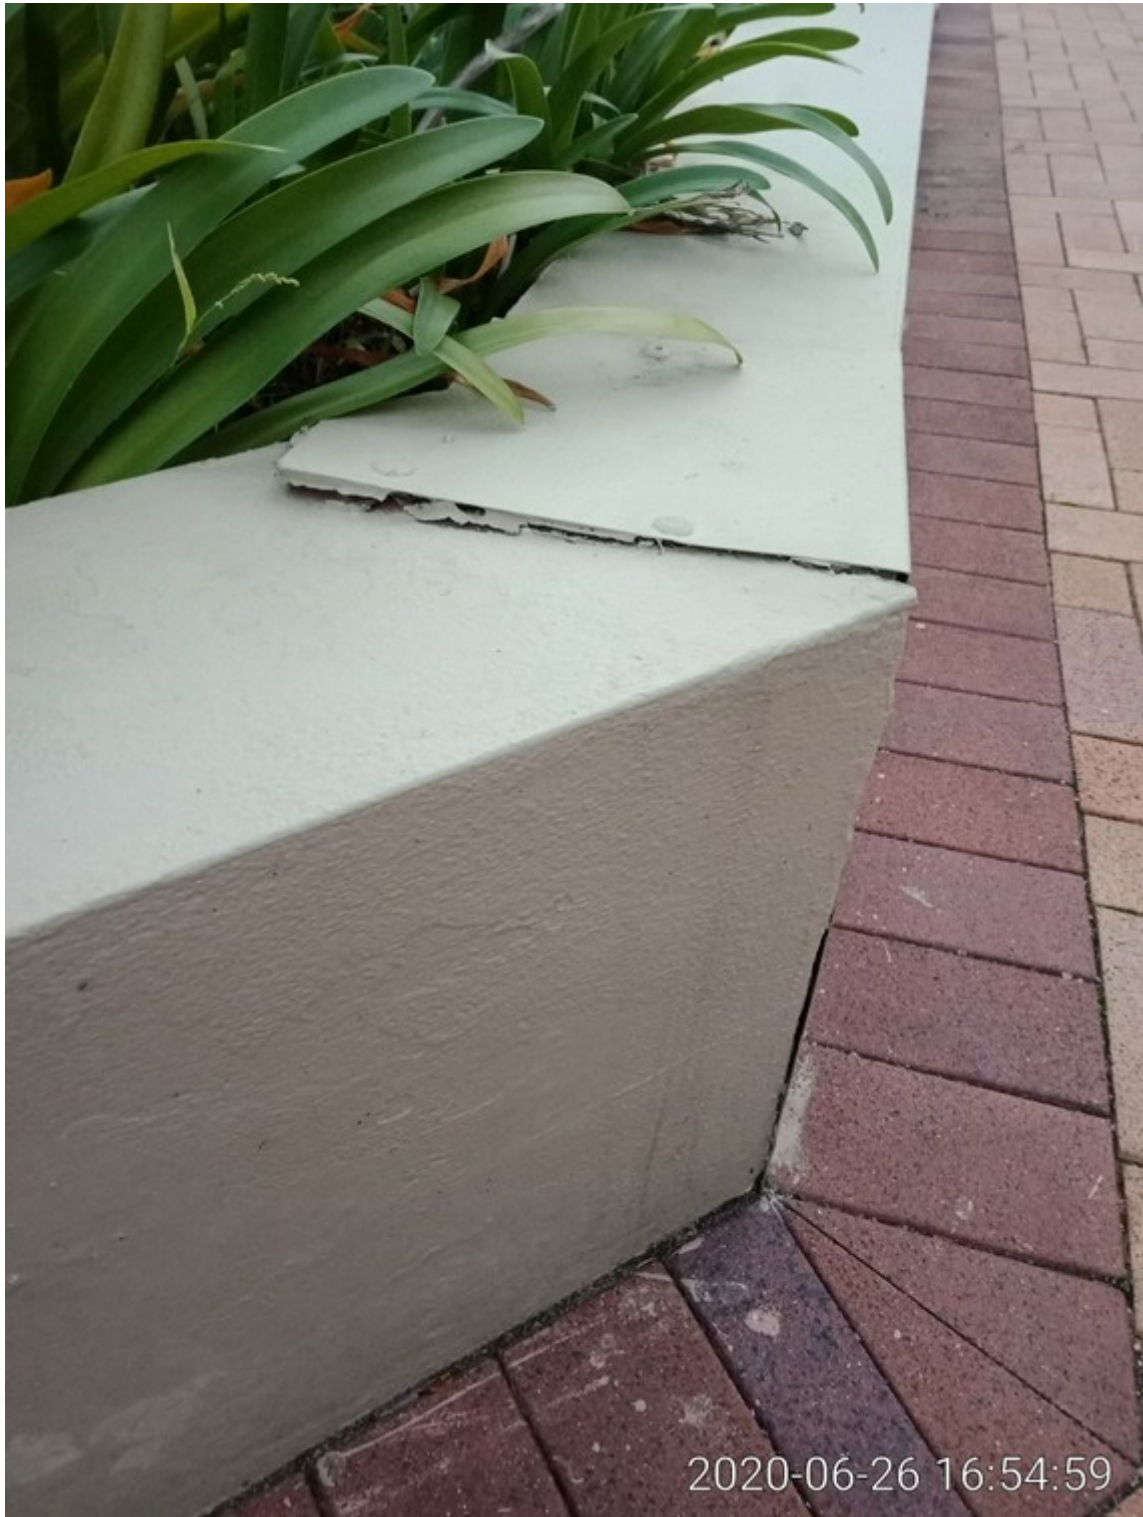
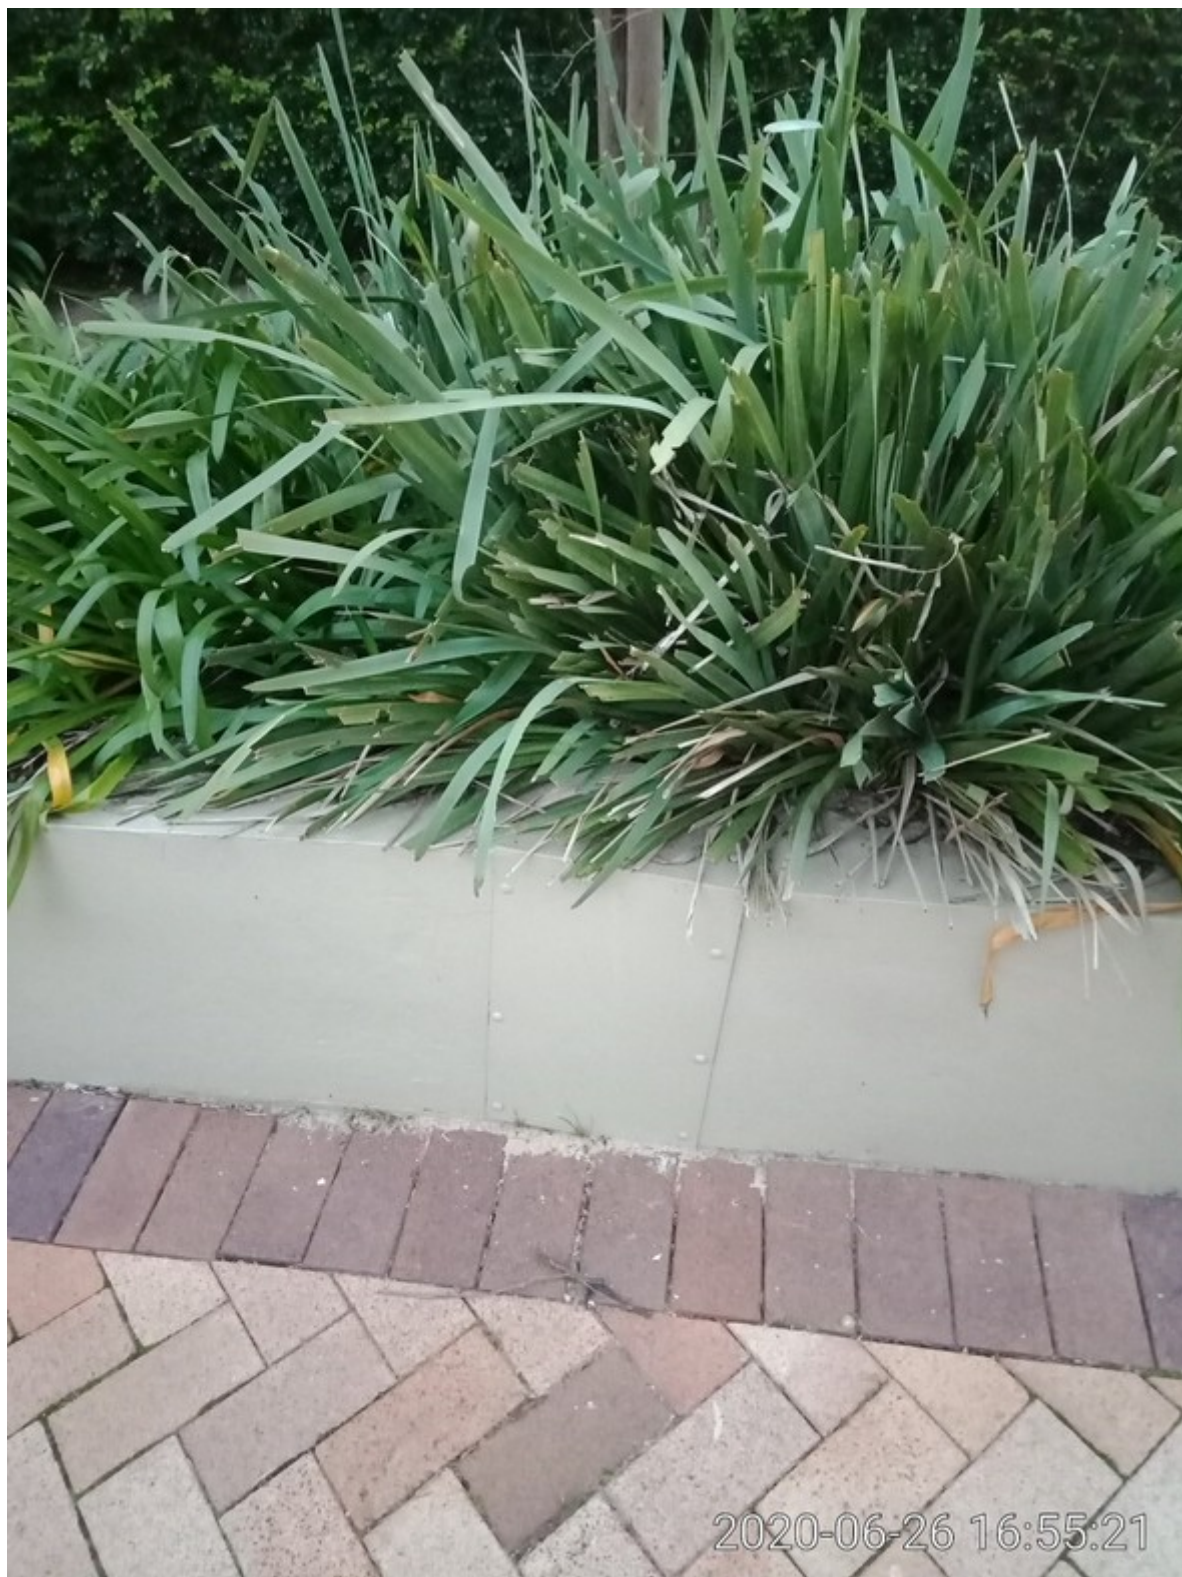
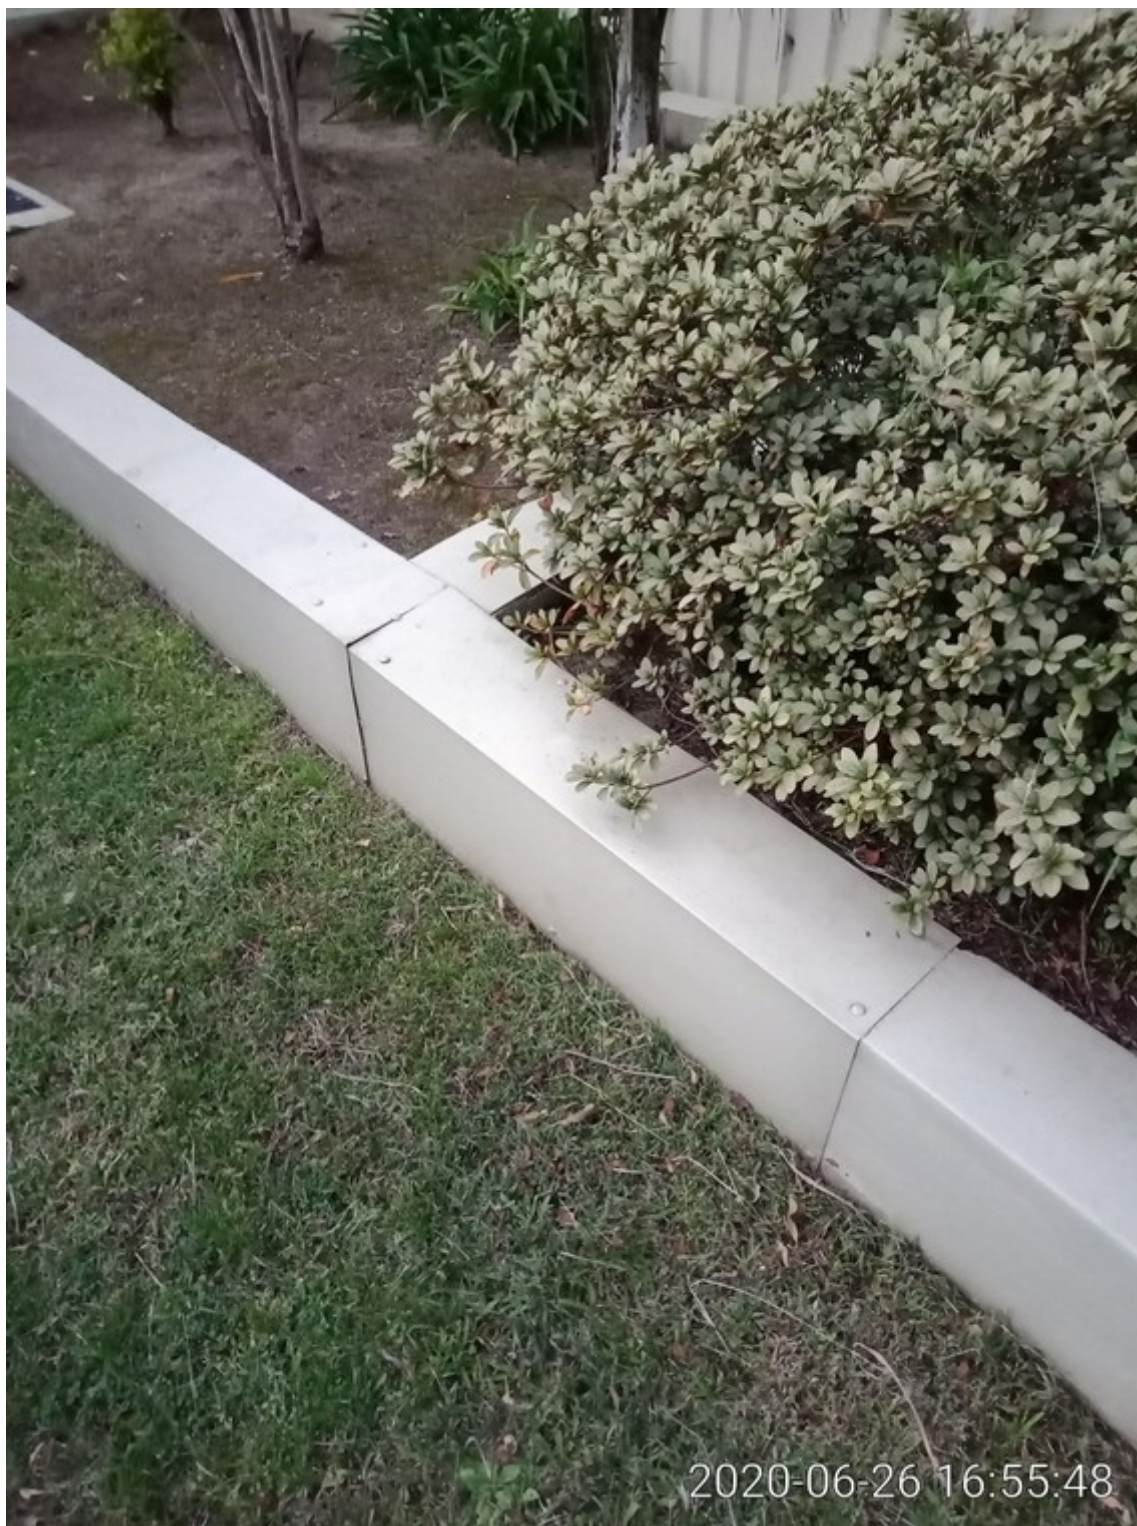
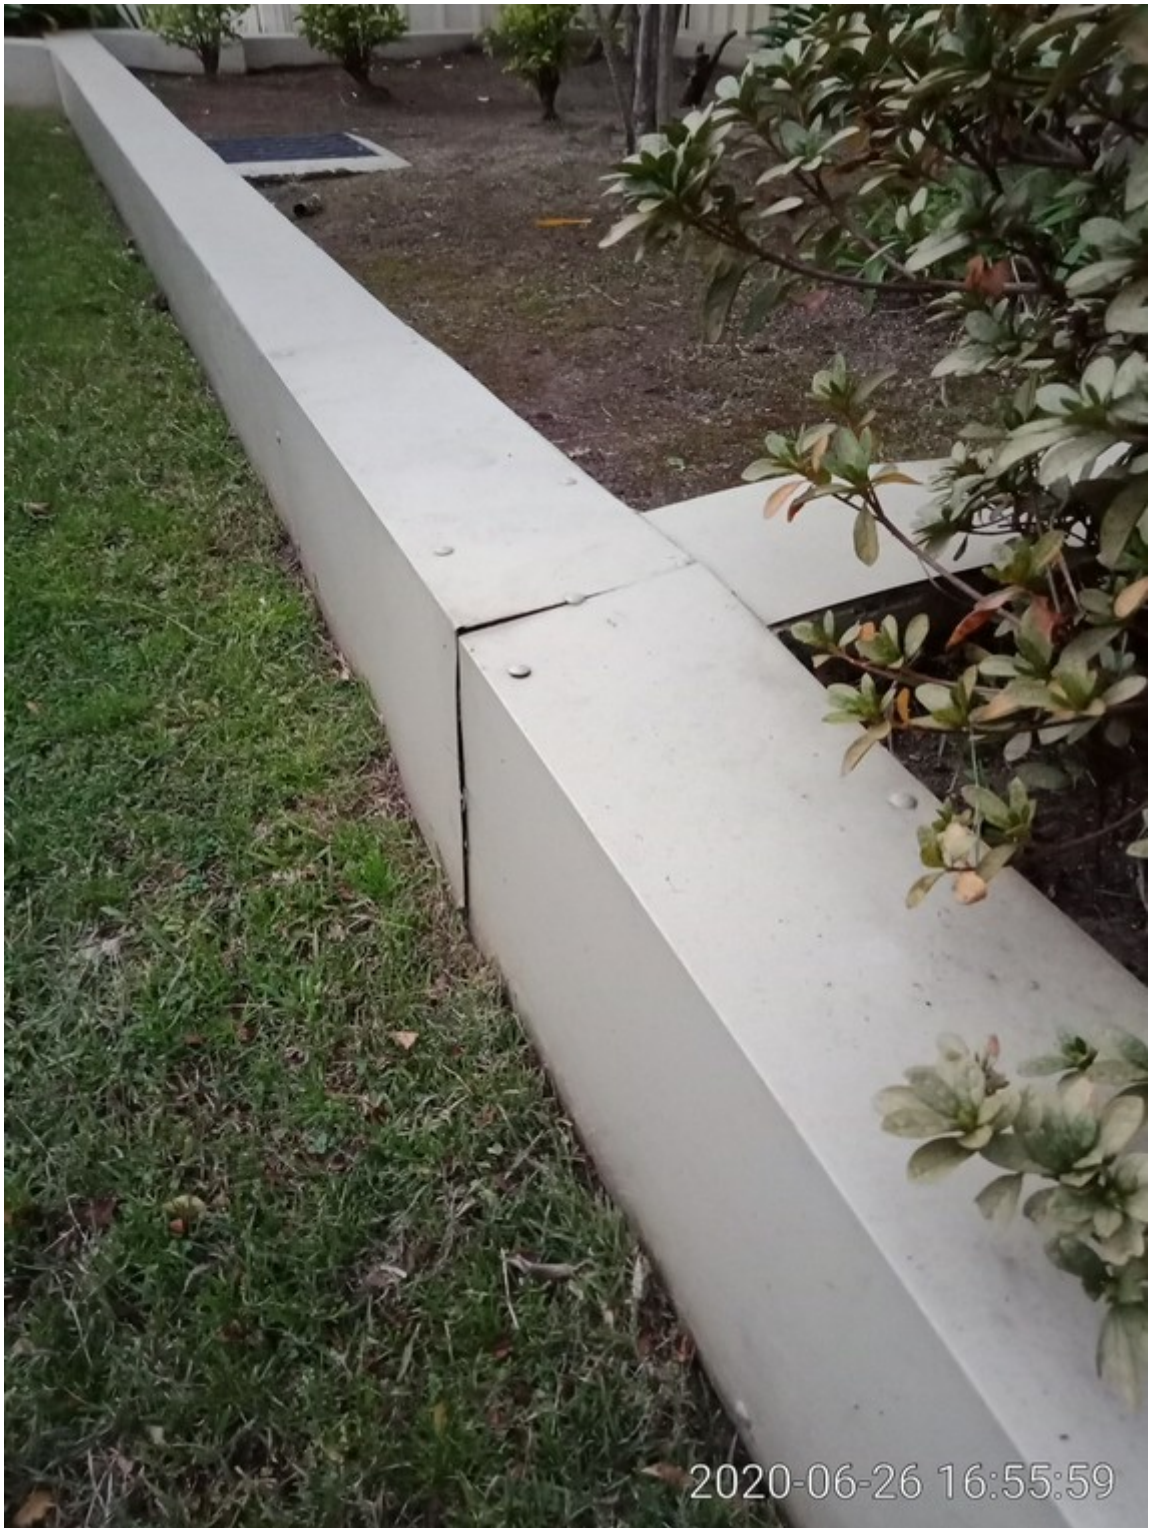
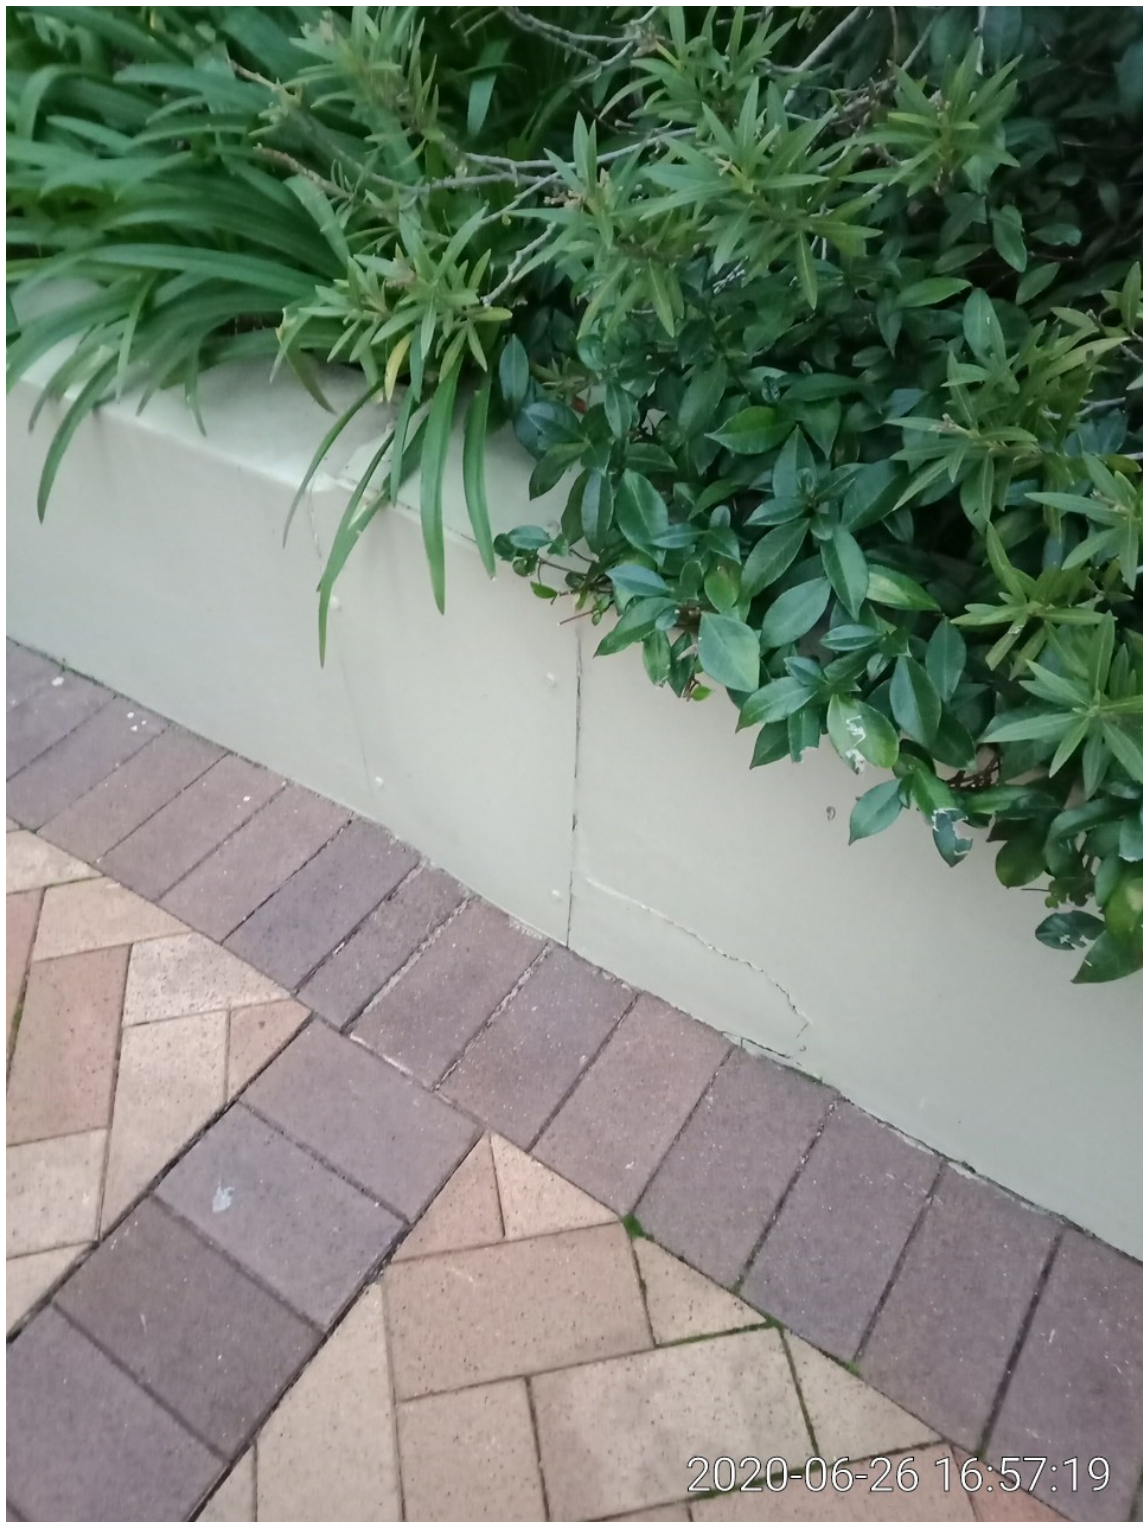
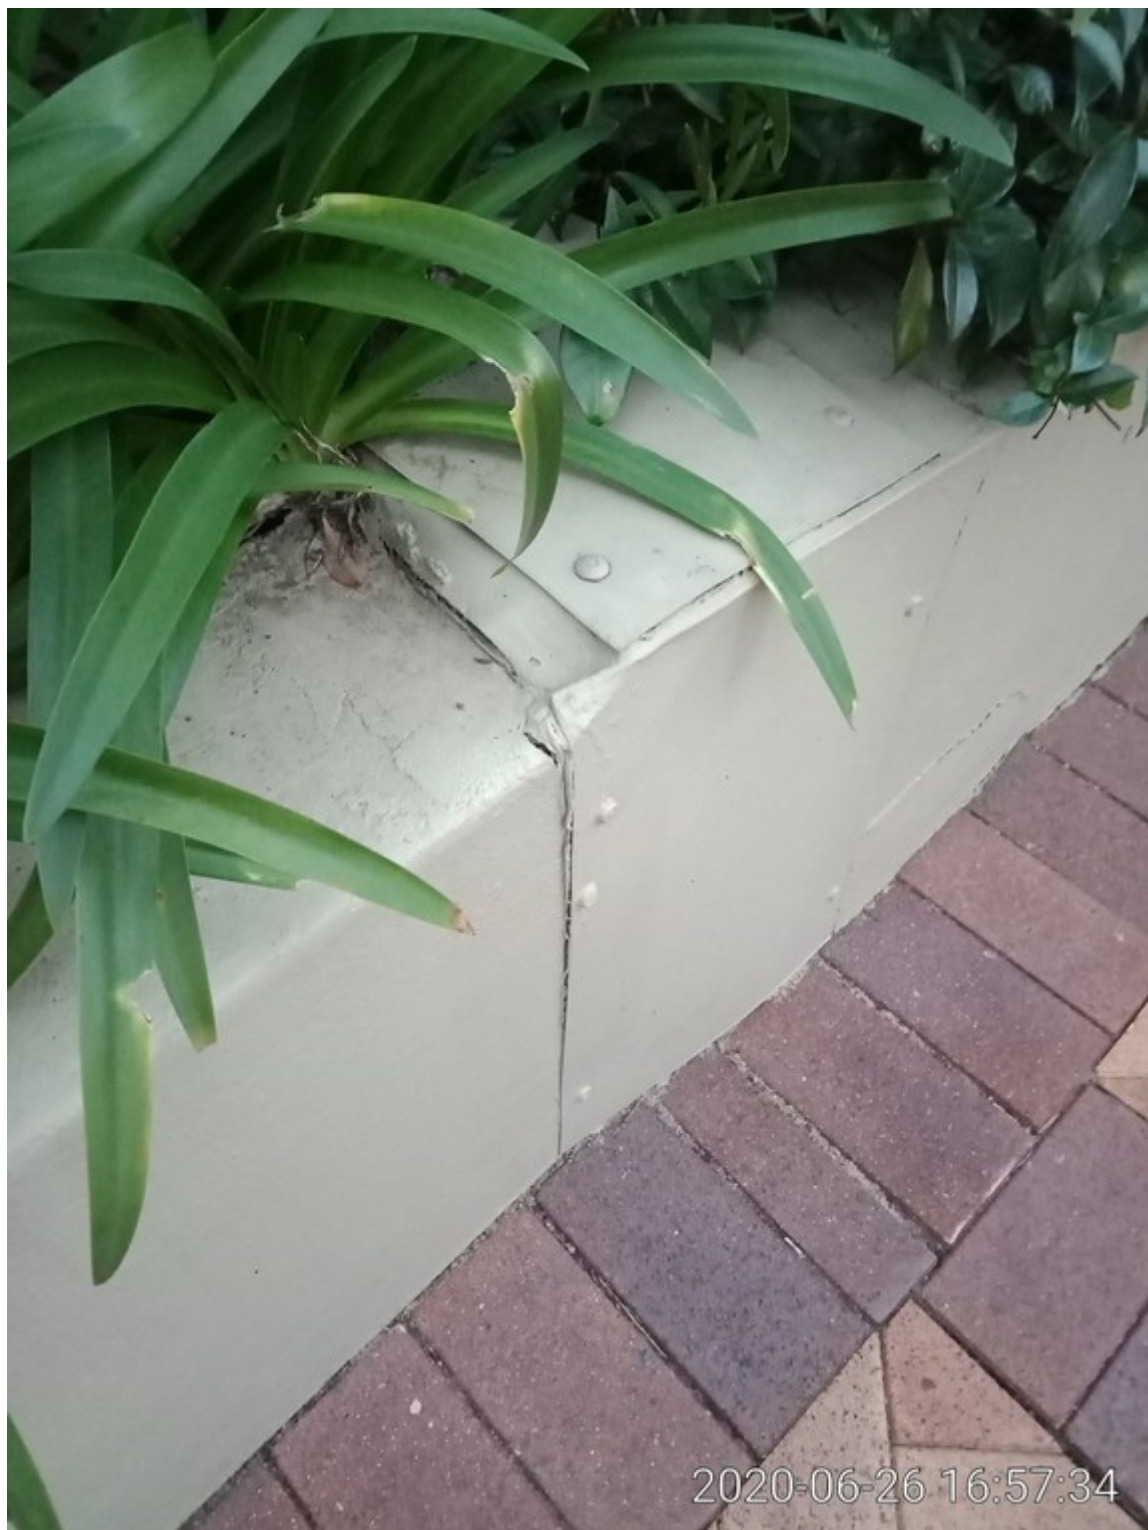
Metal plates, which not only hide status of the concrete behind them but also create safety risks due to sharp edges in areas where children play every day:

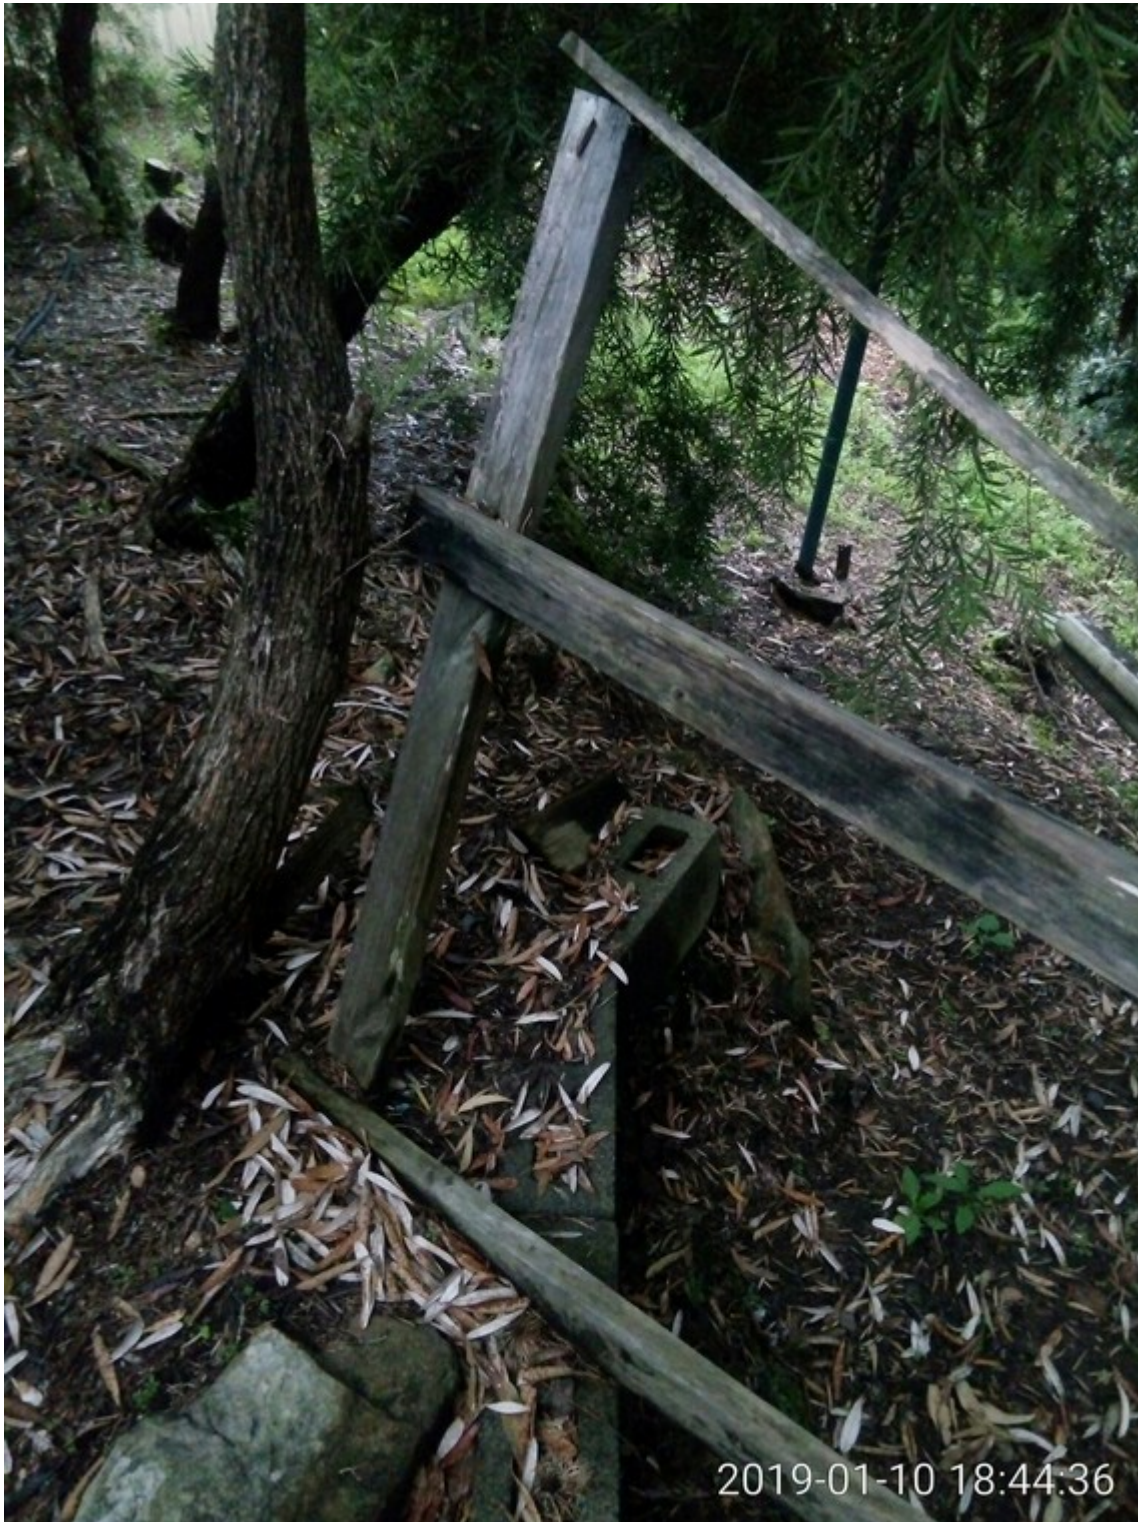
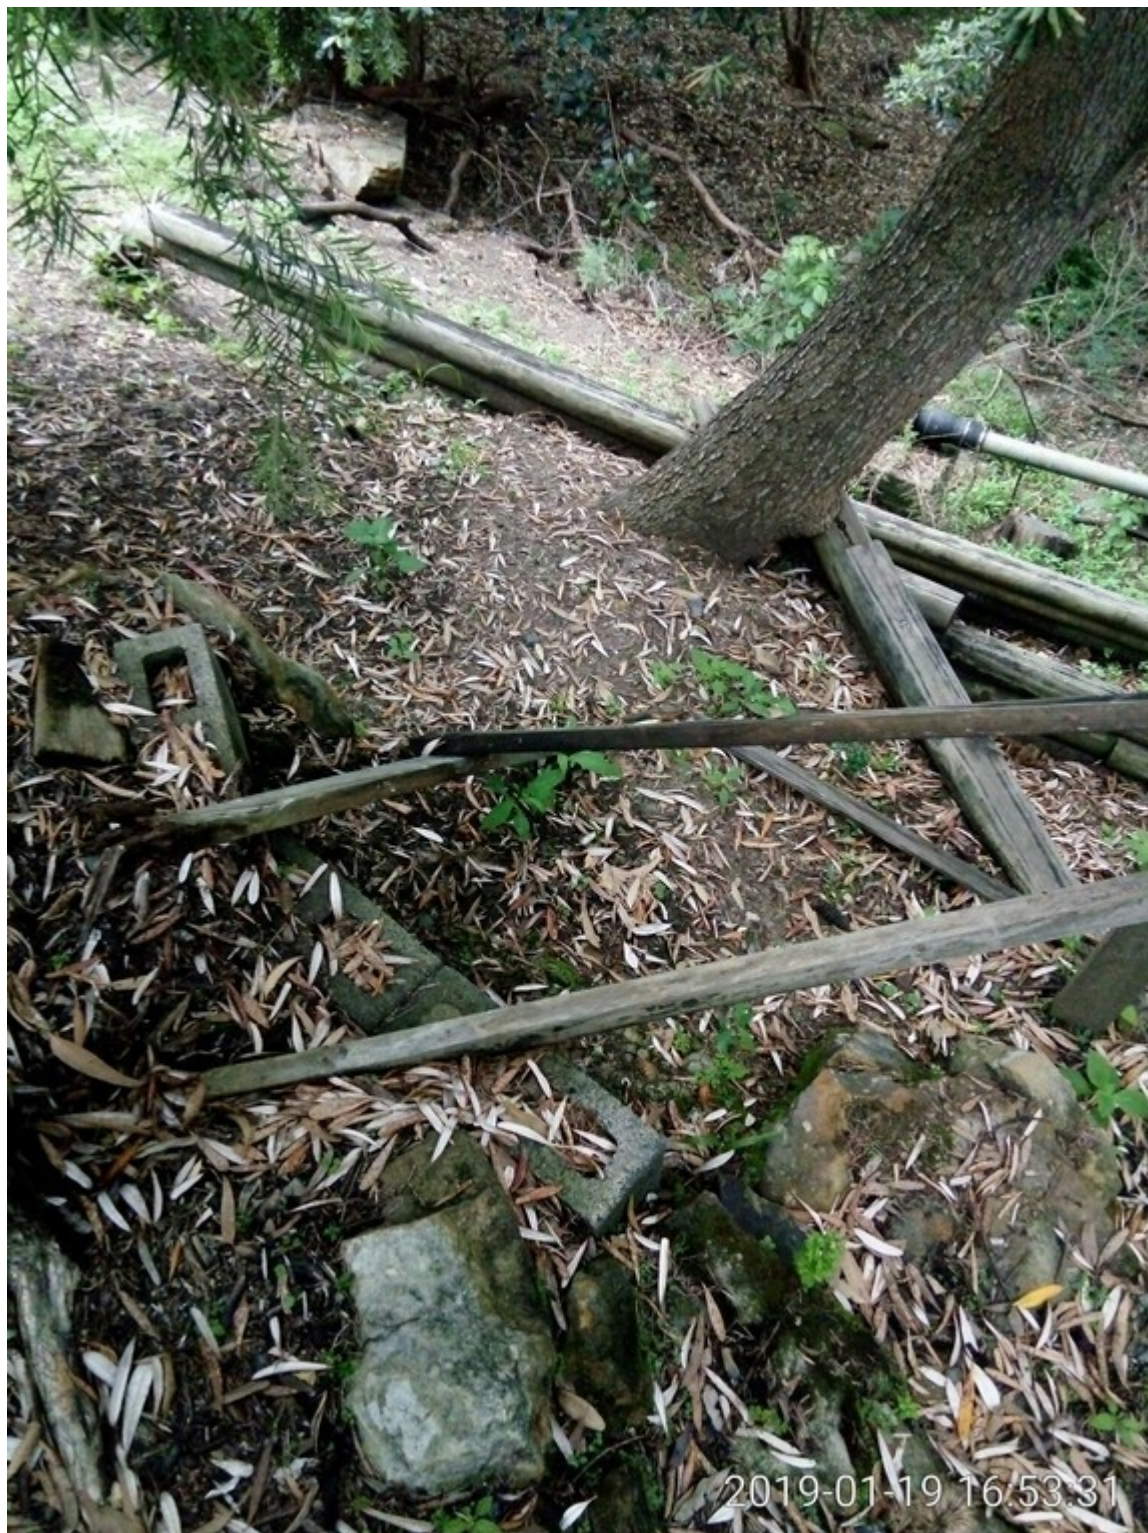
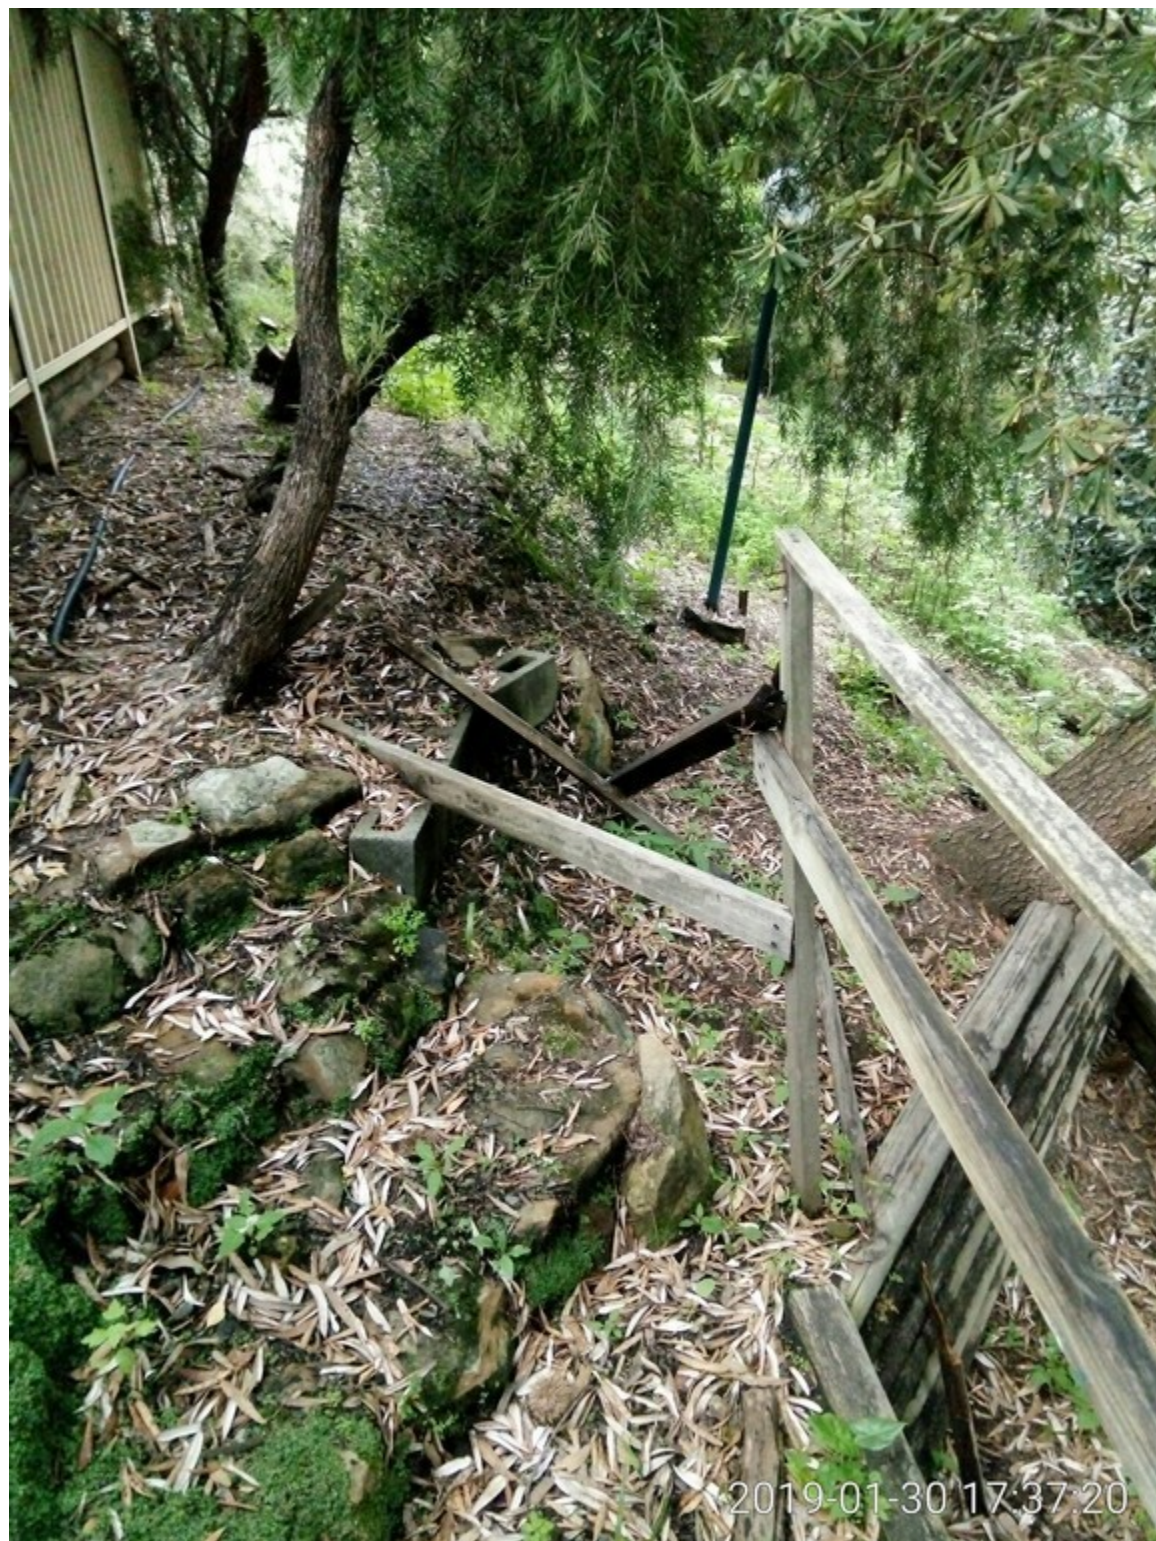
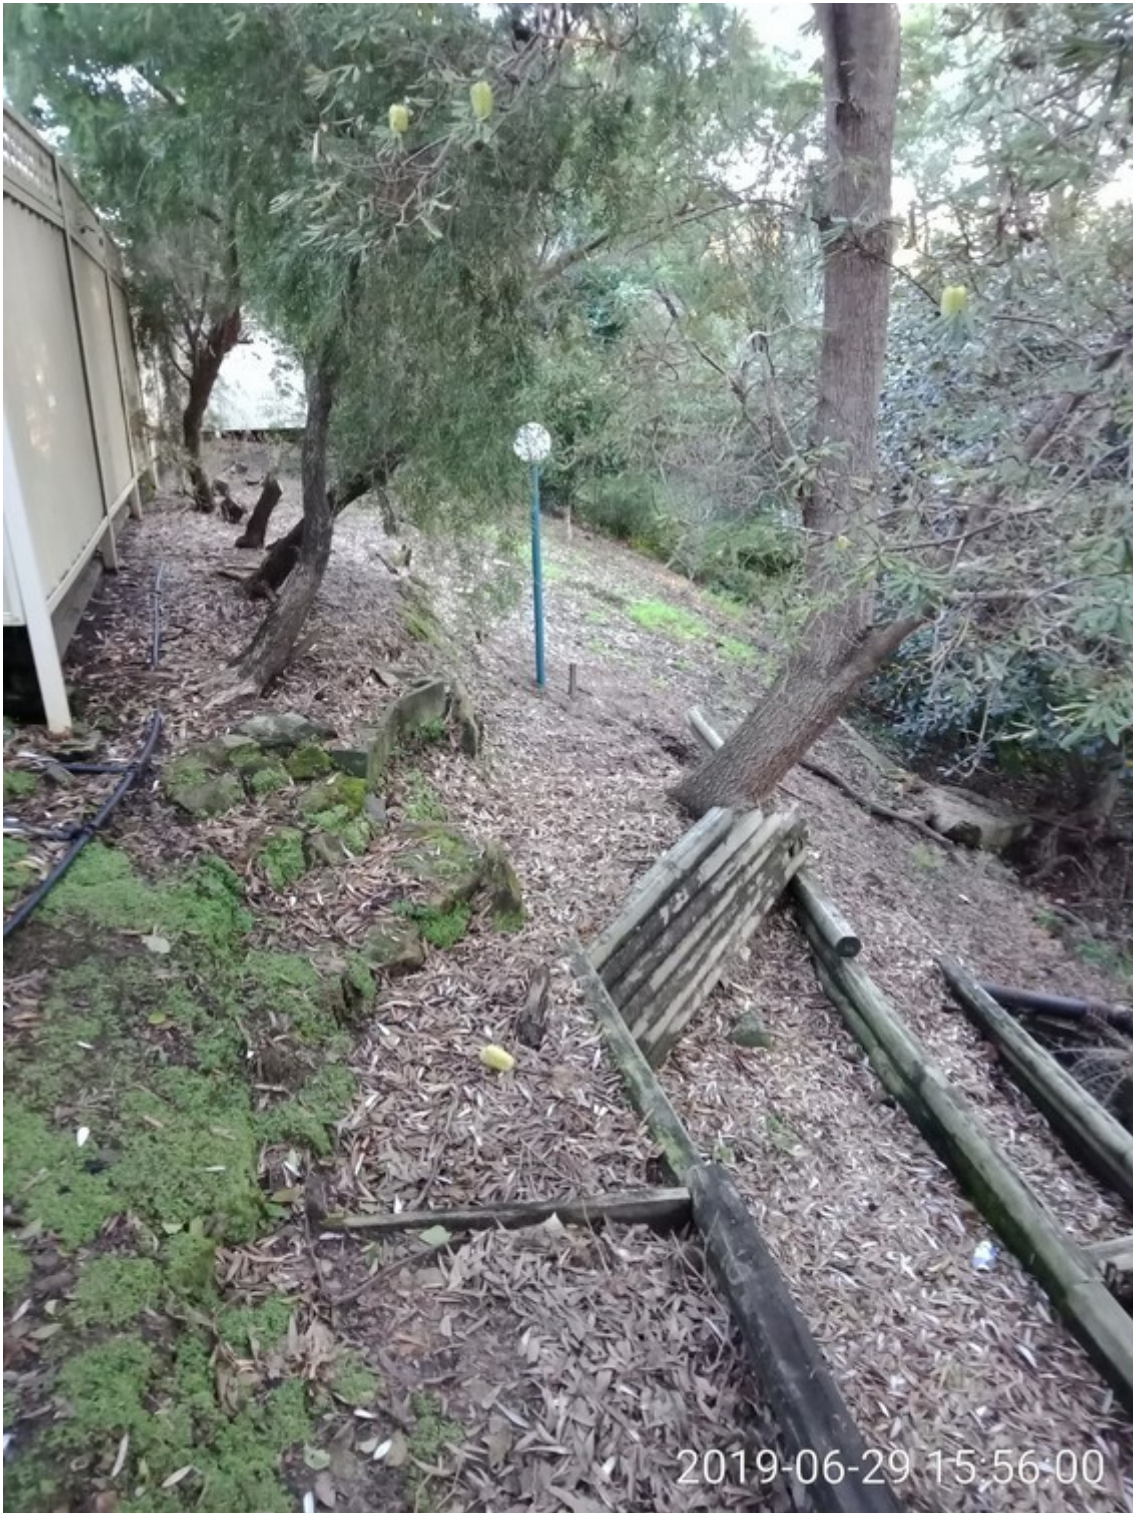
### **35    Wooden railings disappeared behind townhouses due to rot and un-repaired since 2014**

Most of railings started collapsing since 2015. Attempts to reason with strata managers to repair common property failed.

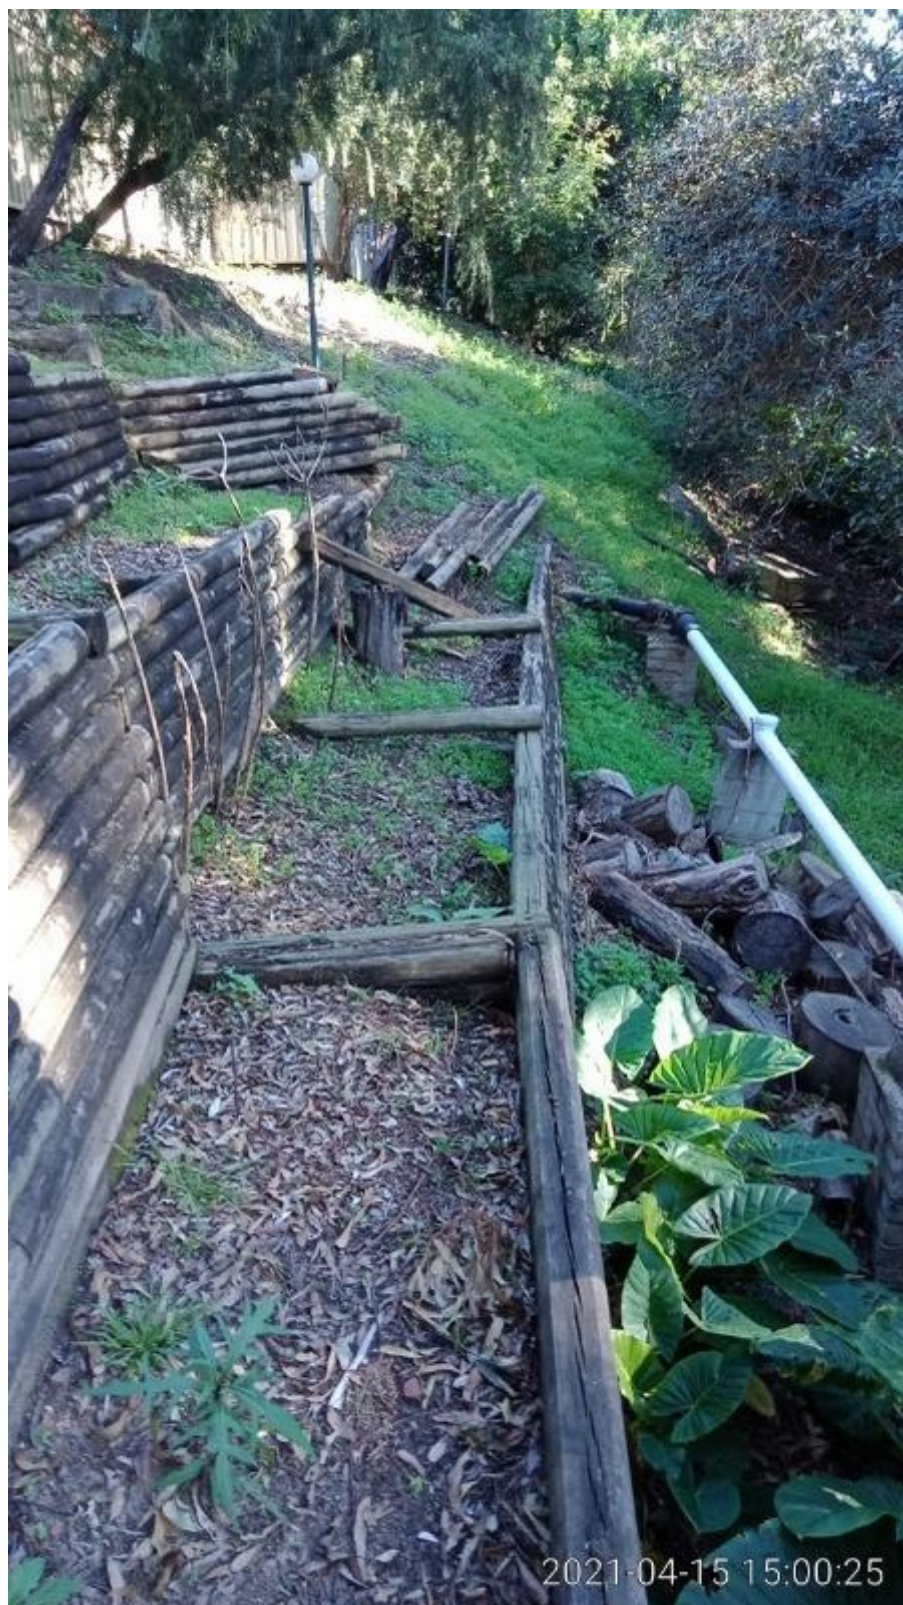
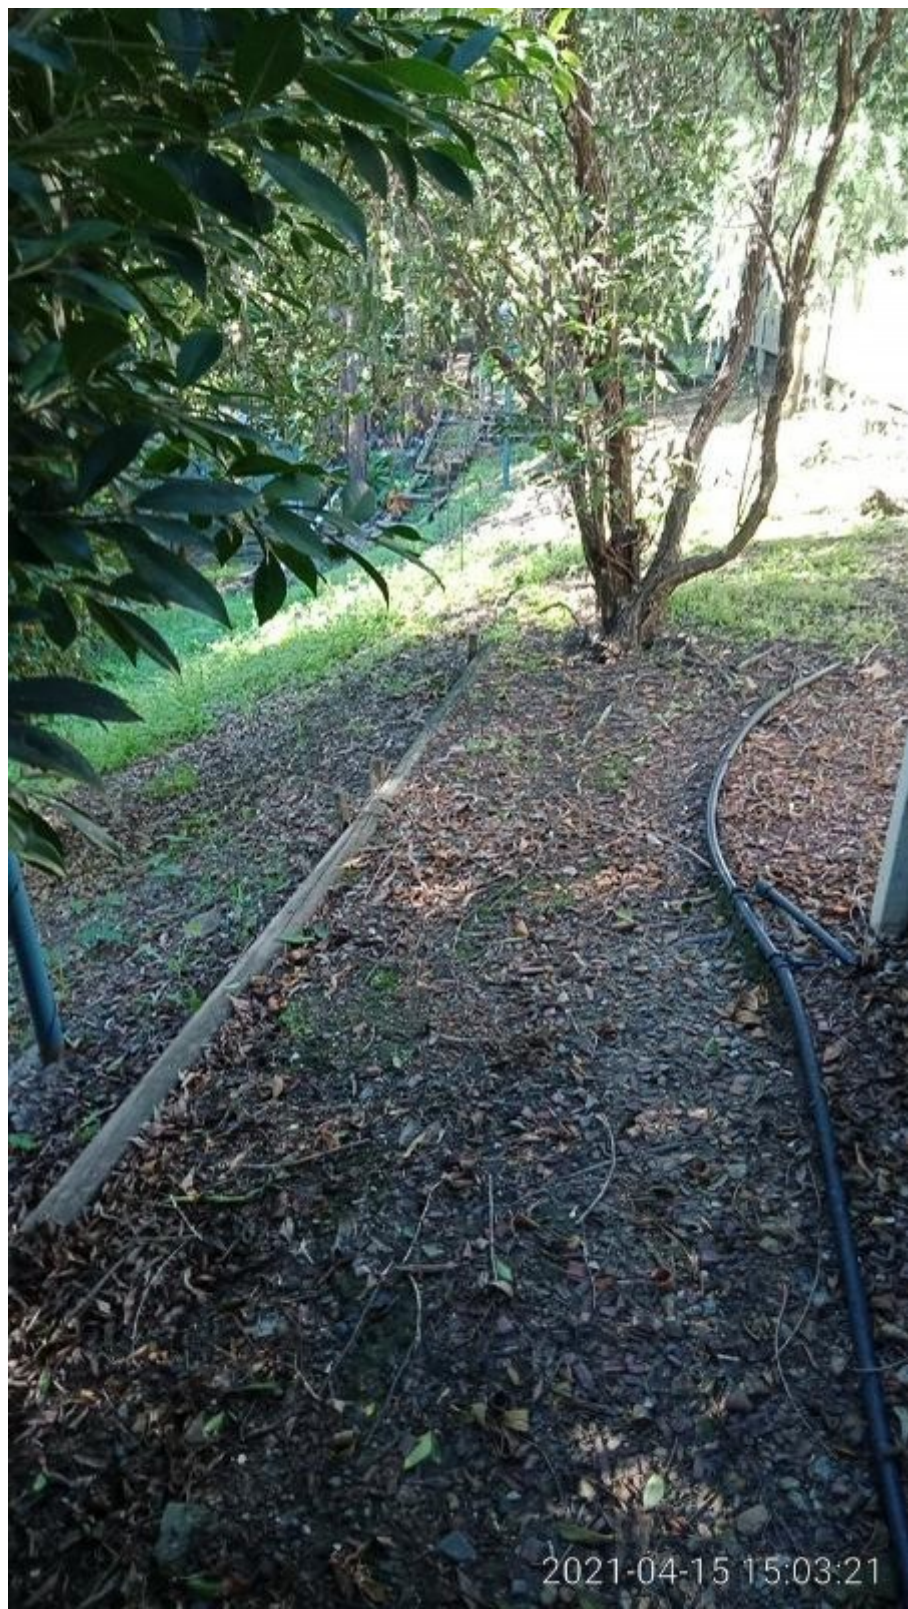
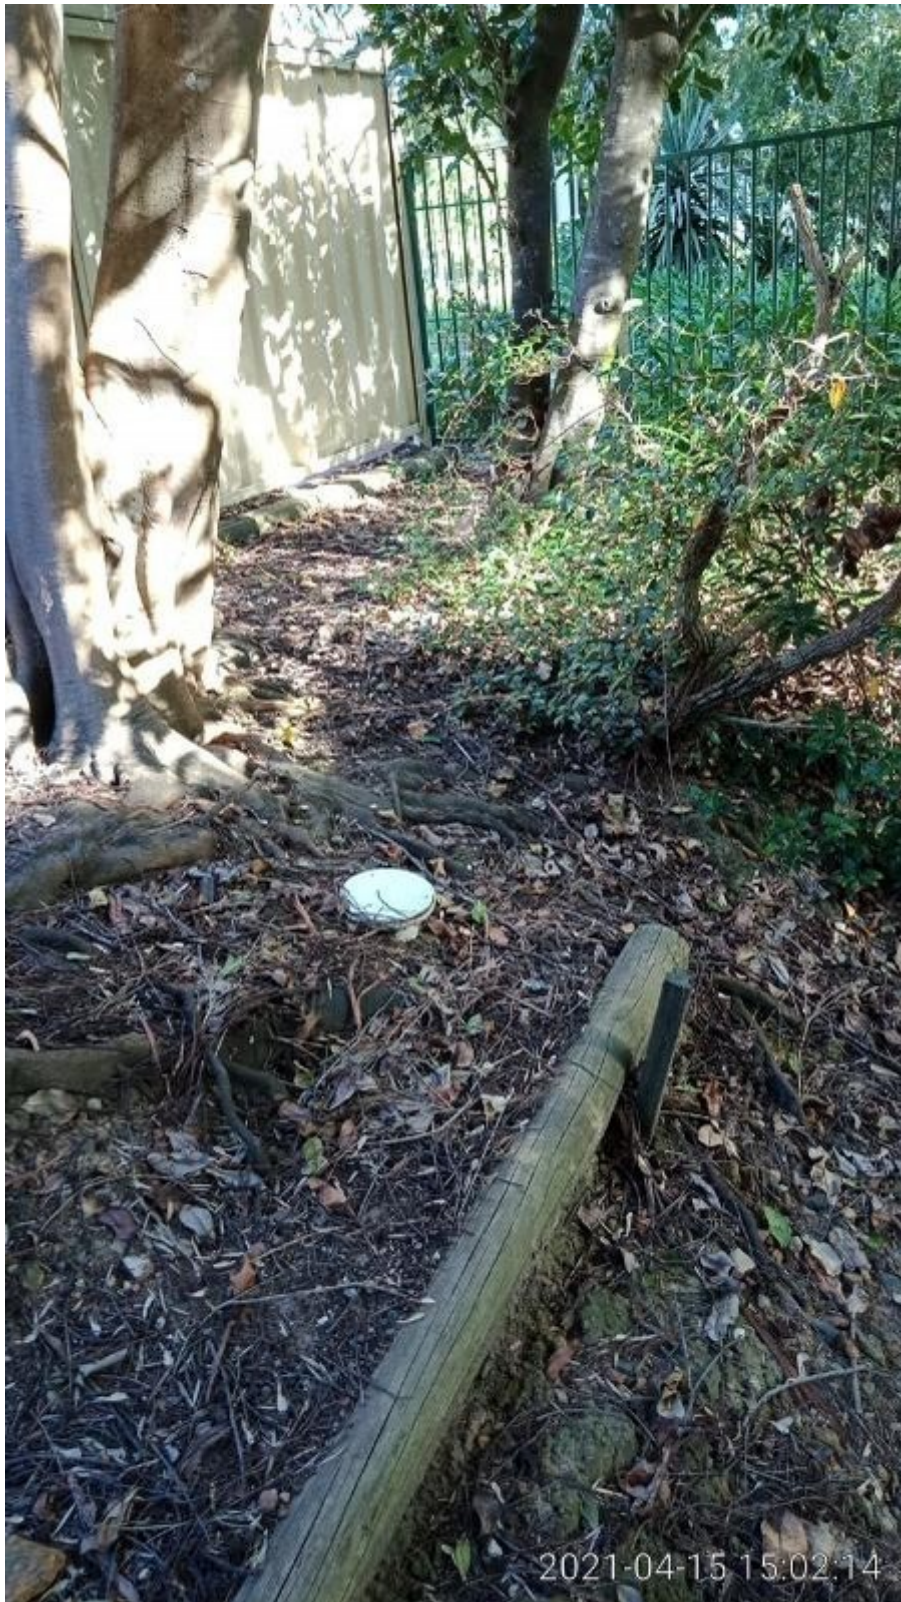
In 2021, walking in sloping site behind townhouses is quote risky, especially work workers.
