## Table of Contents

This document lists just some of the problems in the complex that can cause injury, health problems, or even death in dire circumstances.

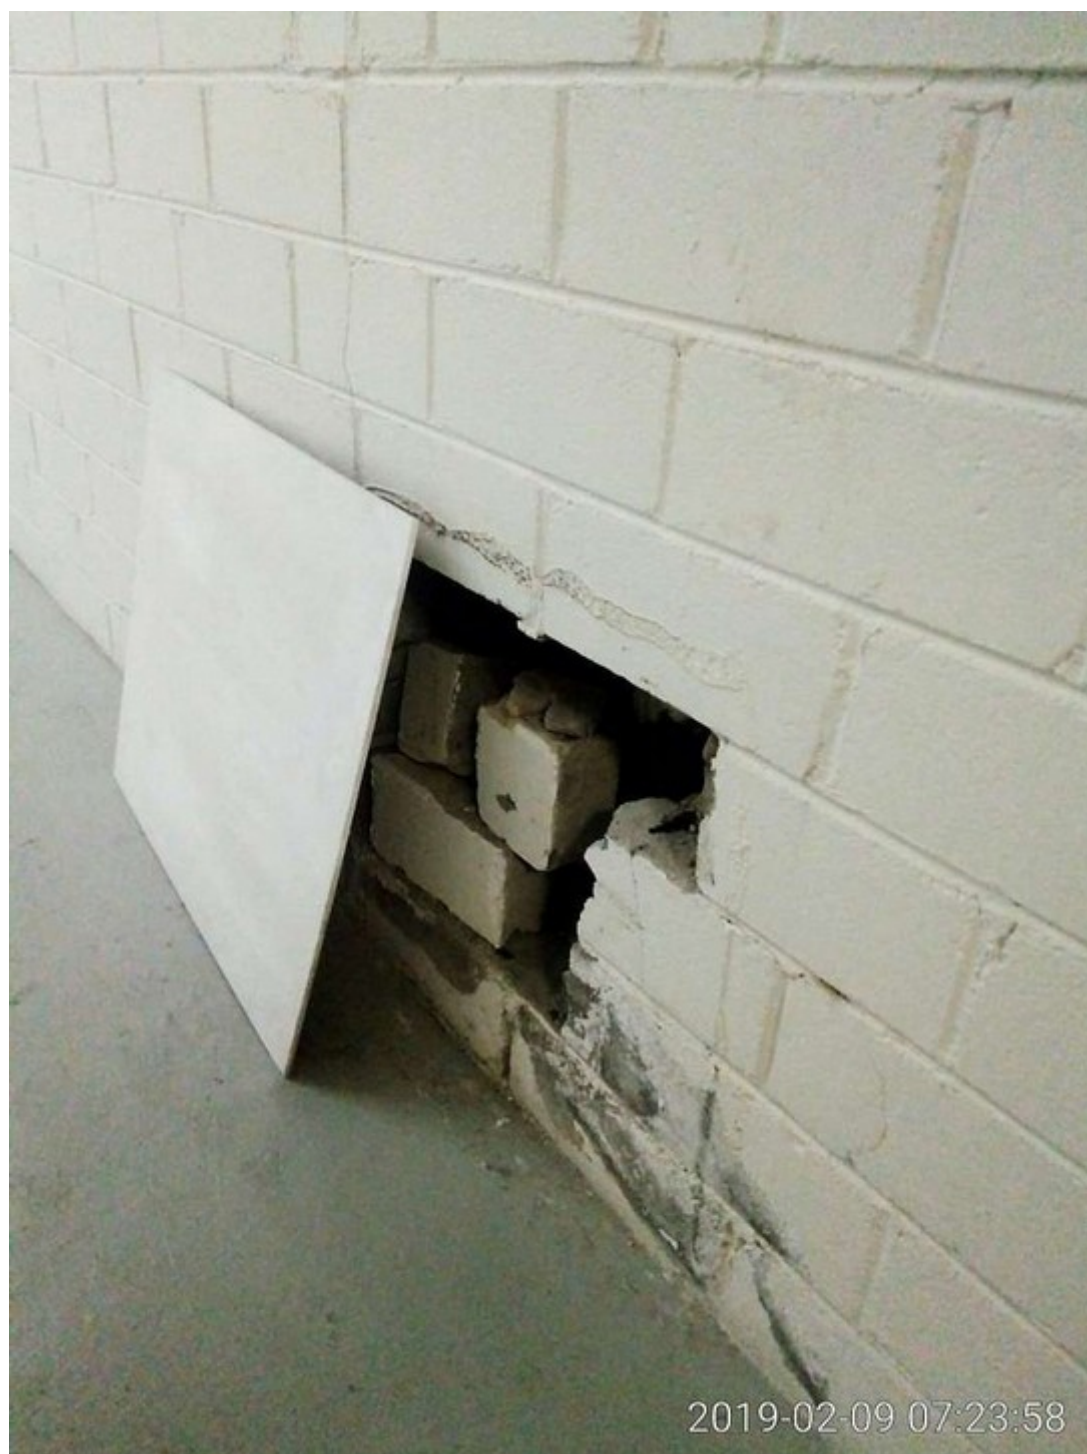
### **36 Example of water leak damages in Block C level 6 in June 2021**

Request to properly repair the hole, open since 2019:

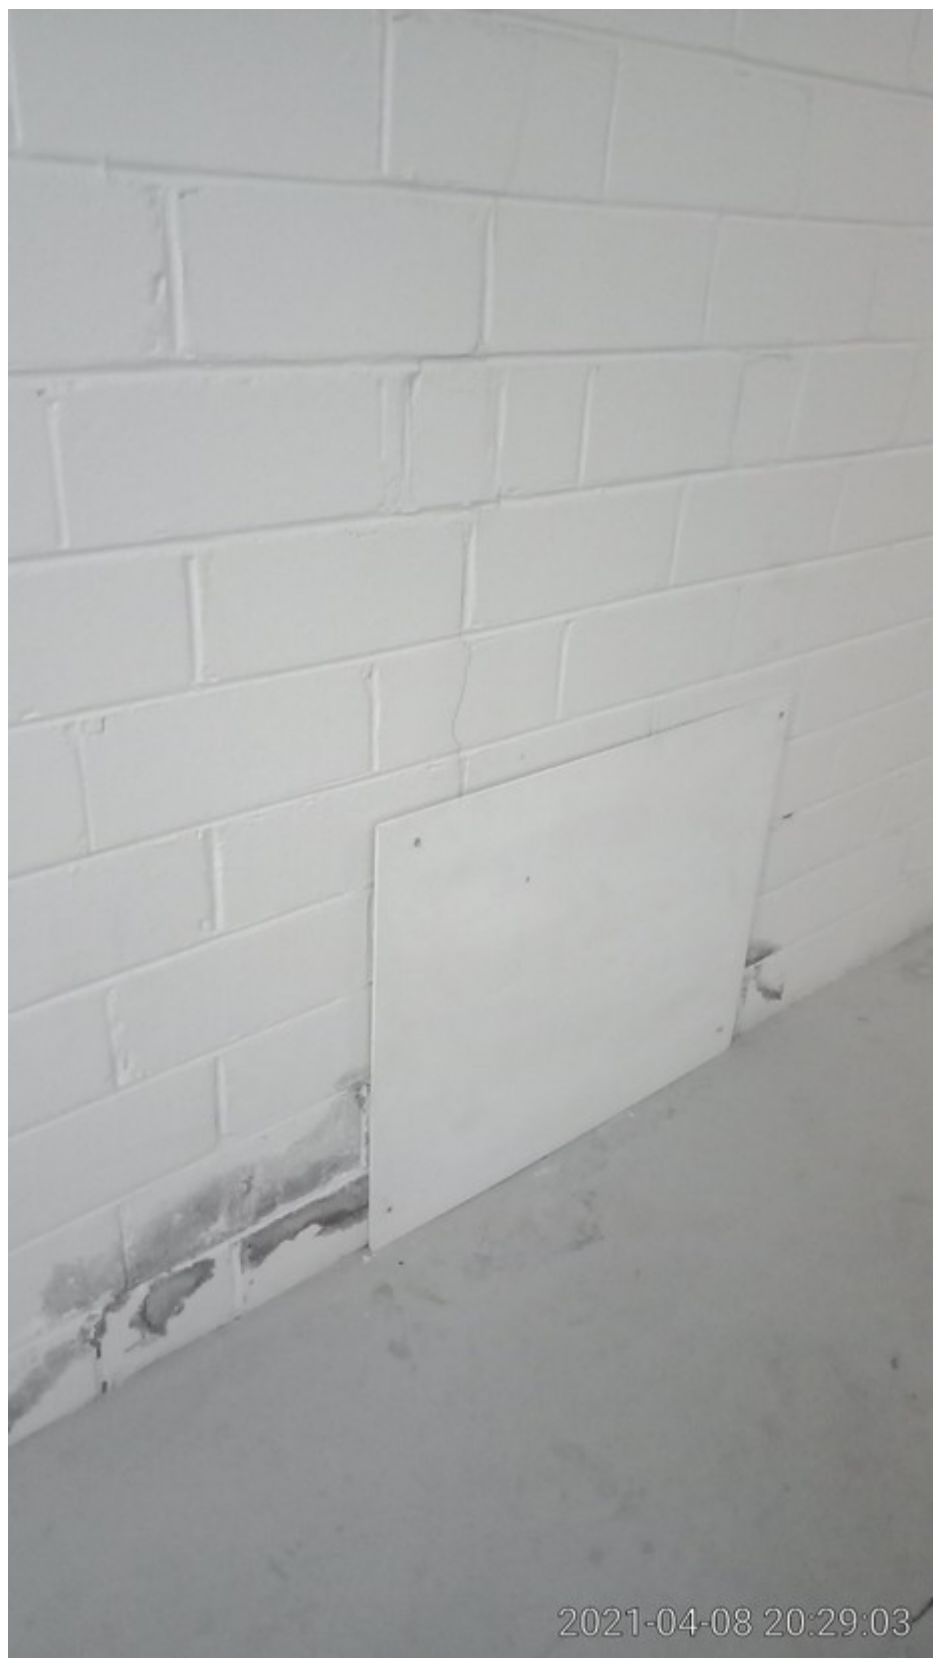
Instead of repair, the hole is simply covered:
