Garden beds have been a sore sight in this large strata complex for a long time:

Howard West Builder is using a unique substandard method by nailing metal plates on the front side of damaged garden beds without proper remediation work, leaving inner side of the bed exposed to water penetration, concrete cancer and movement as pictures show:

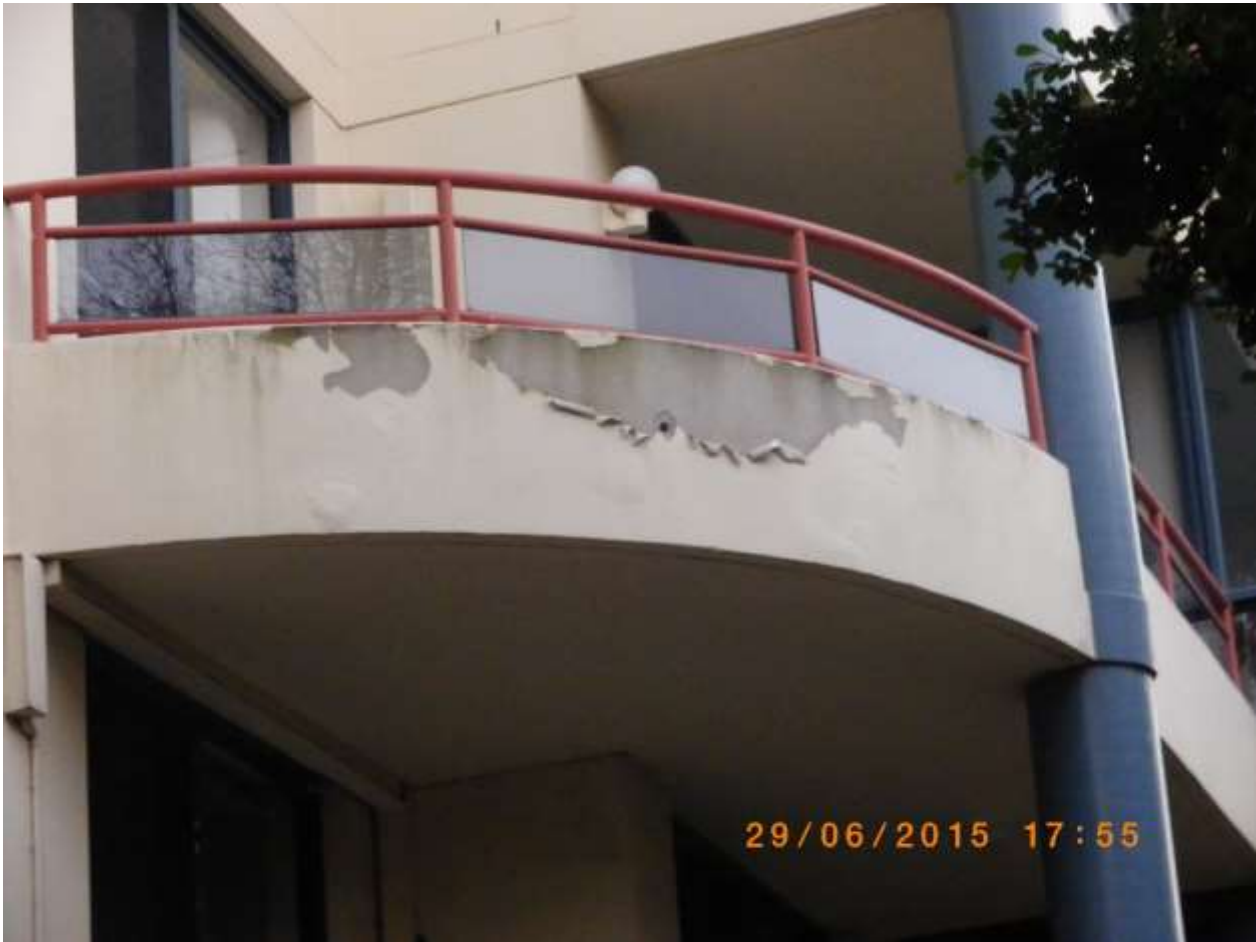
Even a single photo of a building taken on 29th of June 2015 tell a story of neglect that applies not only to gardens but living areas as well:
