1-15 Fontenoy Road

Macquarie Park, NSW 2113

Condition Report

July 2012

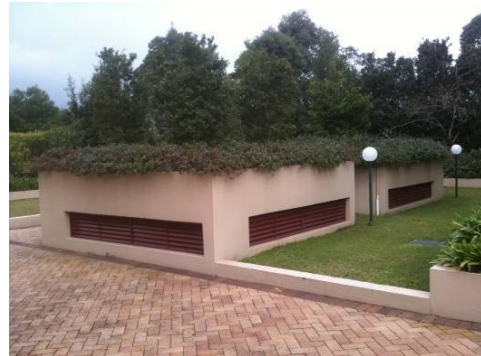
We noted an isolated area of minor water penetration through the concrete soffit of the basement car park adjacent to the raised roof light area between Block A and the tennis courts. This is likely due to the planted areas above which, in heavy rain, will seep water through the planter boxes to the car park below. This will not affect ongoing operations however routine monitoring of the soffit and perimeter walls for any major water seepage is recommended.

Raised planter boxes

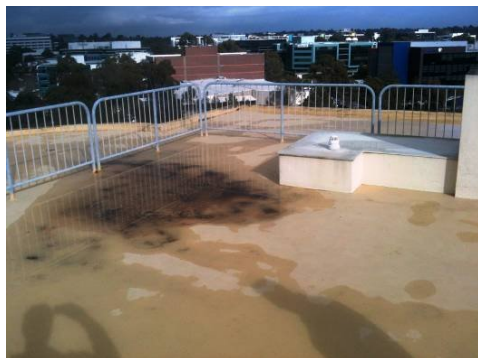
Block A roof coverings

The flat concrete deck roof areas to Blocks A, B, C and D contain large areas of standing water. A number of previous patch repairs have been carried out. The surfaces require preparing and recovering with a liquid applied waterproof membrane within the short to medium term (1-5

years). Block C was observed to be in good overall condition with Block D suffering the most standing water.

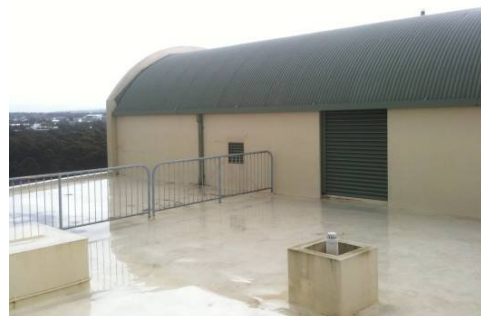
Block C roof coverings

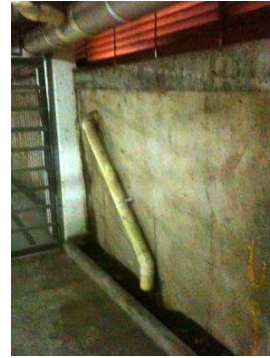
Spoon drains have been constructed in select areas to collect any water penetration through the external walls.

Spoon drain to select areas

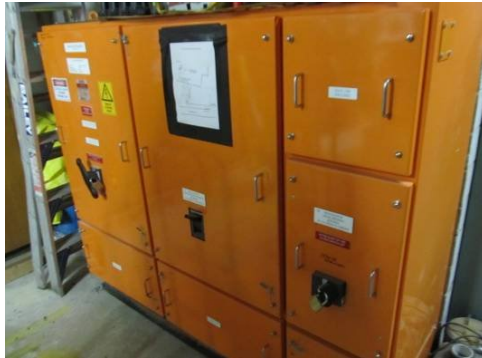
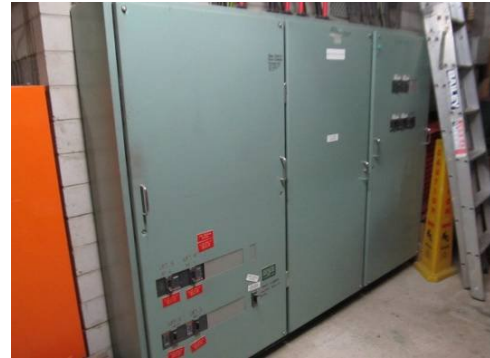
Main switchboard

The main switchboard appeared to be in good condition with no reported defects. Life cycle replacement is not expected in the next 10 years.

Annual inspections and infrared scans of the electrical switchboards is recommended.

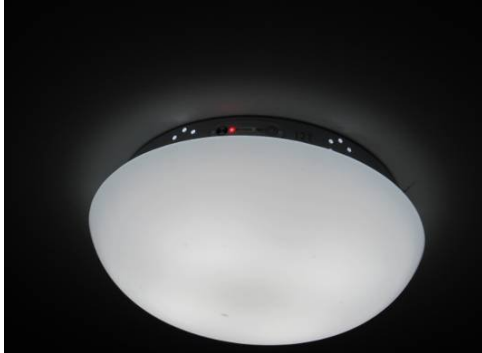
The tower buildings common area interior lighting is currently undergoing an upgrade. The complex exterior and garden lighting will require lifecycle replacement in the long term. The car park lighting will require lifecycle replacement in the long term.

Typical tower building new common area lift lobby lighting

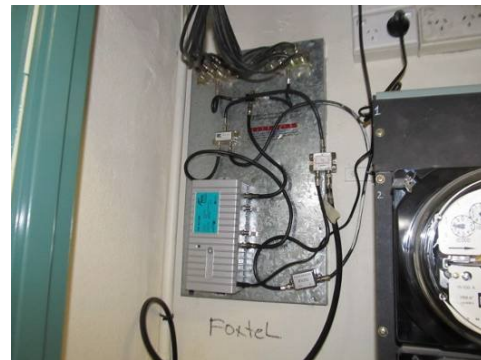
MATV distributor

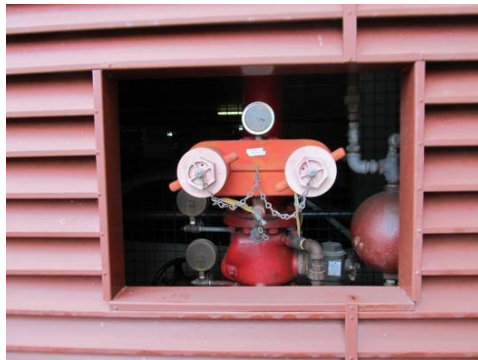
The automatic fire system was found to be in good condition with no visual or reported defects. Life cycle replacement is not expected in the next 10 years.

Sprinkler booster connection

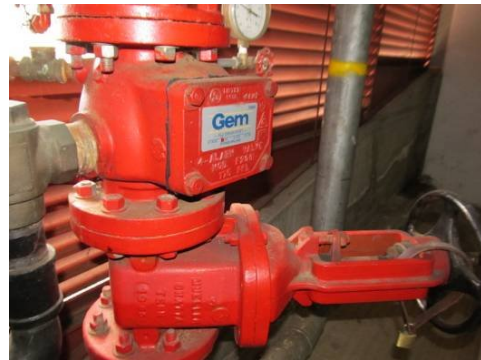
Sprinkler valve set

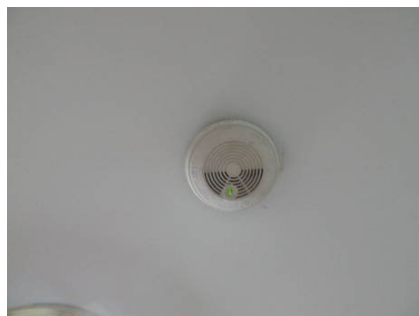
Maintenance and testing documentation was not supplied for review.

Typical domestic type smoke detector

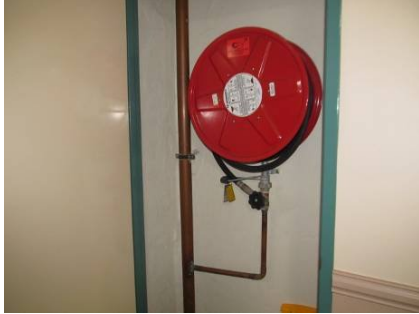
The fire hydrant hose reel systems were found to be in good condition with no visual or reported defects. Life cycle replacement is not expected in the next 10 years.

Typical tower building hose reel

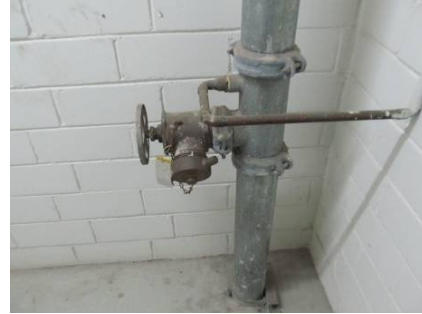
Typical tower building hydrant land valve

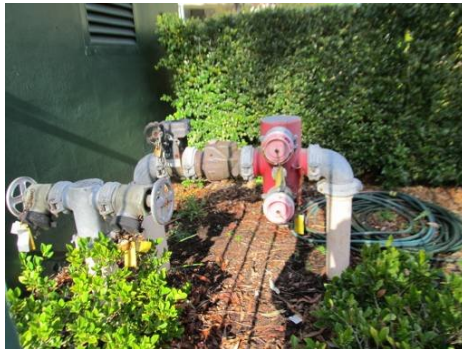
Hydrant booster connection

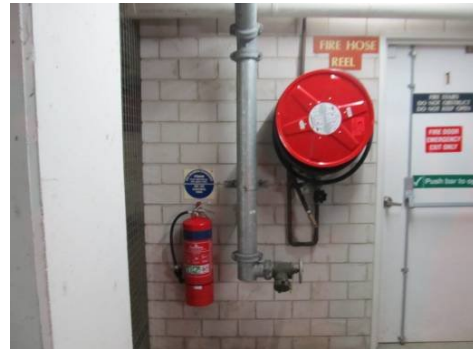
Typical car park extinguisher, hydrant and hose reel

The maintenance tags for the hydrants, hose reels and extinguishers were conflicting which indicates that the different fire services may be under different maintenance contracts. Maintenance contracts were not made available for review. It is recommended that all fire safety measures be surveyed as required by AS 1851.2005.

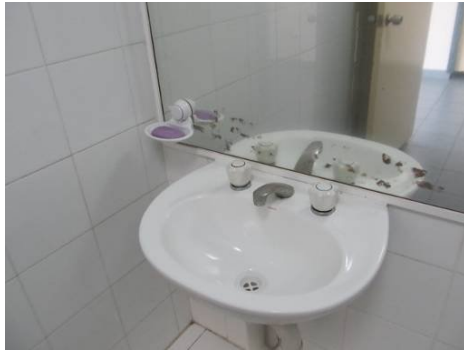
The fittings and fixtures were found to be in good condition with no visual defects found. Life cycle replacement is not expected in the next 10 years.

Typical vanity basins

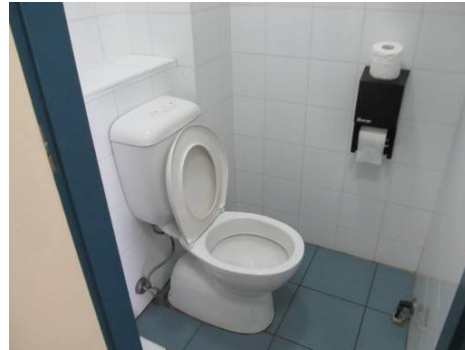
Typical WC

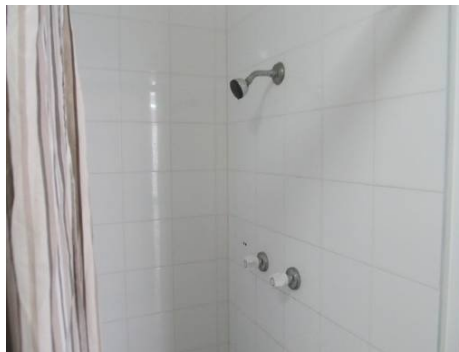
Typical shower

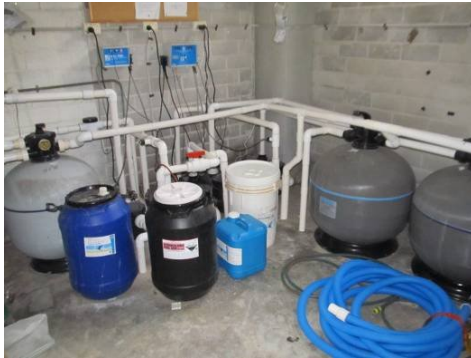
The swimming pool and spa filtration systems were operating at the time of inspection and appeared to be in good condition.

The gas fired heaters appear to be in fair current condition, however, are likely to require replacement toward the end of the long term.

Swimming pool and spa filtration systems

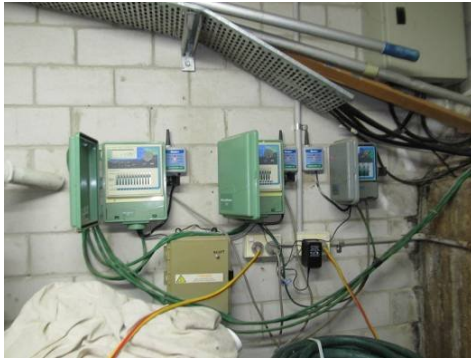
The garden irrigation system appeared to be in good condition with no visual or reported defects. Life cycle replacement is not expected in the next 10 years.

Automated controls for the garden irrigation system

It is recommended that a rain water harvesting system be considered to supplement the towns' mains for garden irrigation.

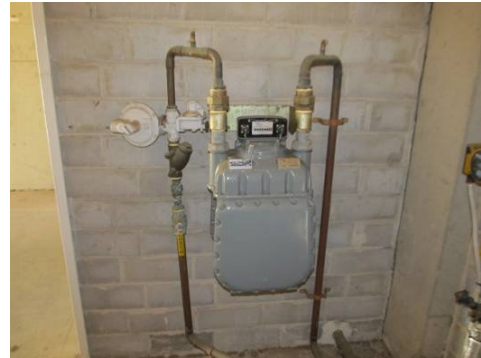
Typical gas meter in the tower building boiler rooms

The system was found to be of a good quality installation with no defects noted.
