Health hazard – Supporting smoking by providing access via fire doors

In spite of many warnings about health hazard and non-compliance with SP52948 By-Laws and SSMA 1996 and 2015, owners corporation provides direct and unrestricted access through fire door at the back of Block A.

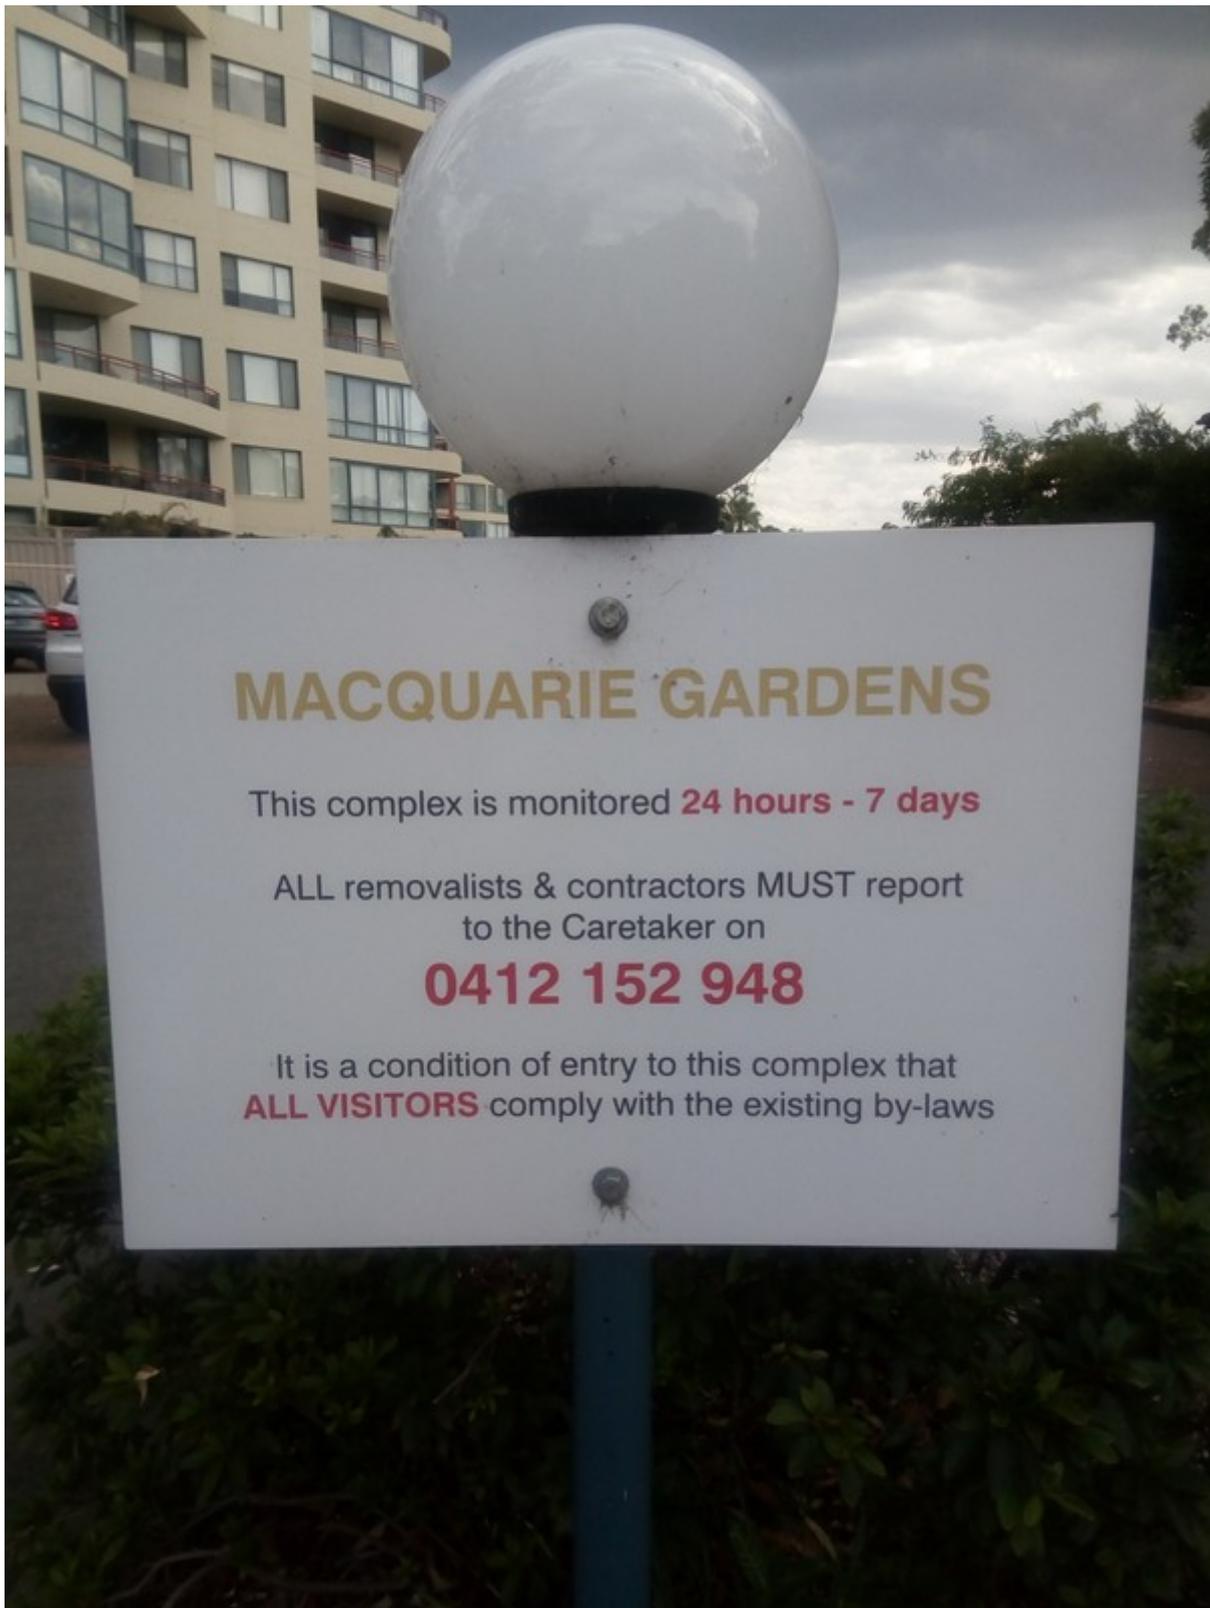
Notice Board at the entrance to the complex, in existence since 2001:

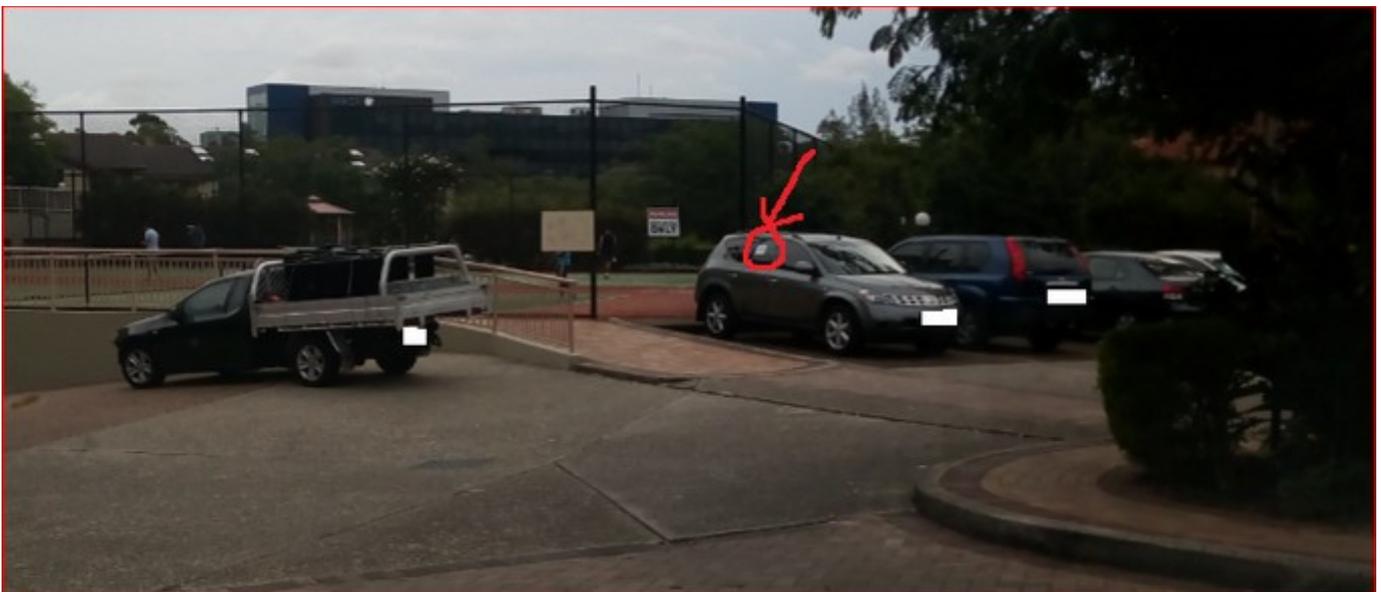
The correct way to deal with illegal parking on common property is to put sticky warning on the window, as shown by this example:
