Table of Contents – SP52948 discrepancies in BIV report for SP52948 10-Year Capital Works Fund in 2017 and 2021 (with strata complex status update in September 2023)

BIV assessments for SP52948 10-Year Capital Works Fund drastic changes in assessments in March 2017 and October 2021, delaying major works for 10 years without professional engineering reports

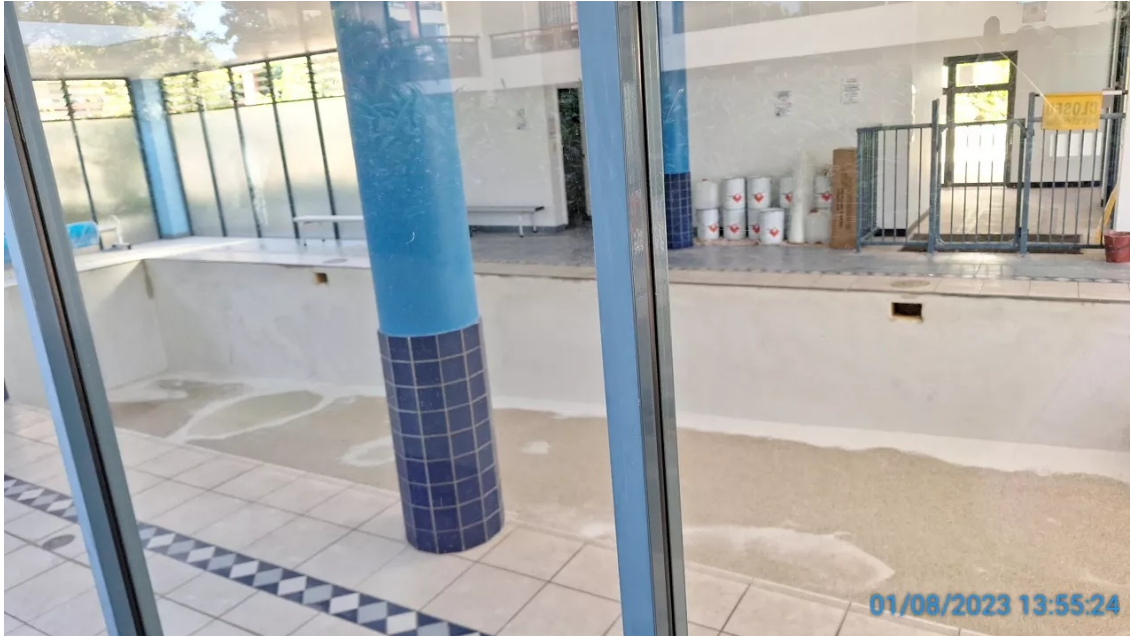
Due to long-term neglect, in May 2023, committee had to make urgent (unapproved at general meeting) decision to repair pool and spa area in amount of \$55,000.00:

The swimming pool has developed several rust spots that need attention.

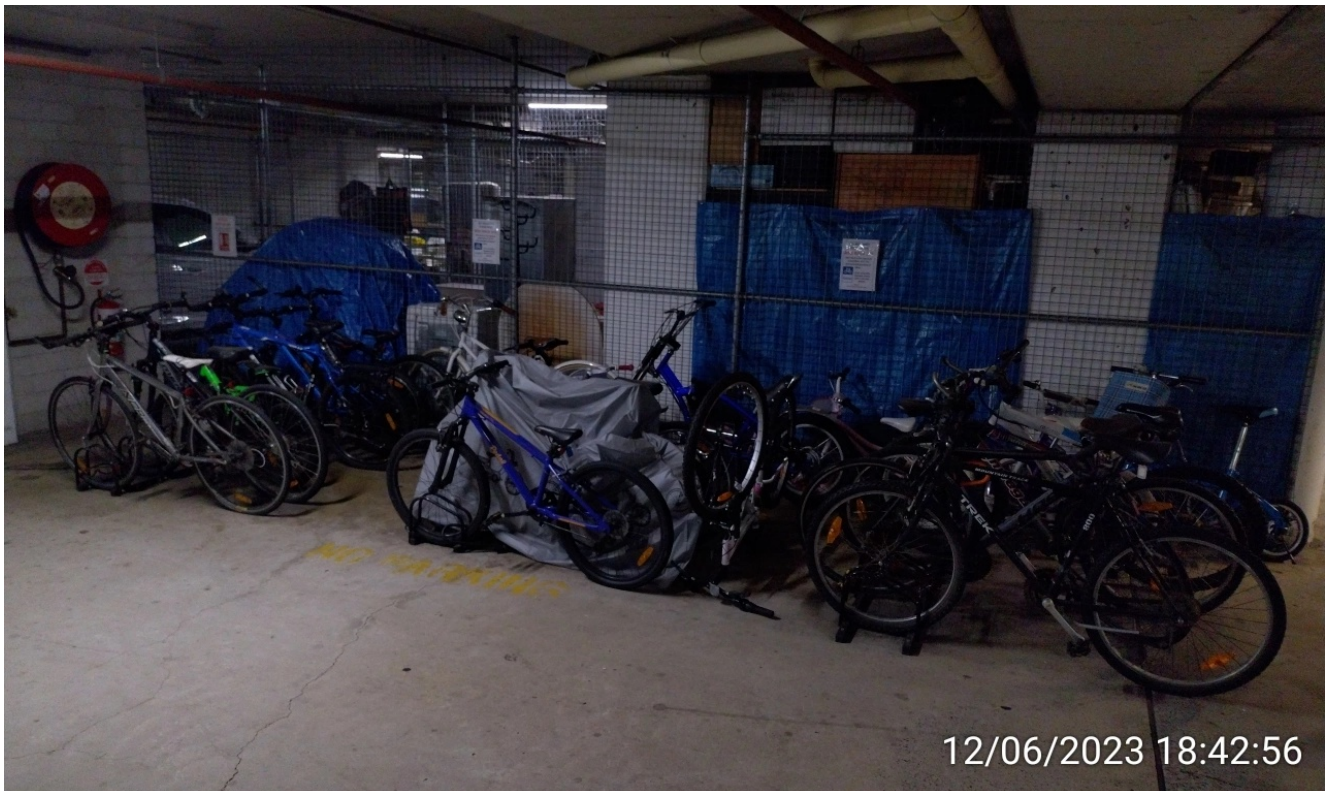
- What kind of risks one of the planned EV charging stations would create for bike riders, including children, in the basement area:
