Table of Contents

SP52948 – Extract from committee meeting on 23rd of September 2021 confirming deficit in Capital Works Fund in amount above 1.5 million (\$1,515,541.00)

Roof membranes

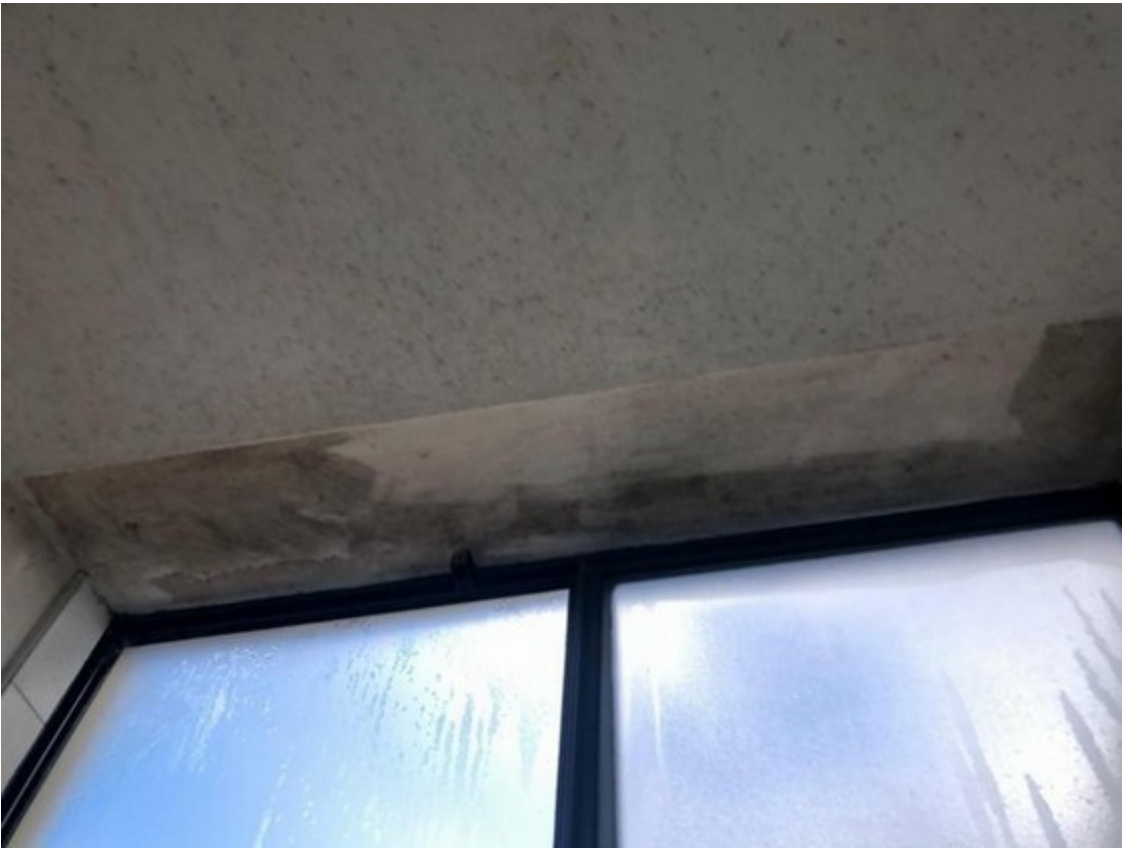
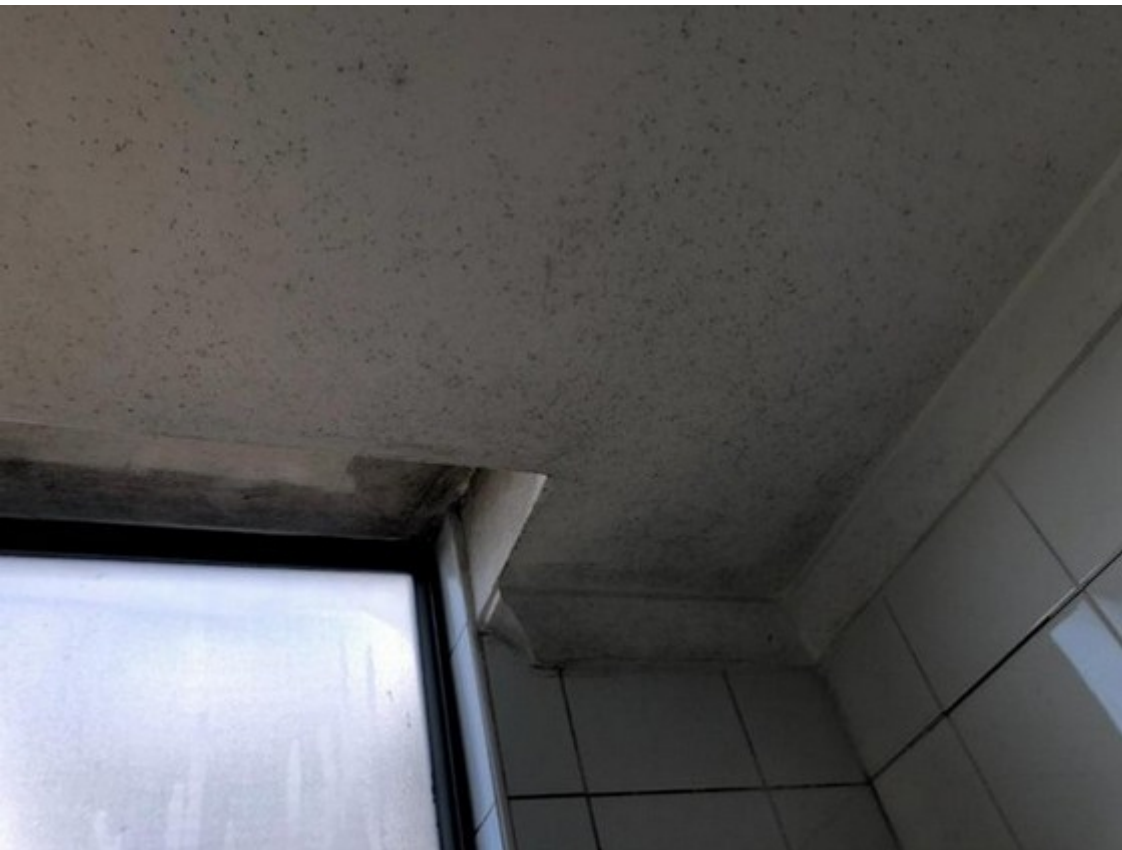
On 13th of June 2020, Lot 158 documented problems with water leaks and dampness in bathrooms of Lot 43 (top floor in Block B), which created not only serious health risks, but also dangers of water entering electrical installations.

1. Investigate causes of mold and humidity in bathrooms of Lot 43, and take corrective actions as required.
2. Investigate air flow in bathrooms and laundry of Lot 43, and take corrective actions as required.
For some tenants (Lot 158 knows a few), owners corporation cleaned up the vents in their units.
3. Verify if any other unit on top floor of Block B (Level 7) has similar problems.
4. Prepare tenders for membrane installation for second half of the roof in Block B and whole roof in Block A and C (Block A and C have not been done properly for 24 years now).
5. Send notice to all owners and tenants about maintenance of vents in bathrooms and laundry rooms, which are especially important during COVID-19.

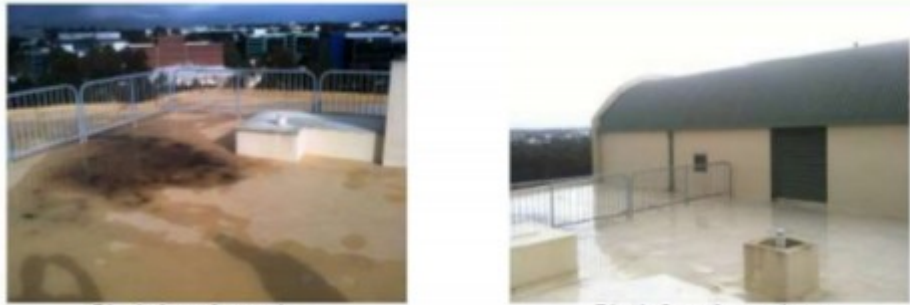
Block A roof coverings

Block C roof coverings

Condition, Observations and Comments

The flat concrete deck roof areas to Blocks A, B, C and D contain large areas of standing water. A number of previous patch repairs have been carried out. The surfaces require preparing and recovering with a liquid applied waterproof membrane within the short to medium term (1-5 years). Block C was observed to be in good overall condition with Block D suffering the most standing water.

The falls to the drainage are insufficient and improving the existing falls should also be considered. The internal units were not inspected for any water penetration via the roof slab.

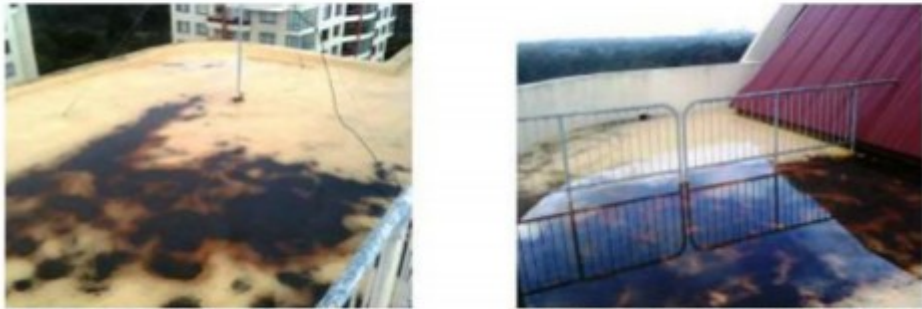
Standing water to flat roof deck, Block A

Standing water to flat roof deck, Block B

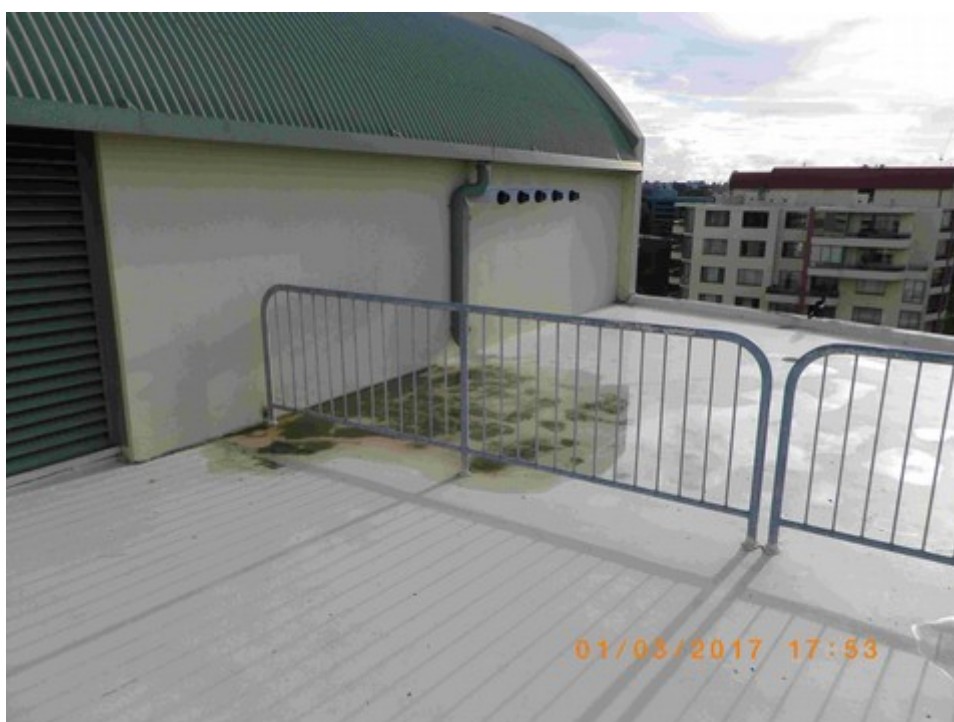
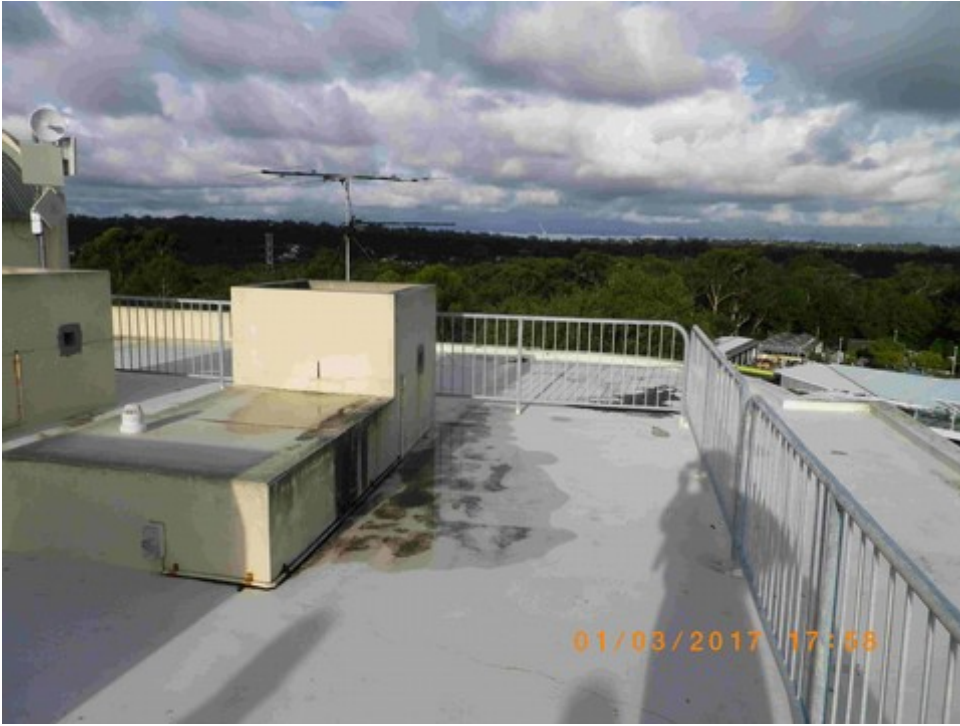
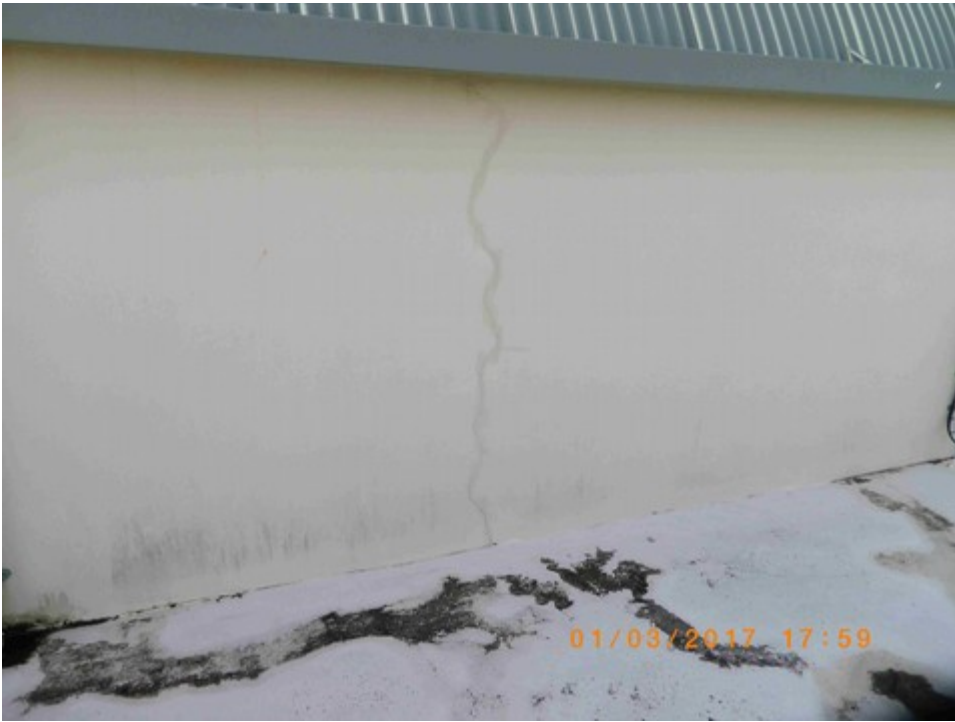
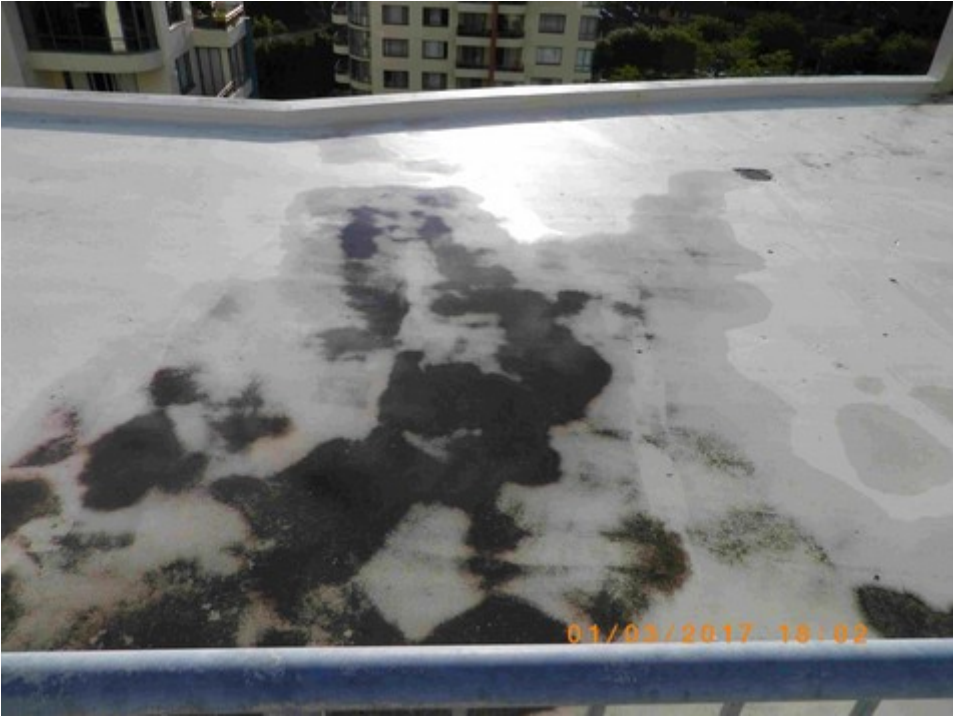
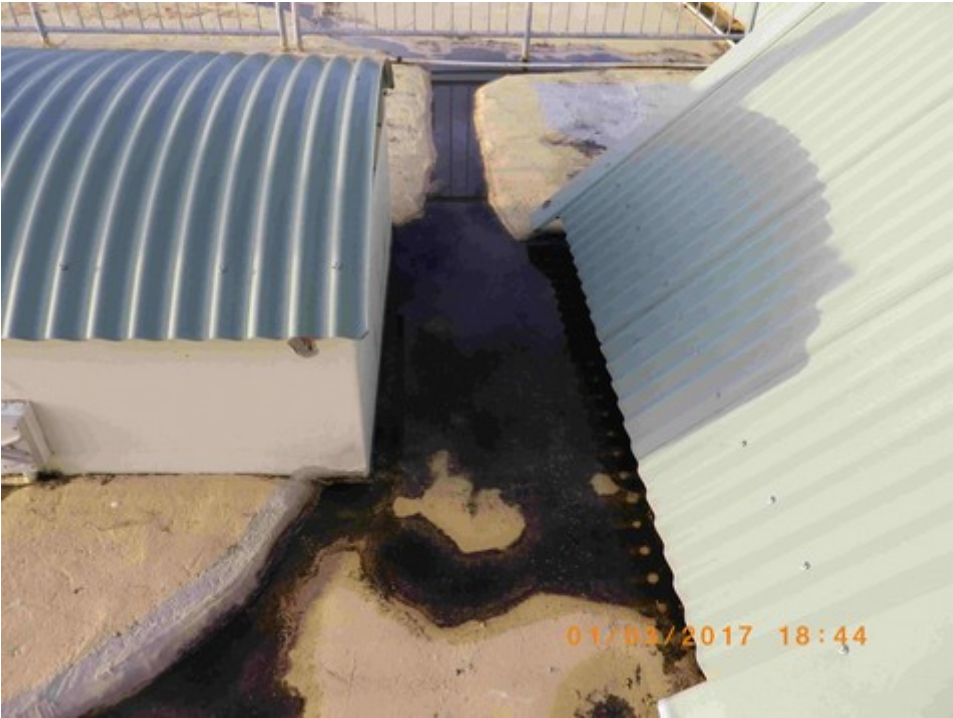
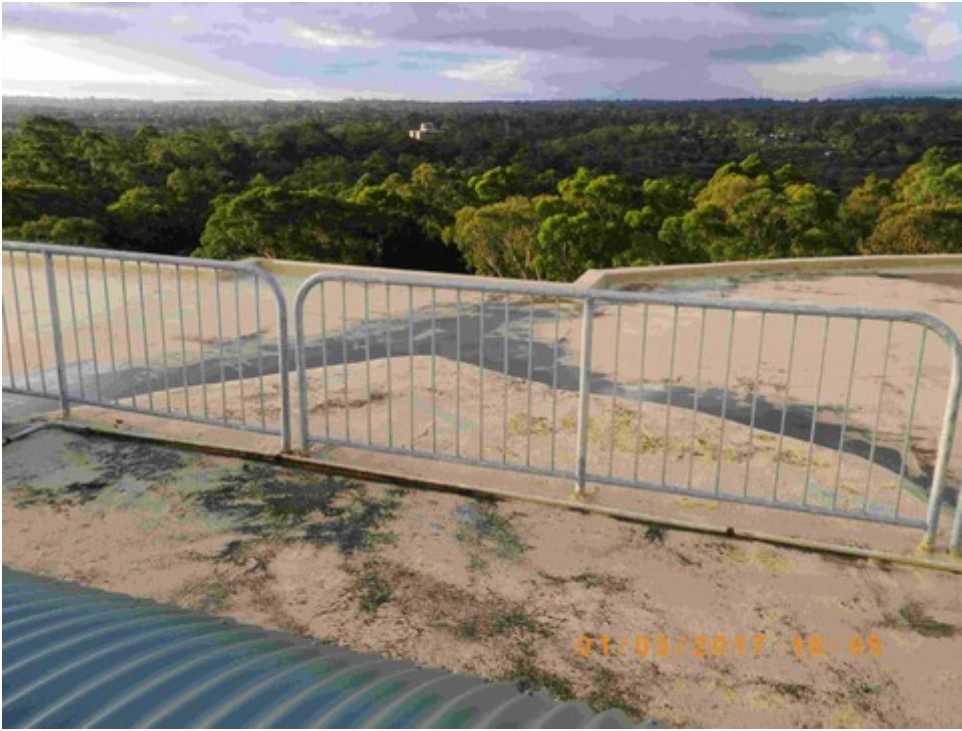
On 1st of March 2017, joint visit with Waratah Strata Management to roof areas of the four building showed the following status:
