## Table of Contents

This document lists just some of the problems in the complex that can cause injury, health problems, or even death in dire circumstances.

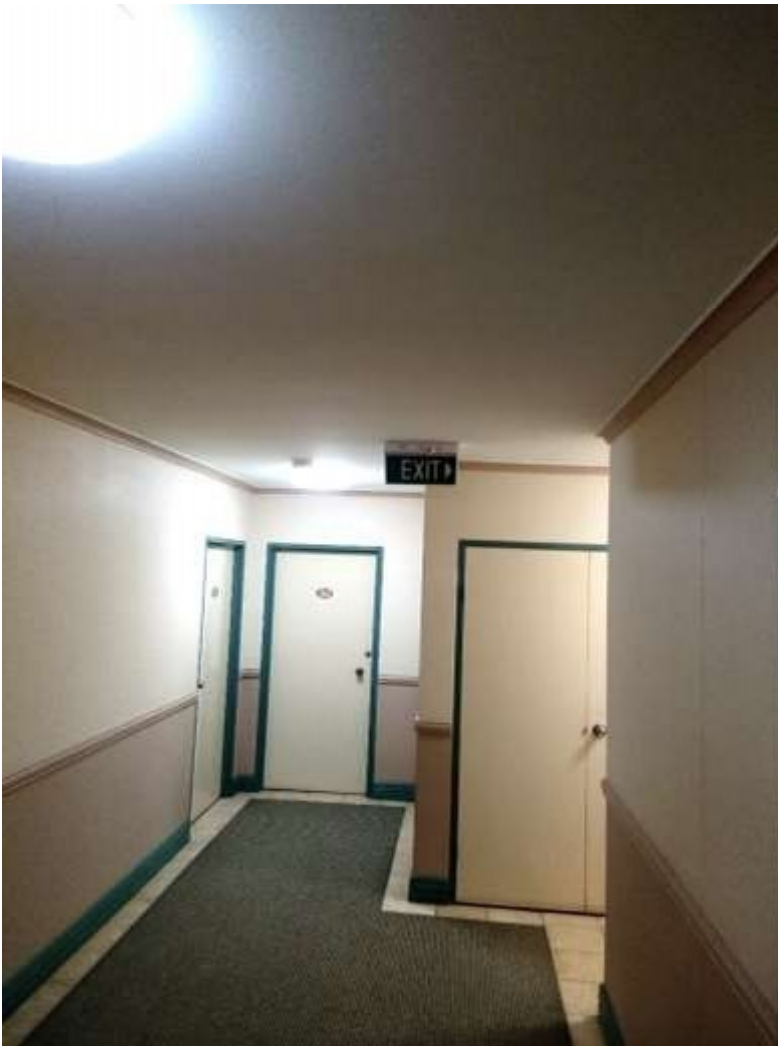
As an example, in Block A, second floor, exit light was not operational in period between 7<sup>th</sup> of February 2018 and 26<sup>th</sup> of March 2018 (total of 48 days!) .

In phone conversation with the staff at the time who called us on 23<sup>rd</sup> of March 2018 at 07:41 hours, he admitted that allegedly there were 22 faulty lights in the complex.

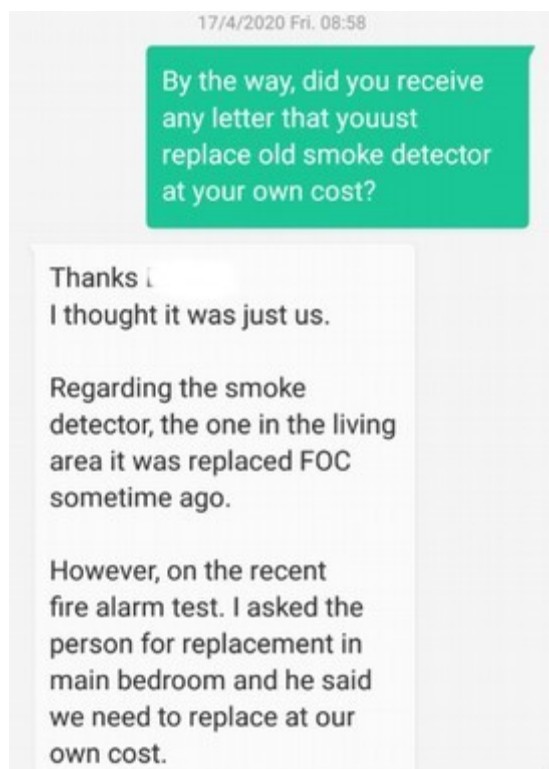
Here is SMS from another owner who was told to replace smoke alarm at own cost on 17<sup>th</sup> of April 2020:

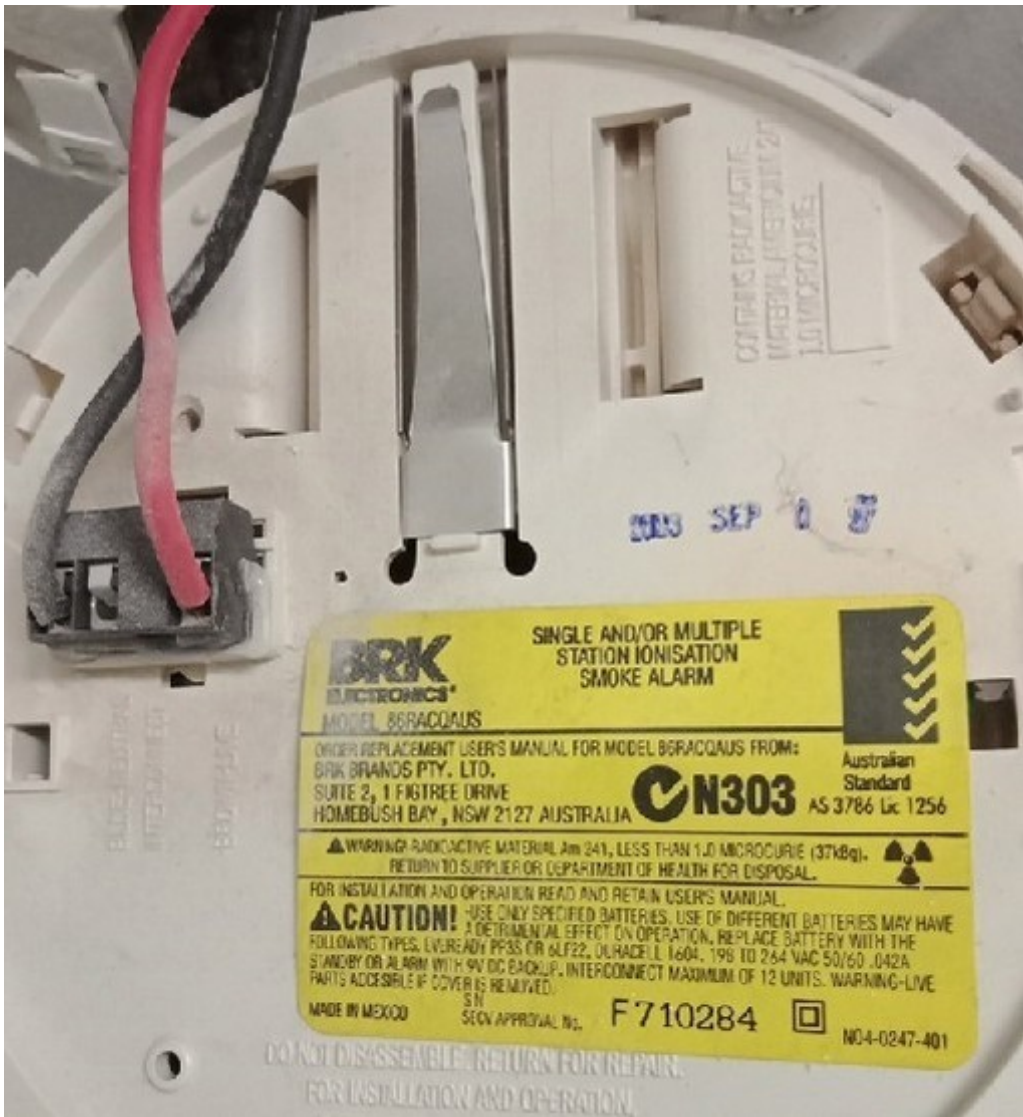
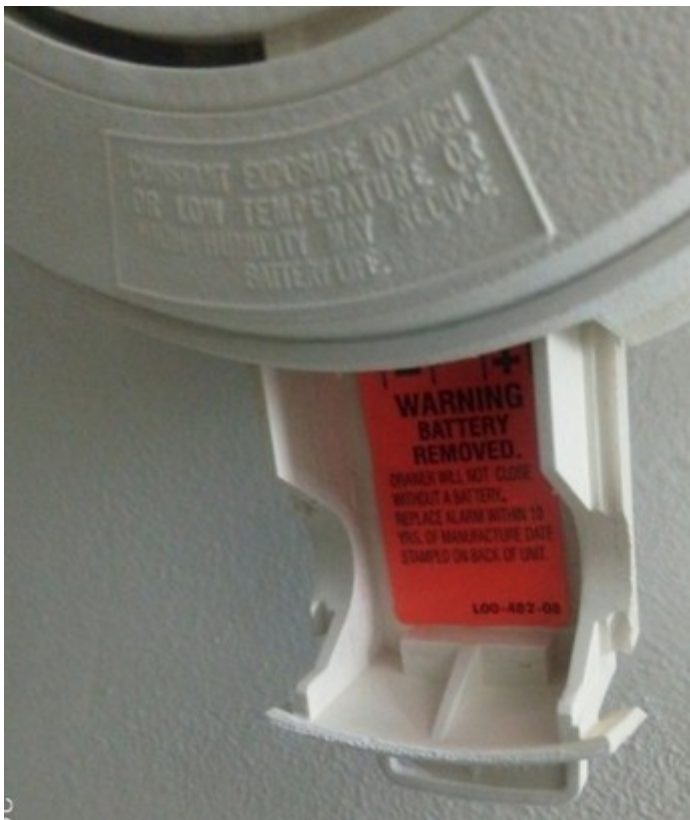
As of June 2021, both smoke alarms in Lot 158 are not yet replaced.

Foyer near main bathroom and kitchen (manufacture date 2008, expired in 2019)

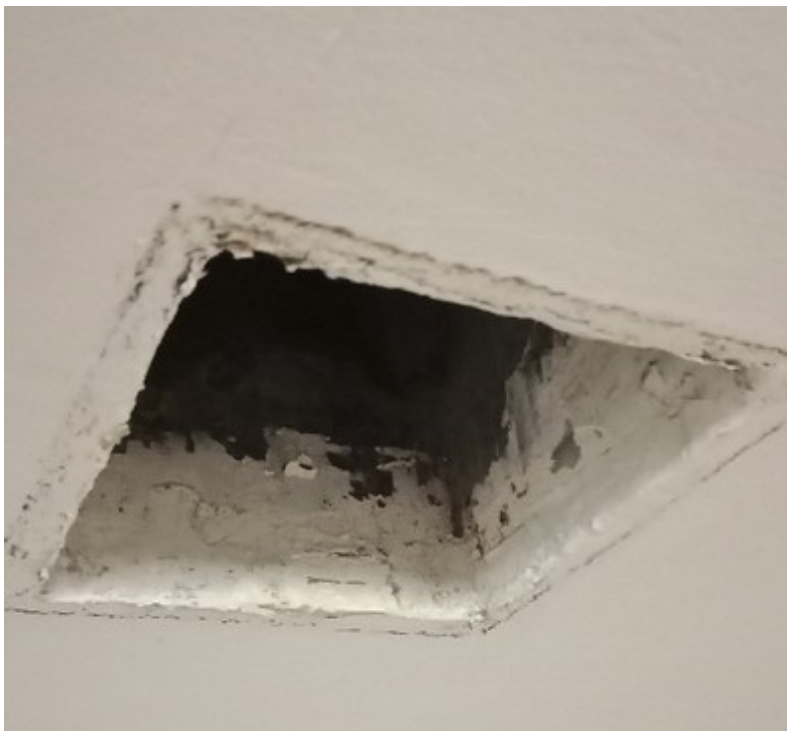
12 May 2021

As of June 2021, this is still an unresolved problem.

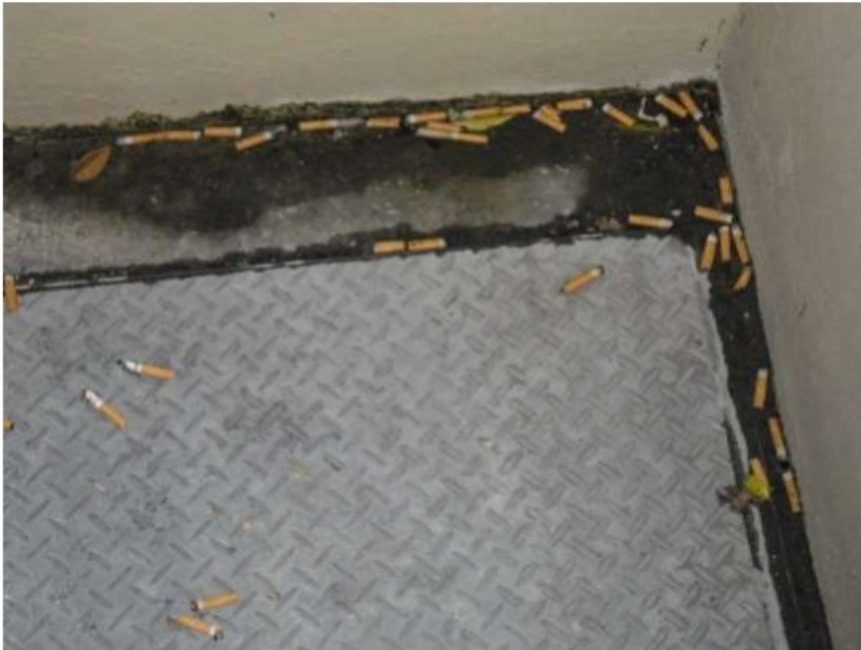
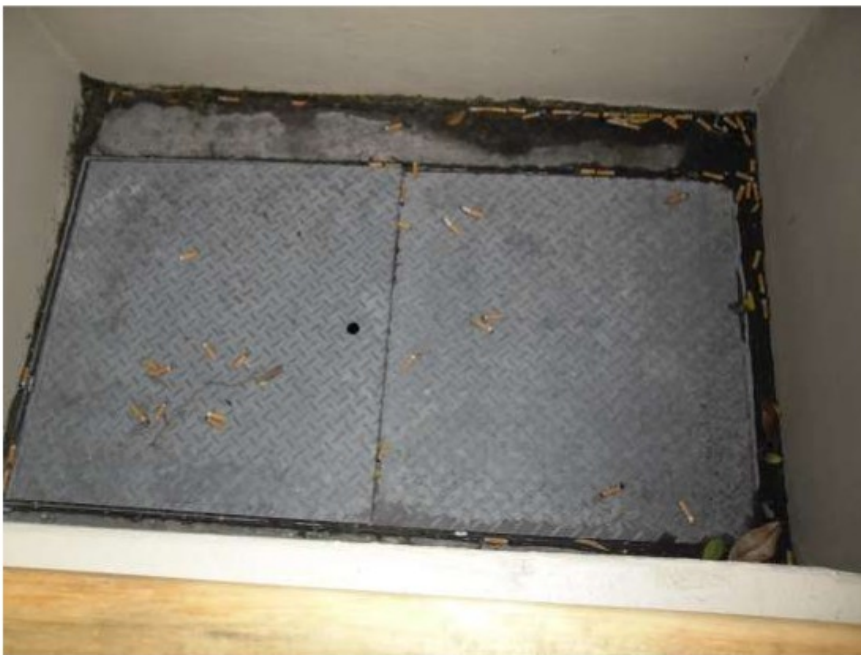
Example of cigarette butt litter on 24<sup>th</sup> of November 2014:

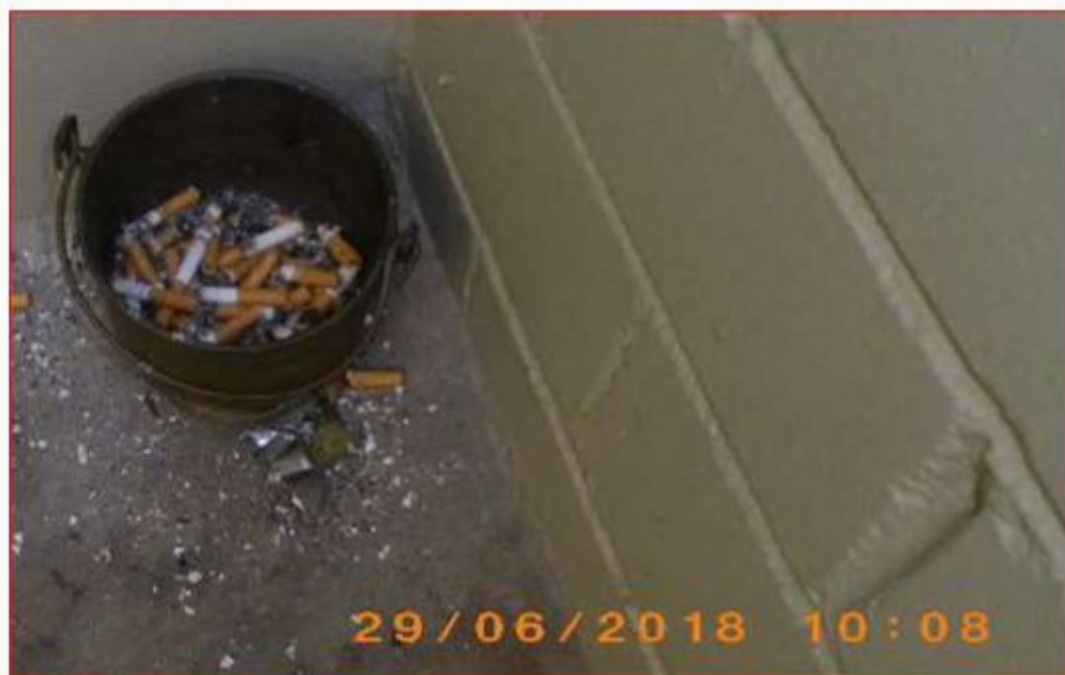
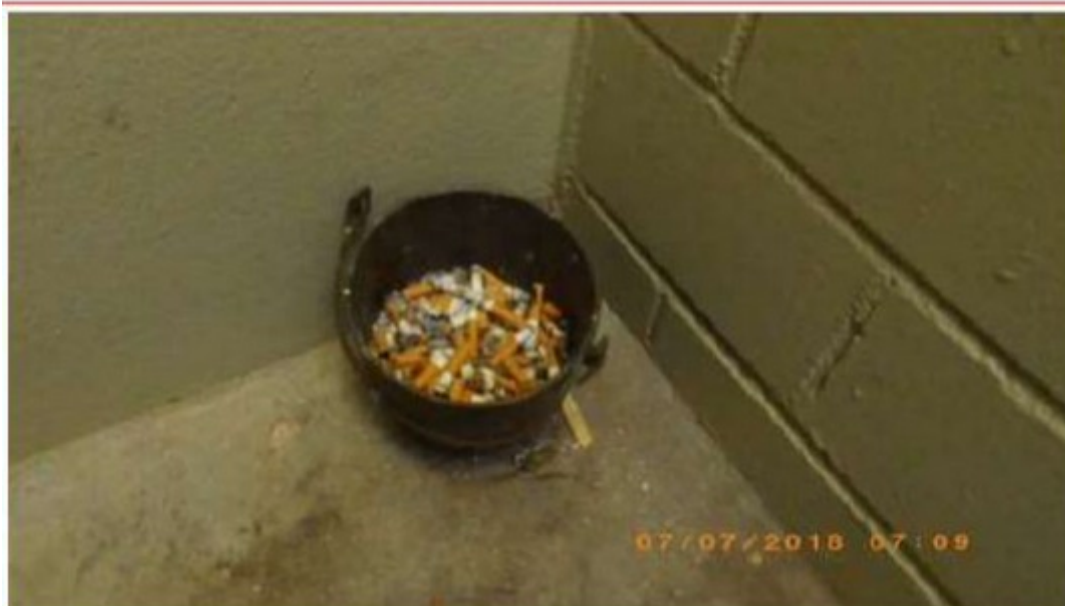
Examples of smoking near fire door 2 below Block A in June and July 2018:

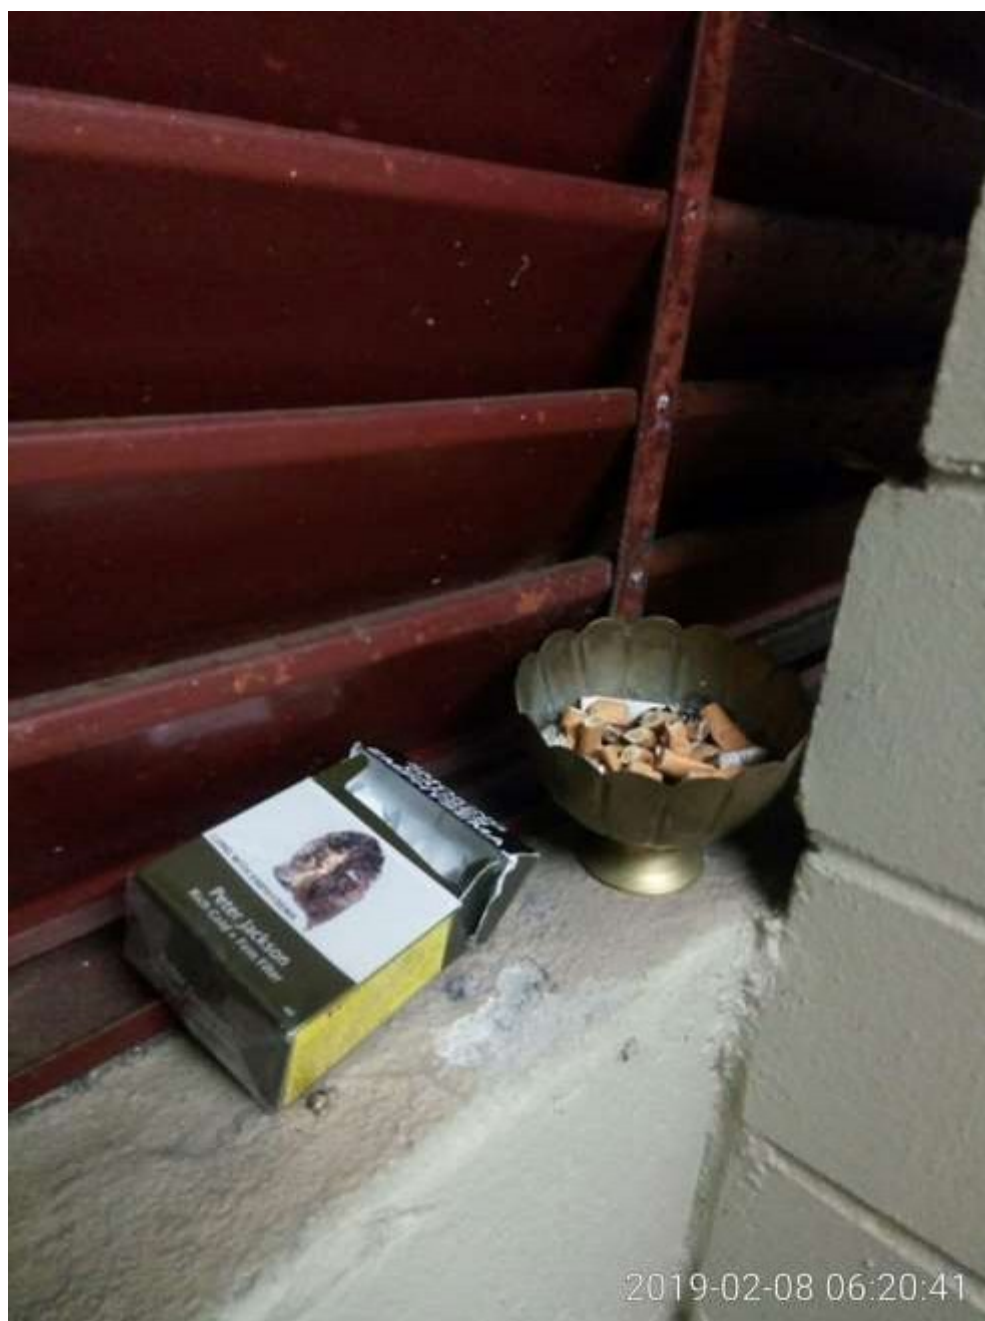
Example of hiding cigarette butts near louvres behind fire door 2 below Block A in February 2019:

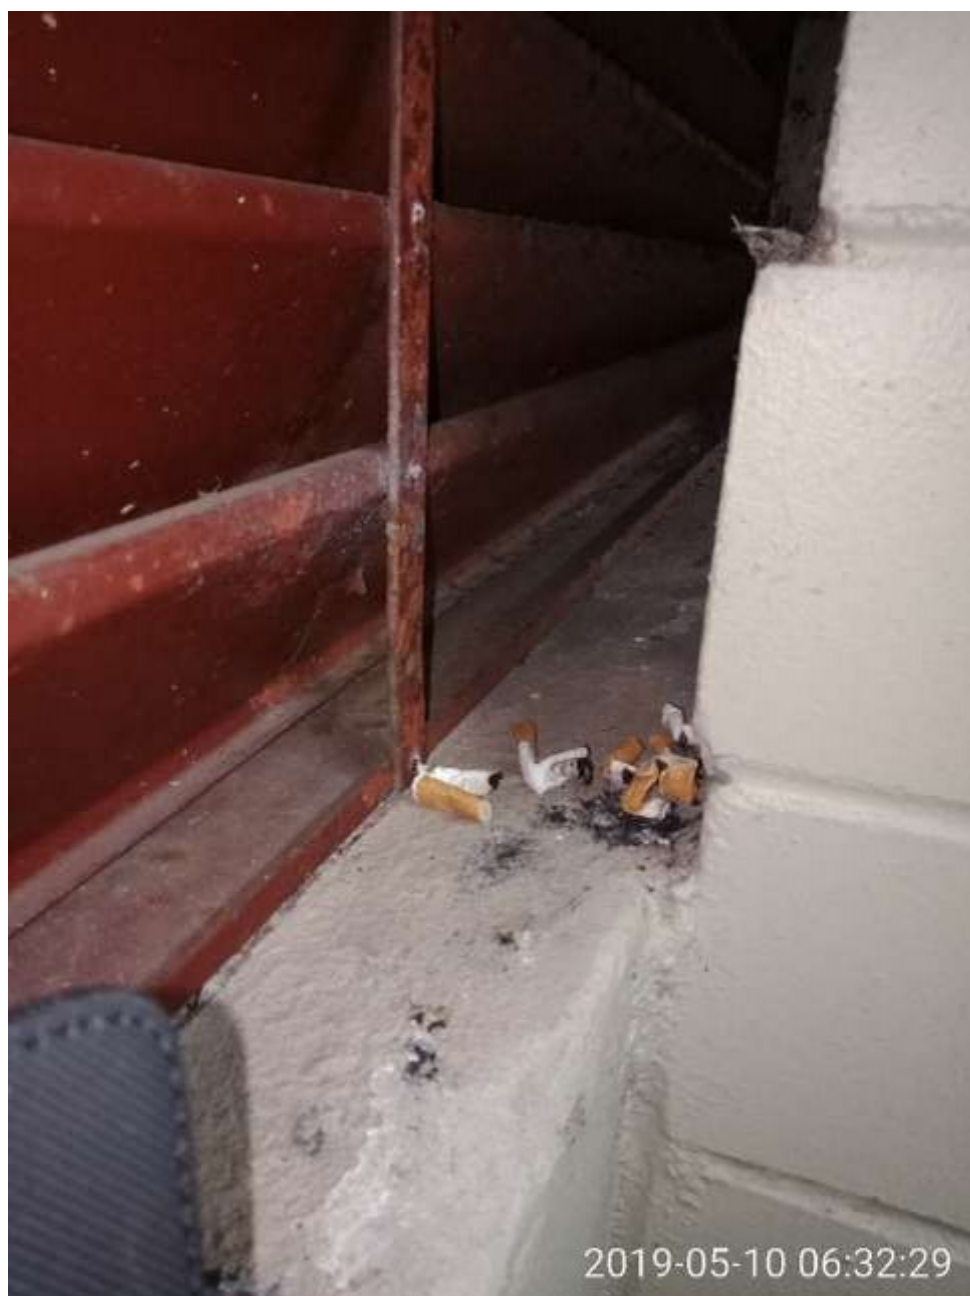
Example of hiding cigarette butts near louvres behind fire door 2 below Block A in May 2019:

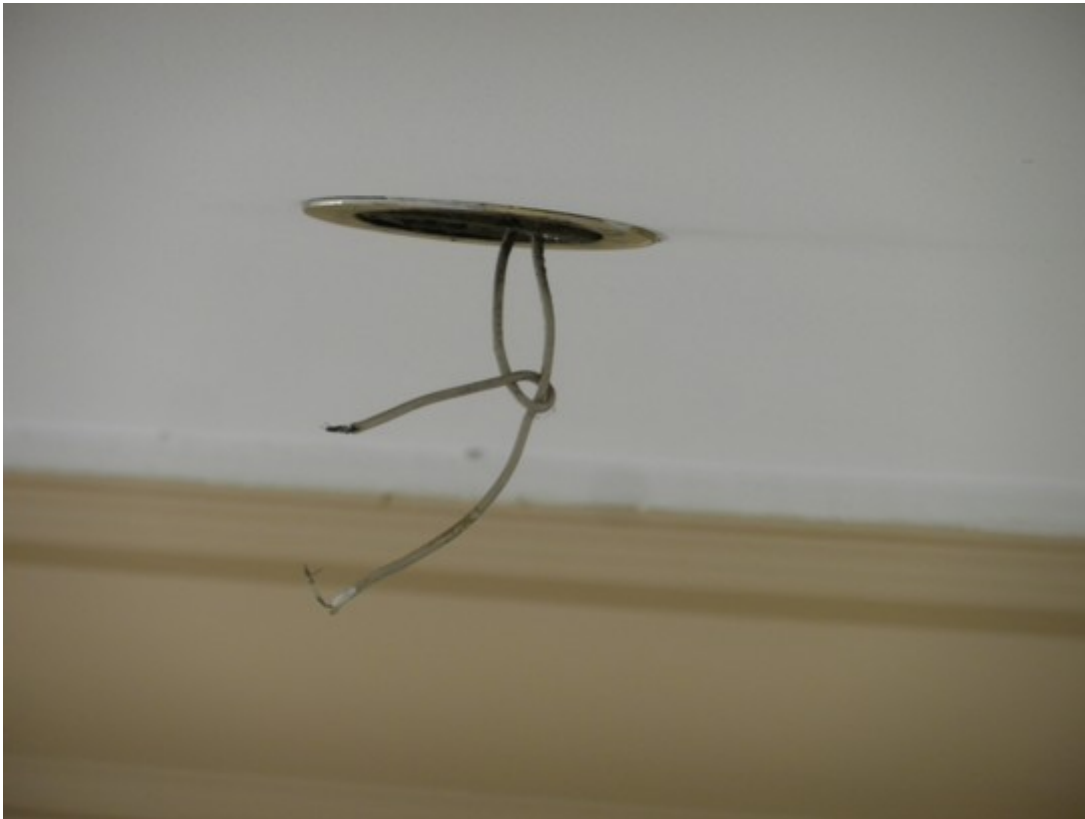
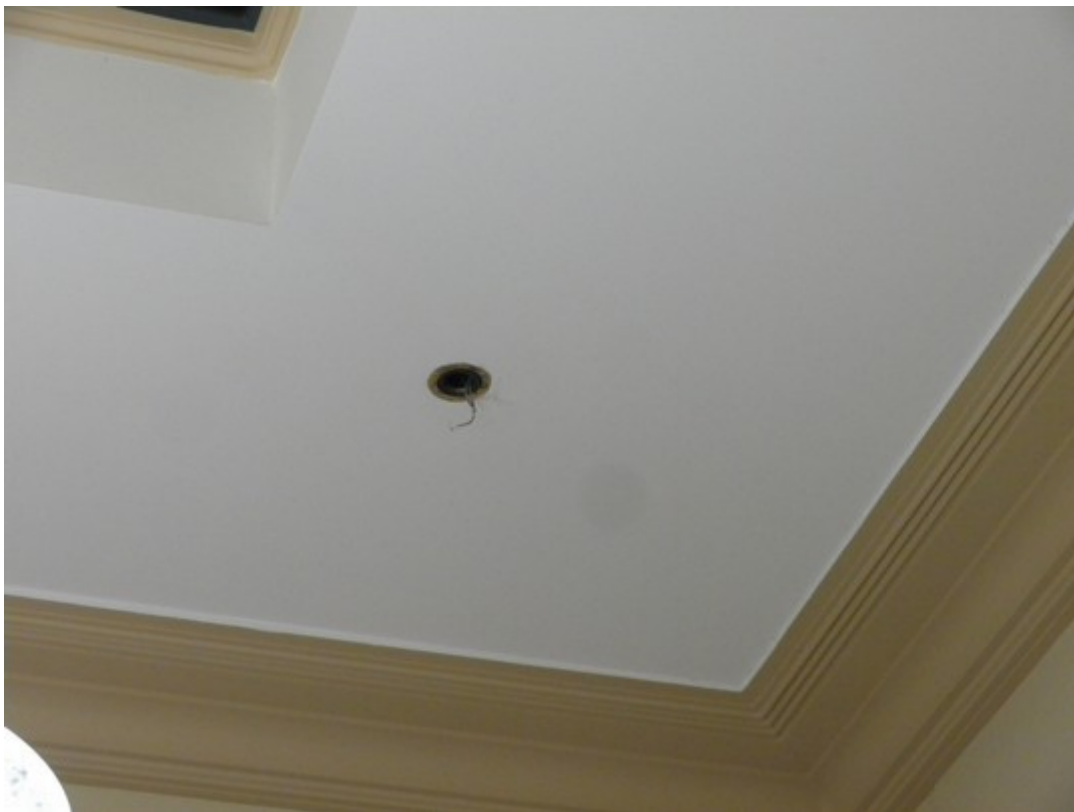
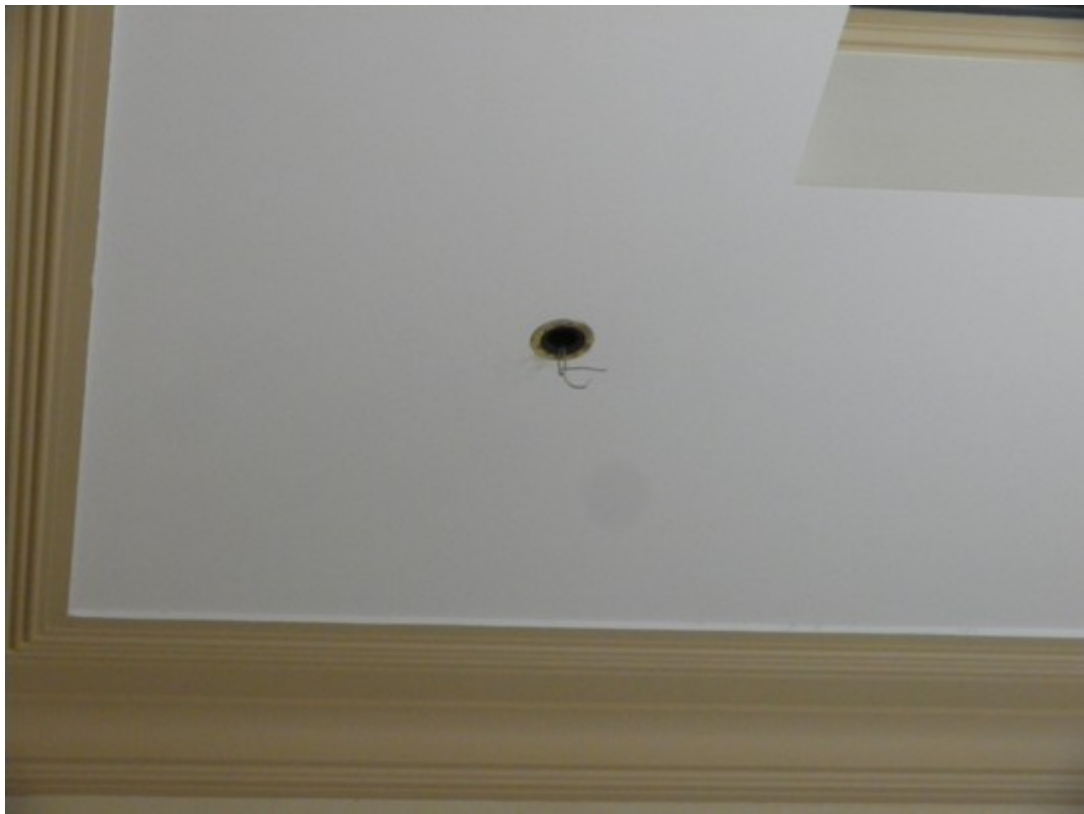
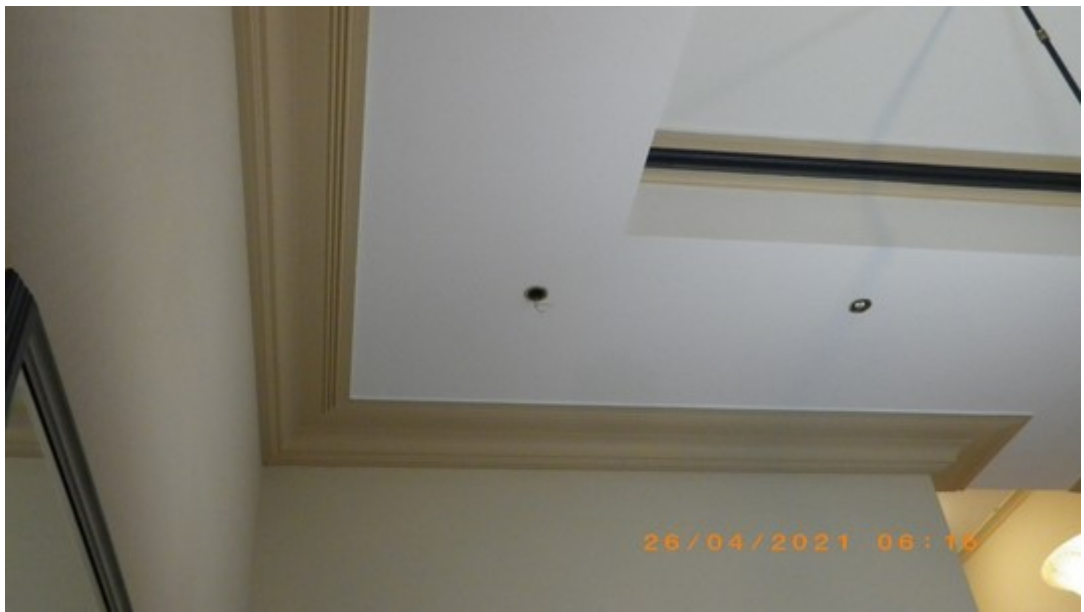
**19 Electrical wires on ceiling for one down-light in Block D foyer for more than one year**

Reported to strata managers repeatedly, Still an unresolved issue.

Not only down-light is not operational but potentially live wires are protruding from the ceiling.

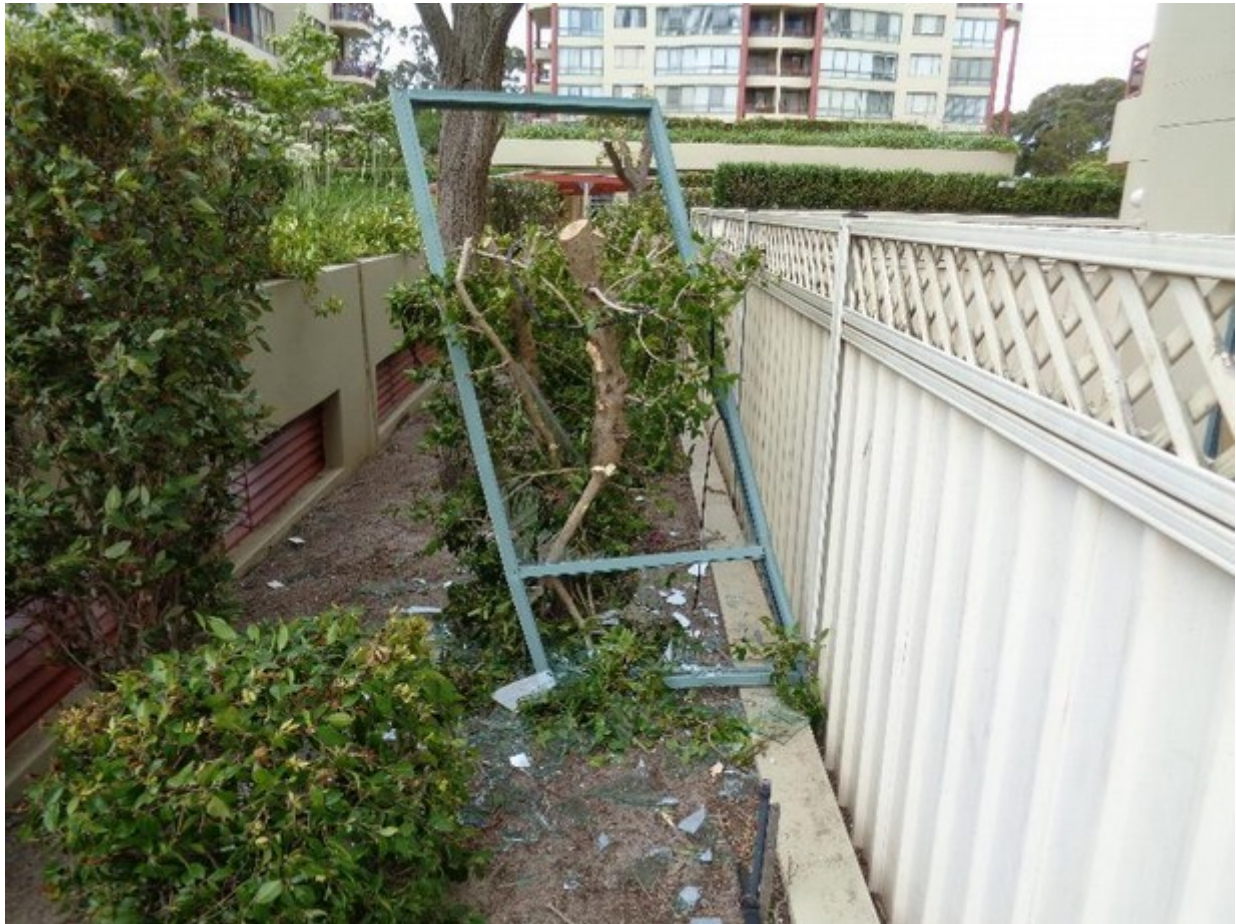
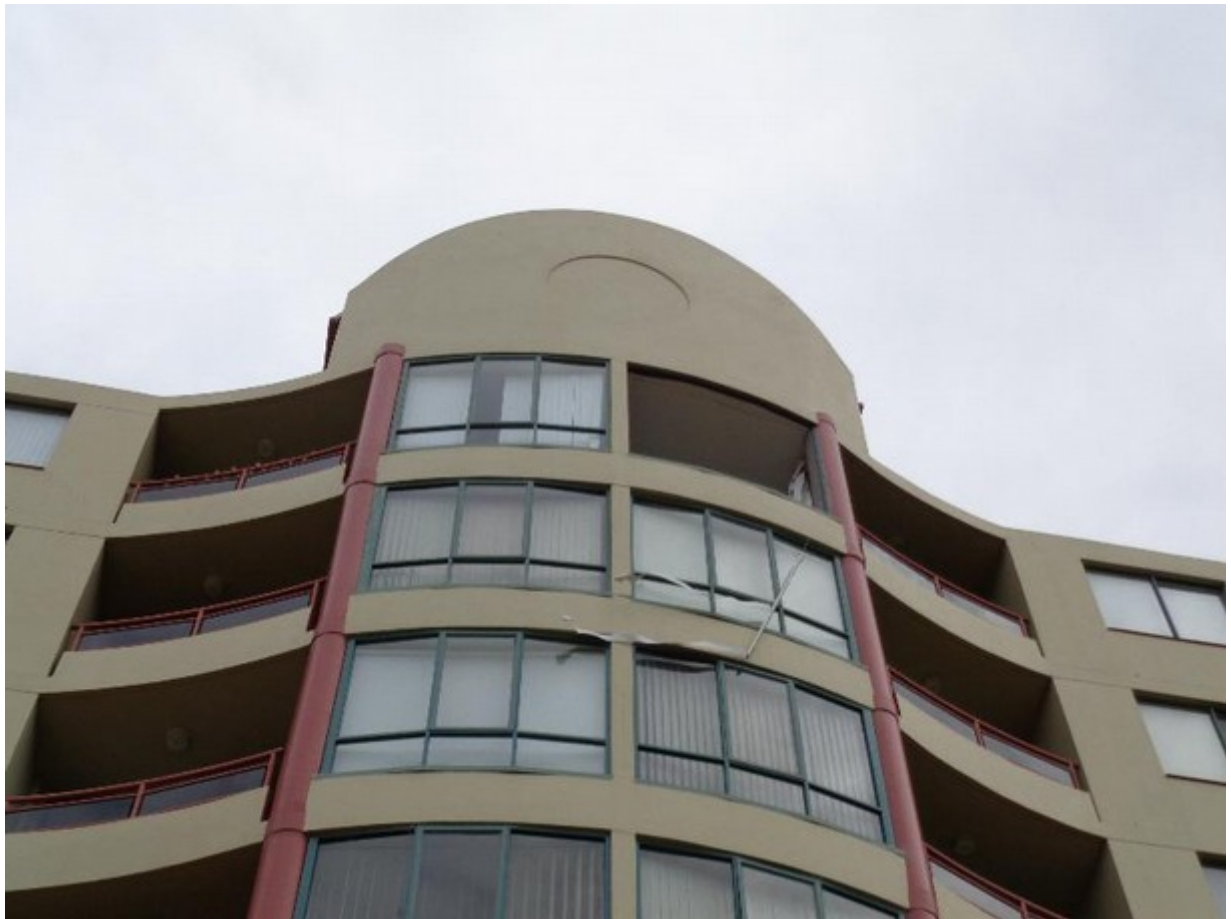
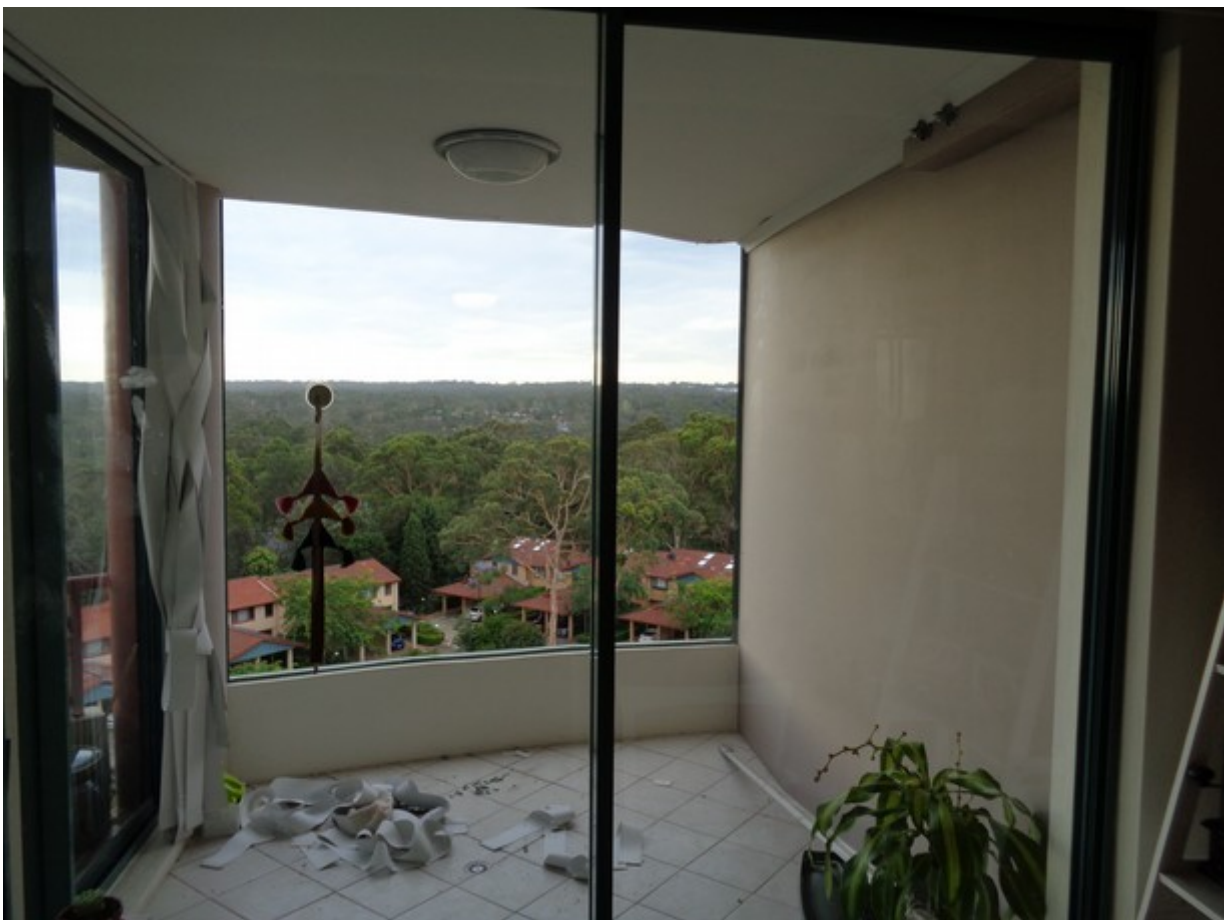
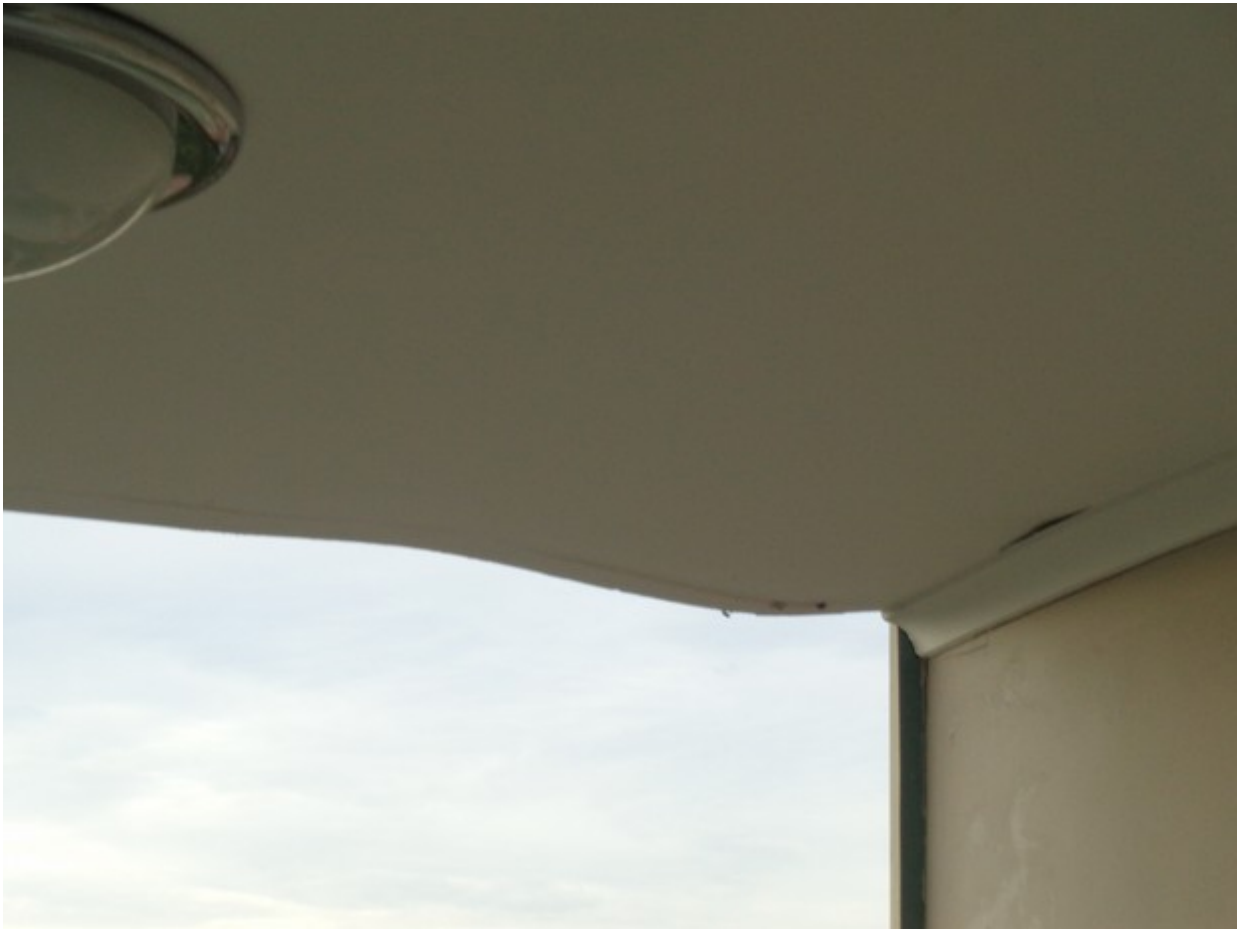
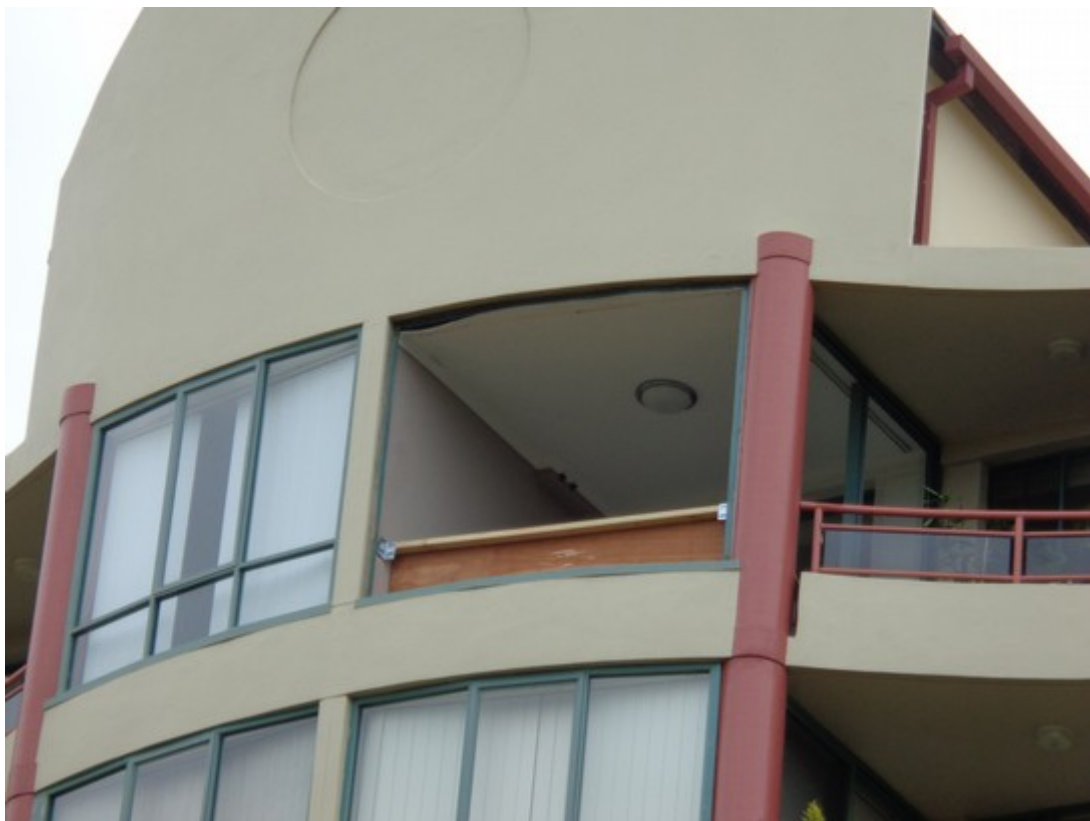
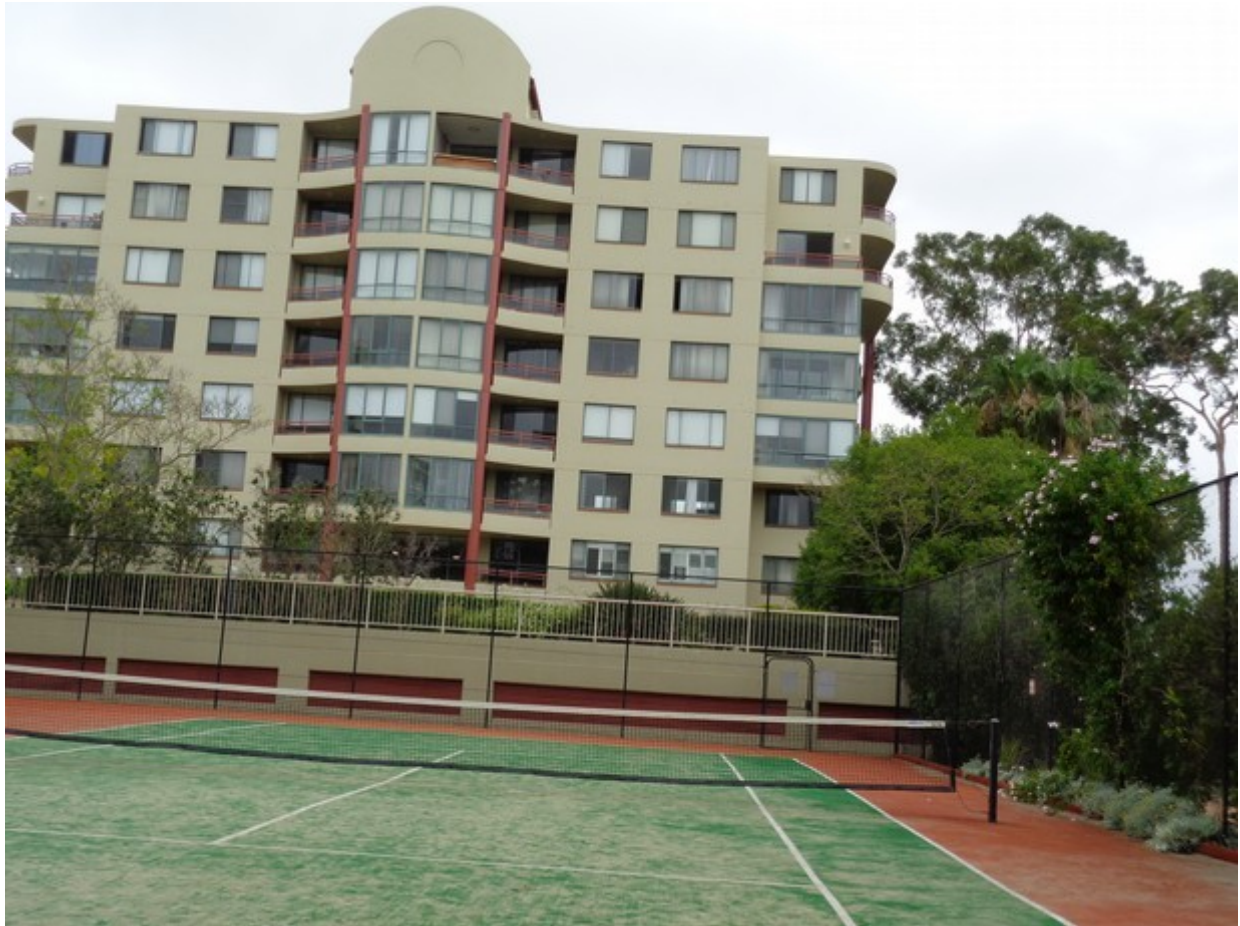
- Third time it happened on 29<sup>th</sup> of November 2020 for Lot 190.

SP52948 has been extremely lucky that female tenant of Lot 190 let go off sunroom frame before it was blown in front of the building. She tried to hold onto it but was too weak to prevent the disaster. Otherwise, we would have had major or even fatal incident.

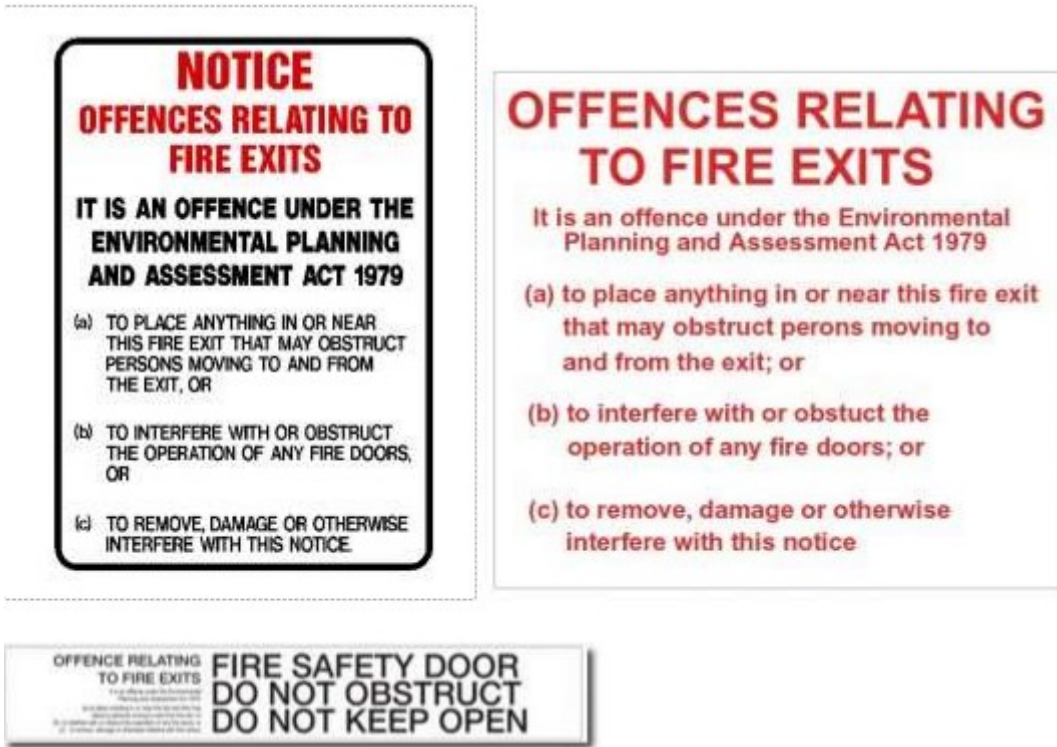
Starta managers were repeatedly asked to confirm if the following is valid and if so, why various fire doors in SP52948 have very different or missing signage – no reply was ever received:

*In NSW all fire doors must permanently display the sign (Fire Safety Door / Do Not Obstruct / Do Not Keep Open) and display sign outlining the 'Offences Relating to Fire Exits':*

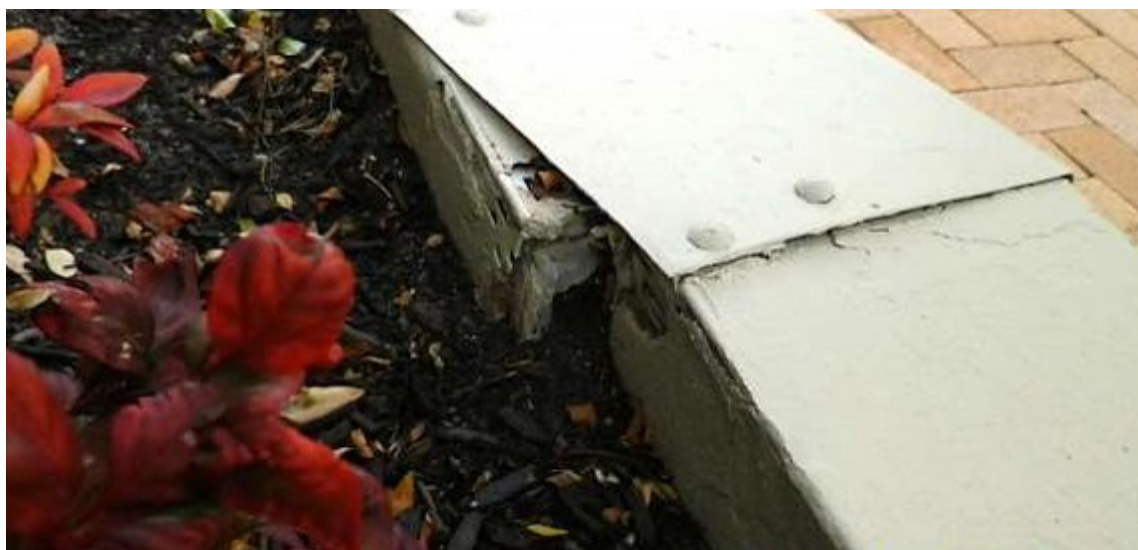
### 32 Example of garden bed collapse risk near Block D in June 2021

Problem exists since 2013:

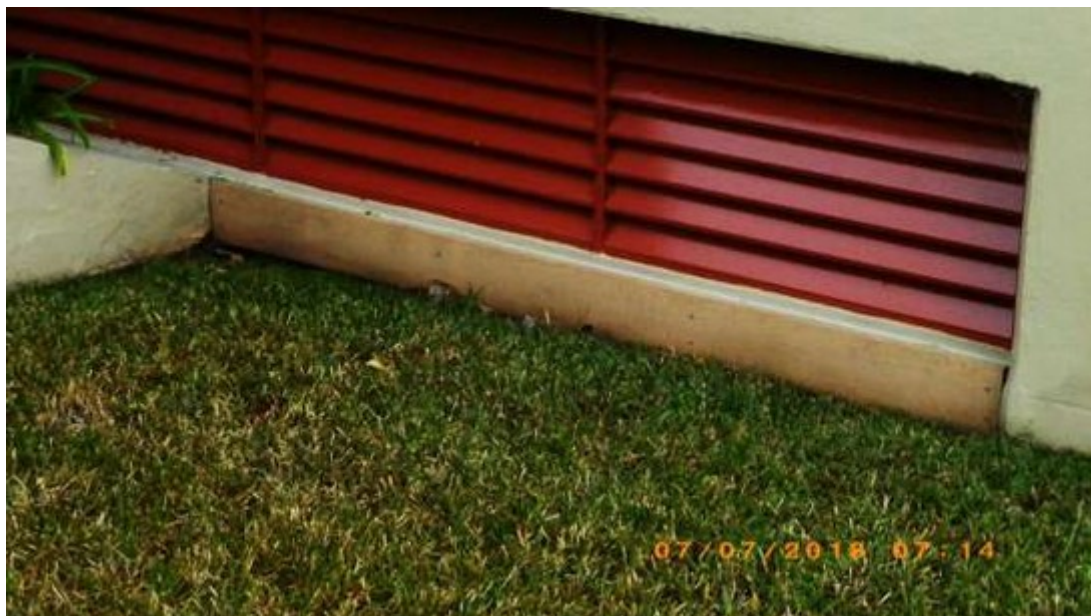
After installation of wooden plank:
